St Mel's Cathedral Longford – Fire 25th December 2009

Summary of Nature & Extent of Damage

Presentation to the Diocese of Ardagh & Clonmacnois

Saturday 10th April 2010

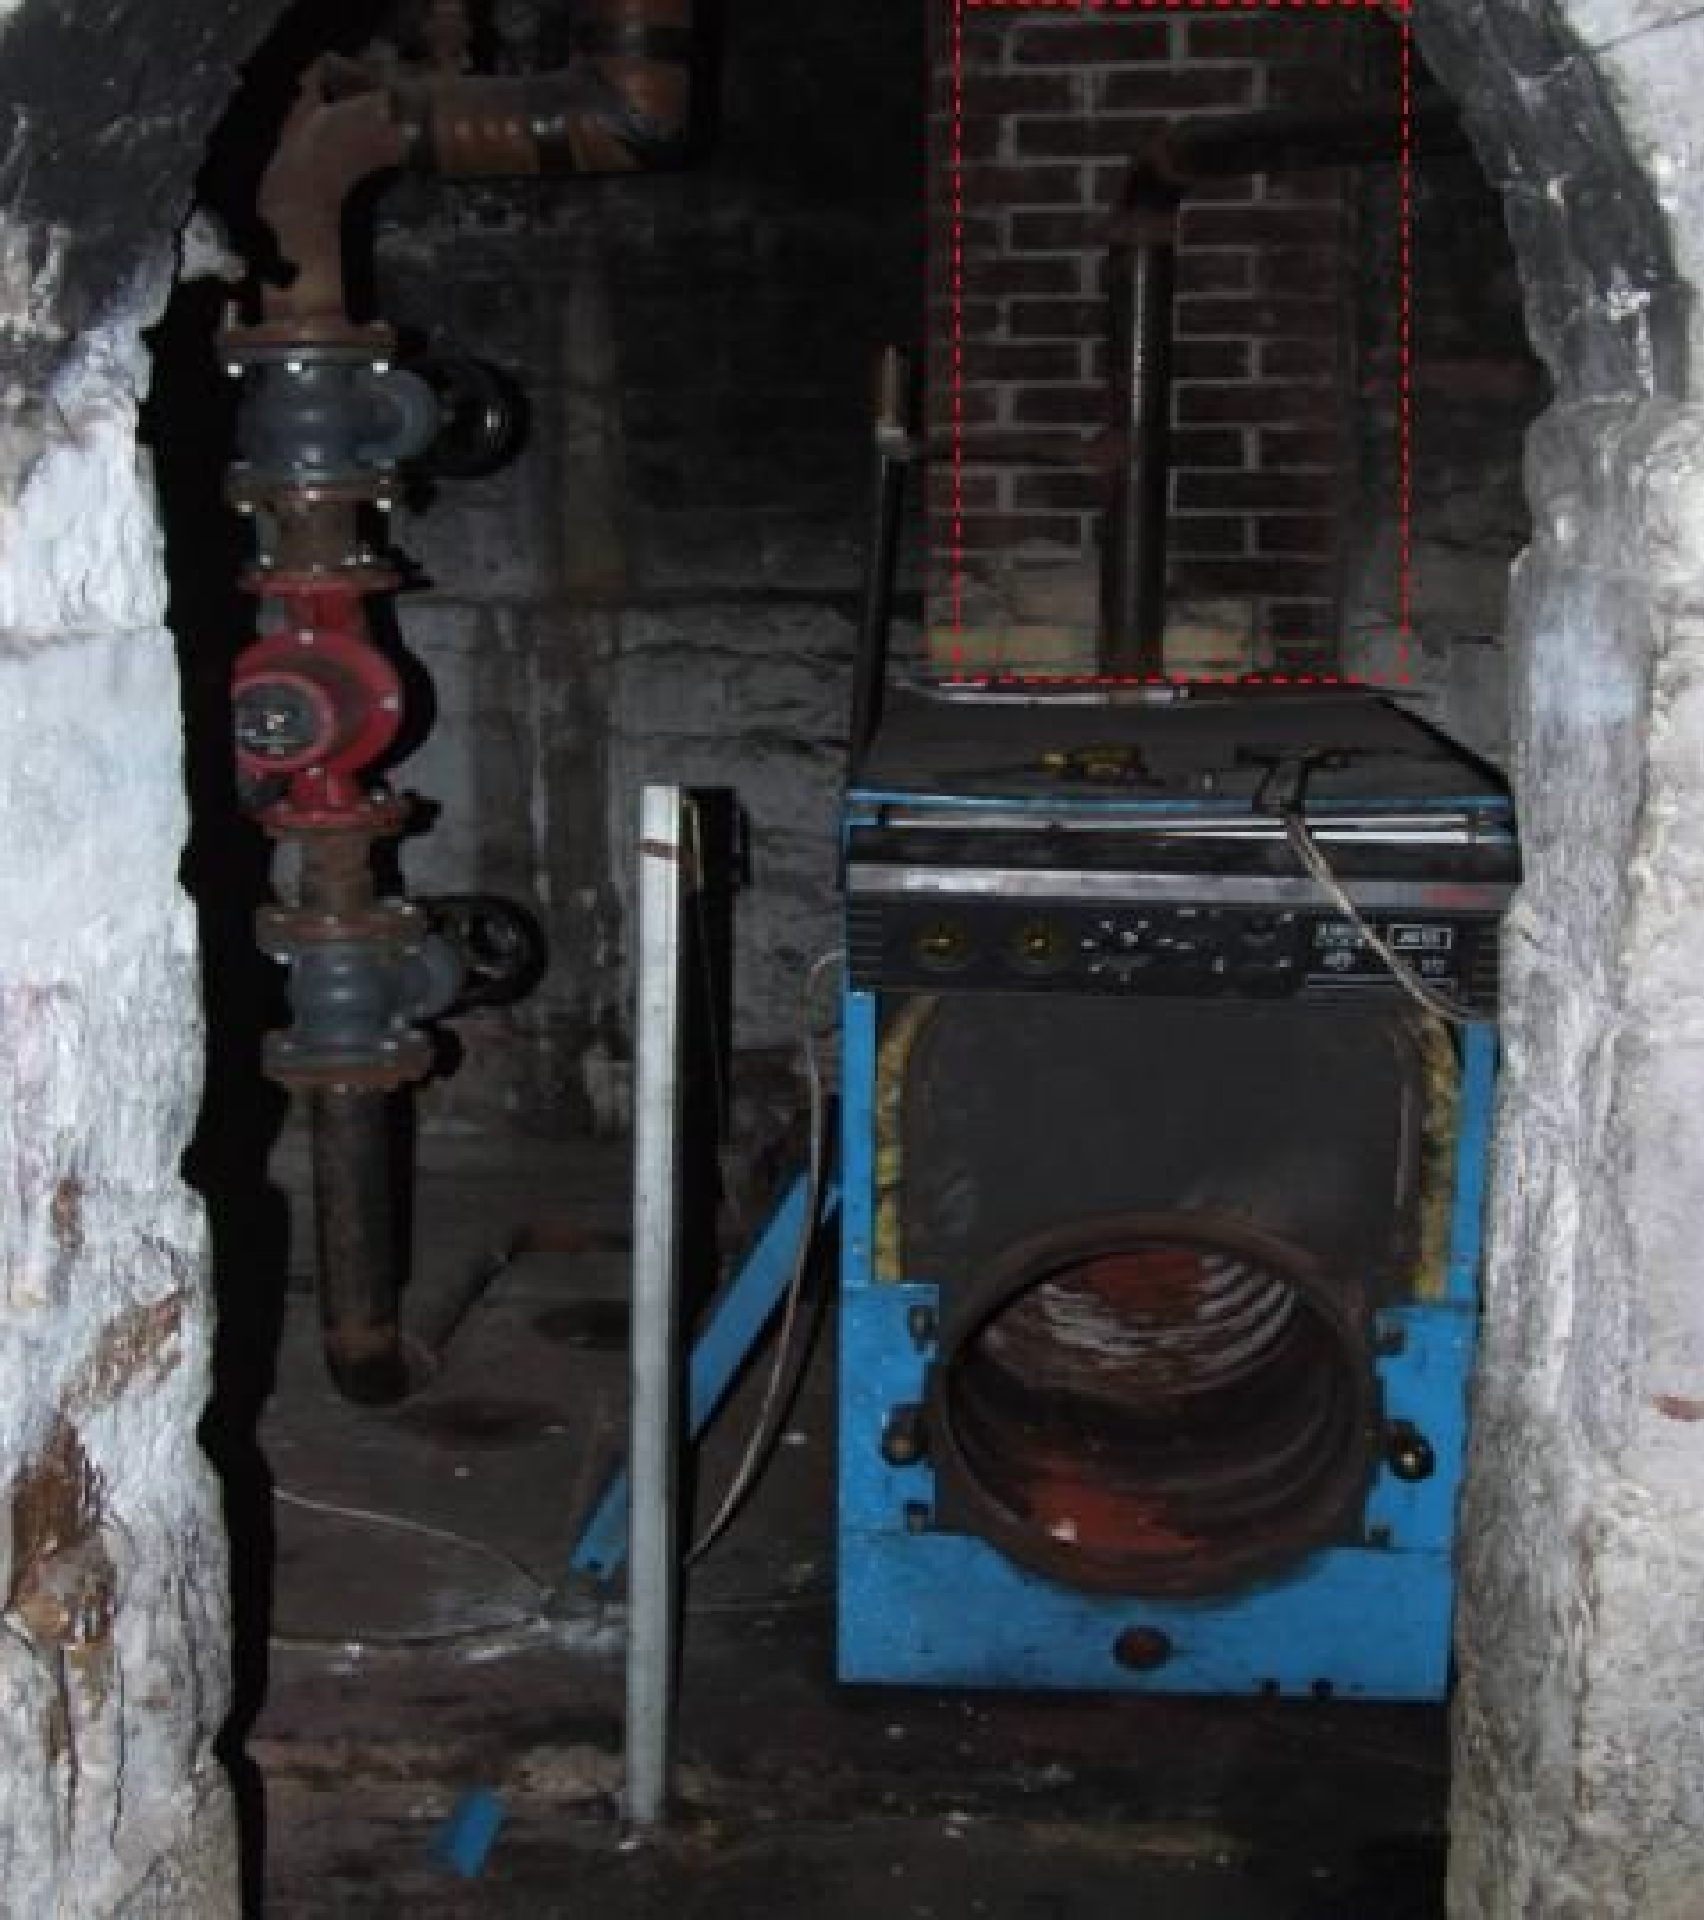
Boiler room and boiler.

Note absence of
burning in this room.
Brick flue in which seat
of fire was located is
indicated in red

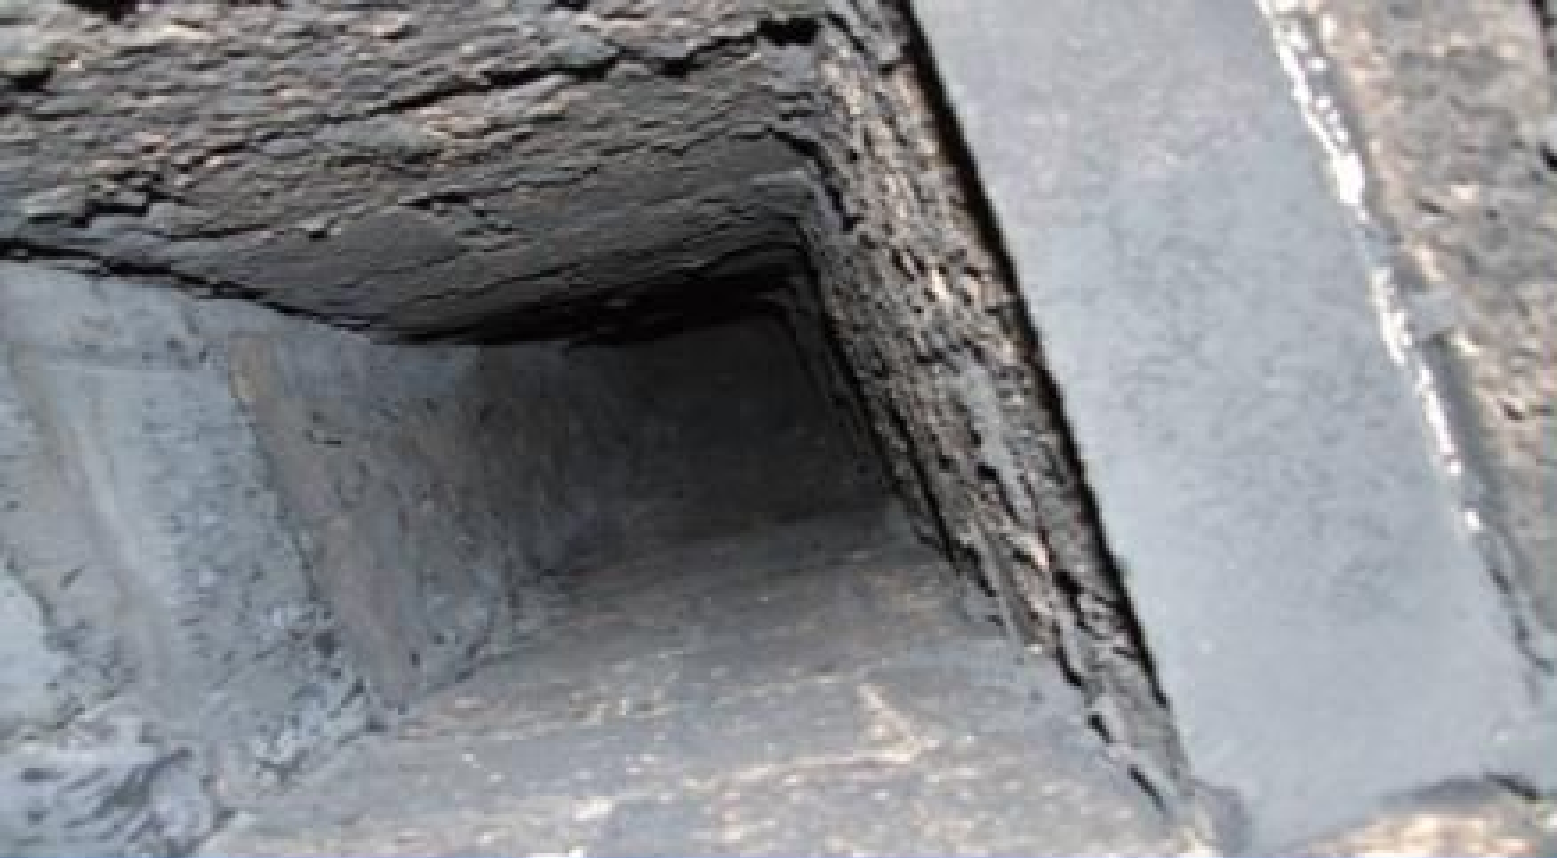
- The flue serving this boiler connected into an old brick lined chimney which formed part of the original cathedral construction
- Old combustible material which had accumulated in this old brick lined chimney over many years became dried out and were likely super-heated and glowing

- When the burner was turned off an oxygen supply was restored and now assisted by a natural and maintained draught these old deposits ignited leading to a serious flue fire

Boiler flue above
inspection hatch
(note old deposits
burnt away)

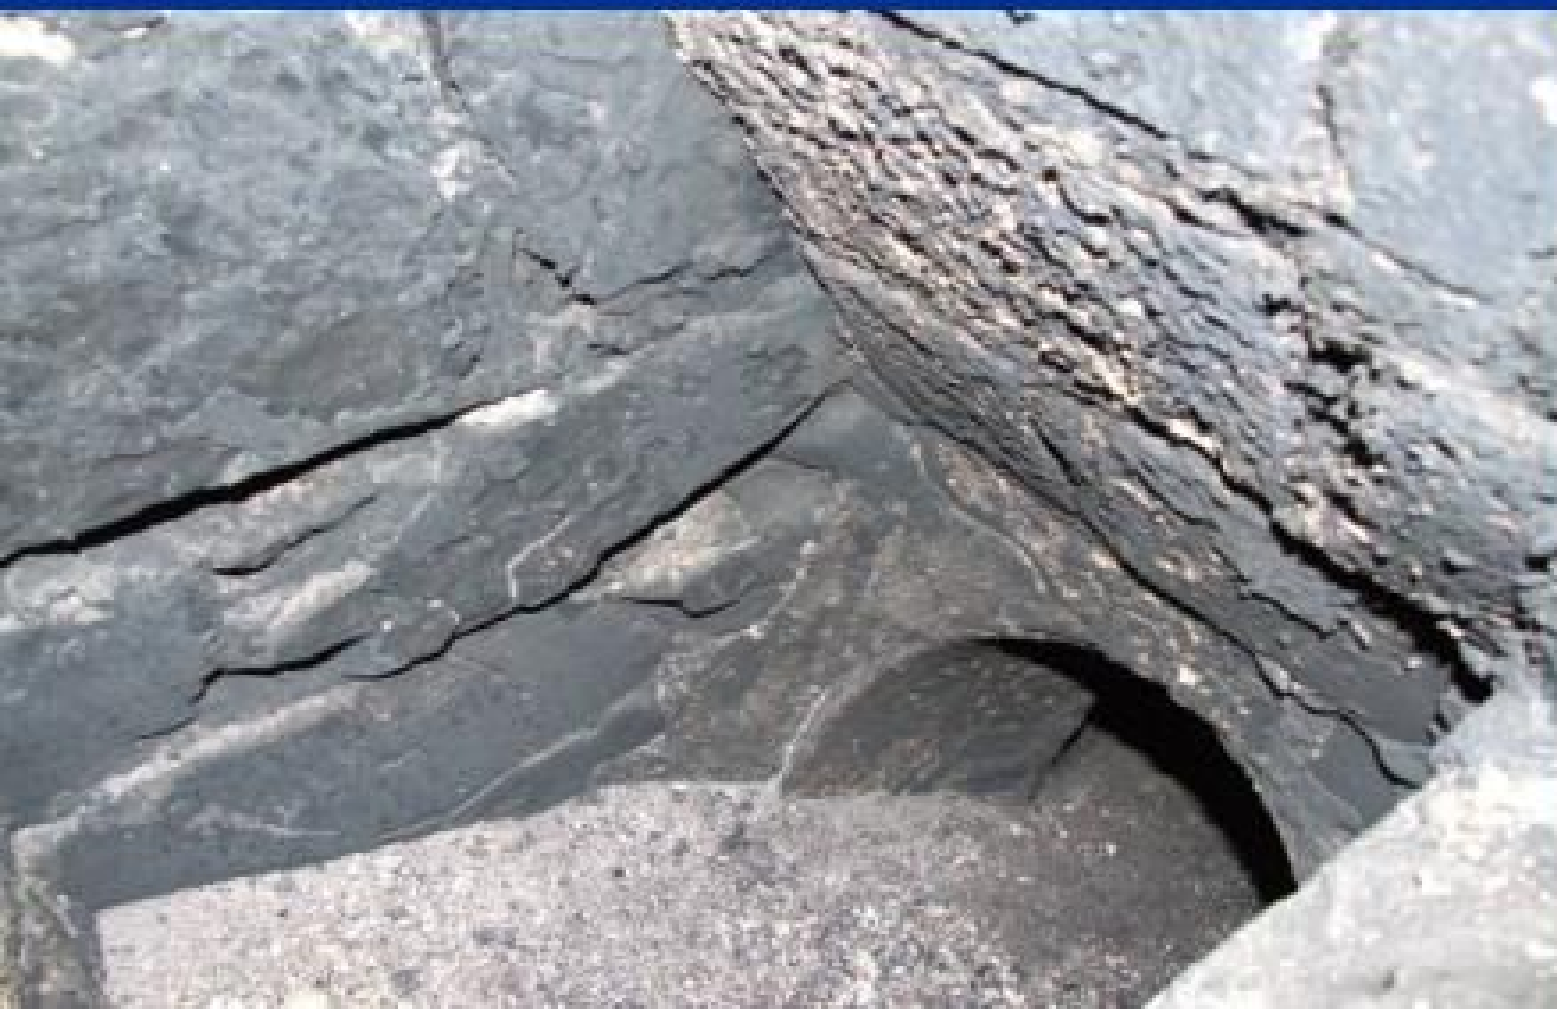
Brick flue inside of
inspection hatch (note
ashes from burnt
deposits)

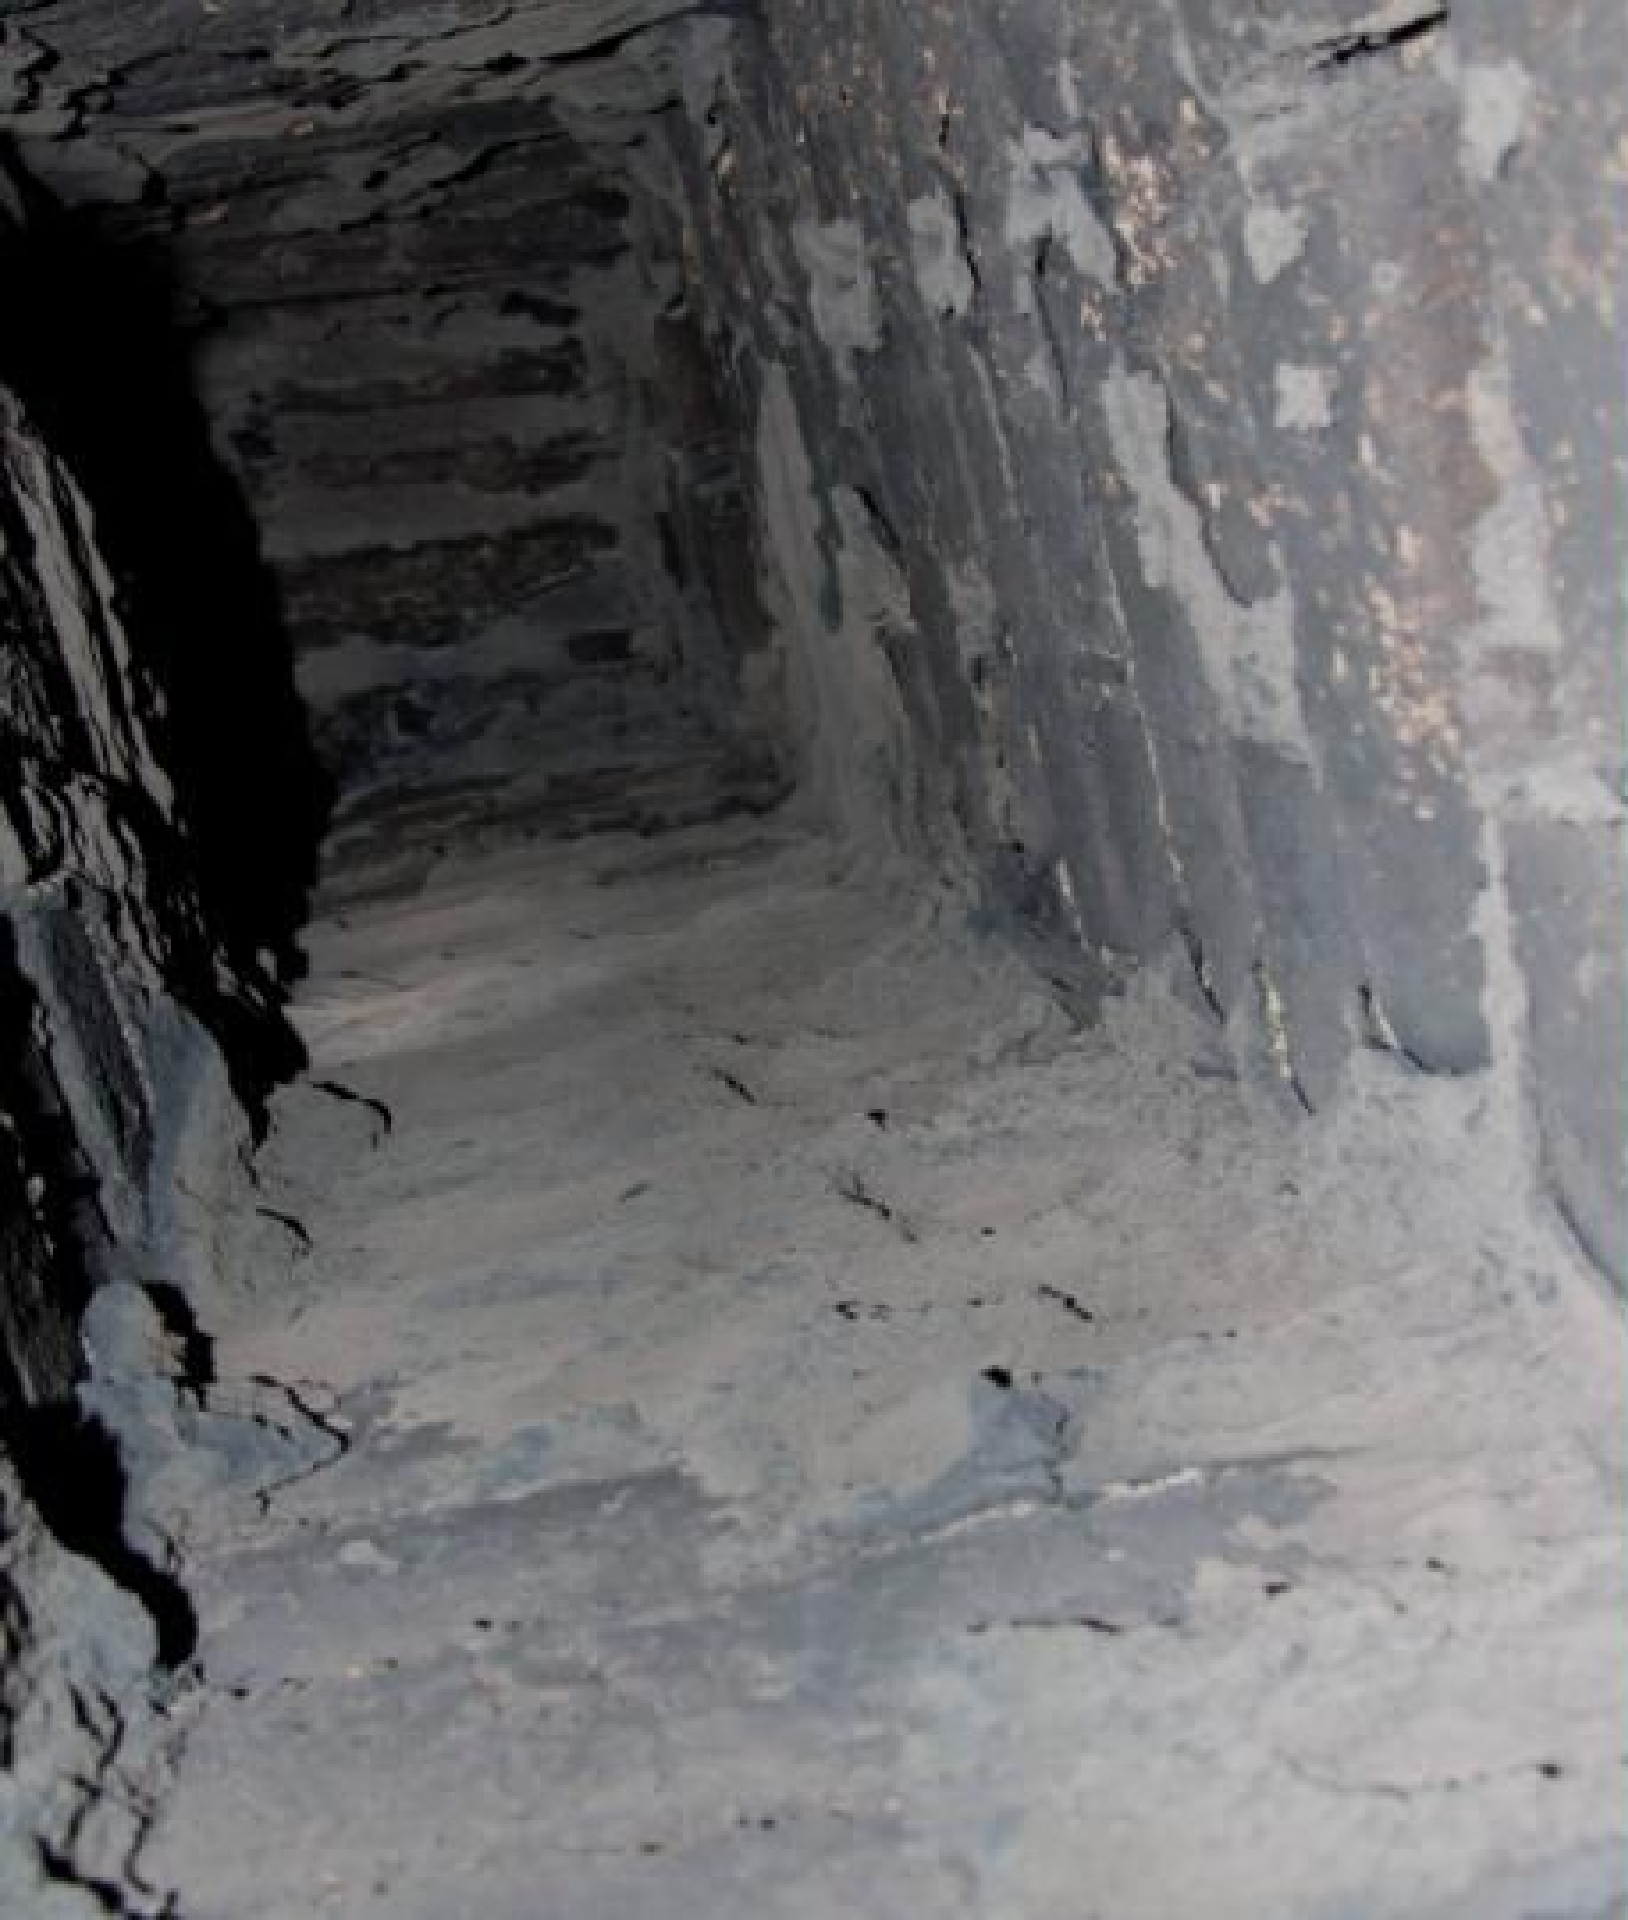
Interior of flue in
crypt (Note remains
of heavy deposits
still in place after
flue fire)

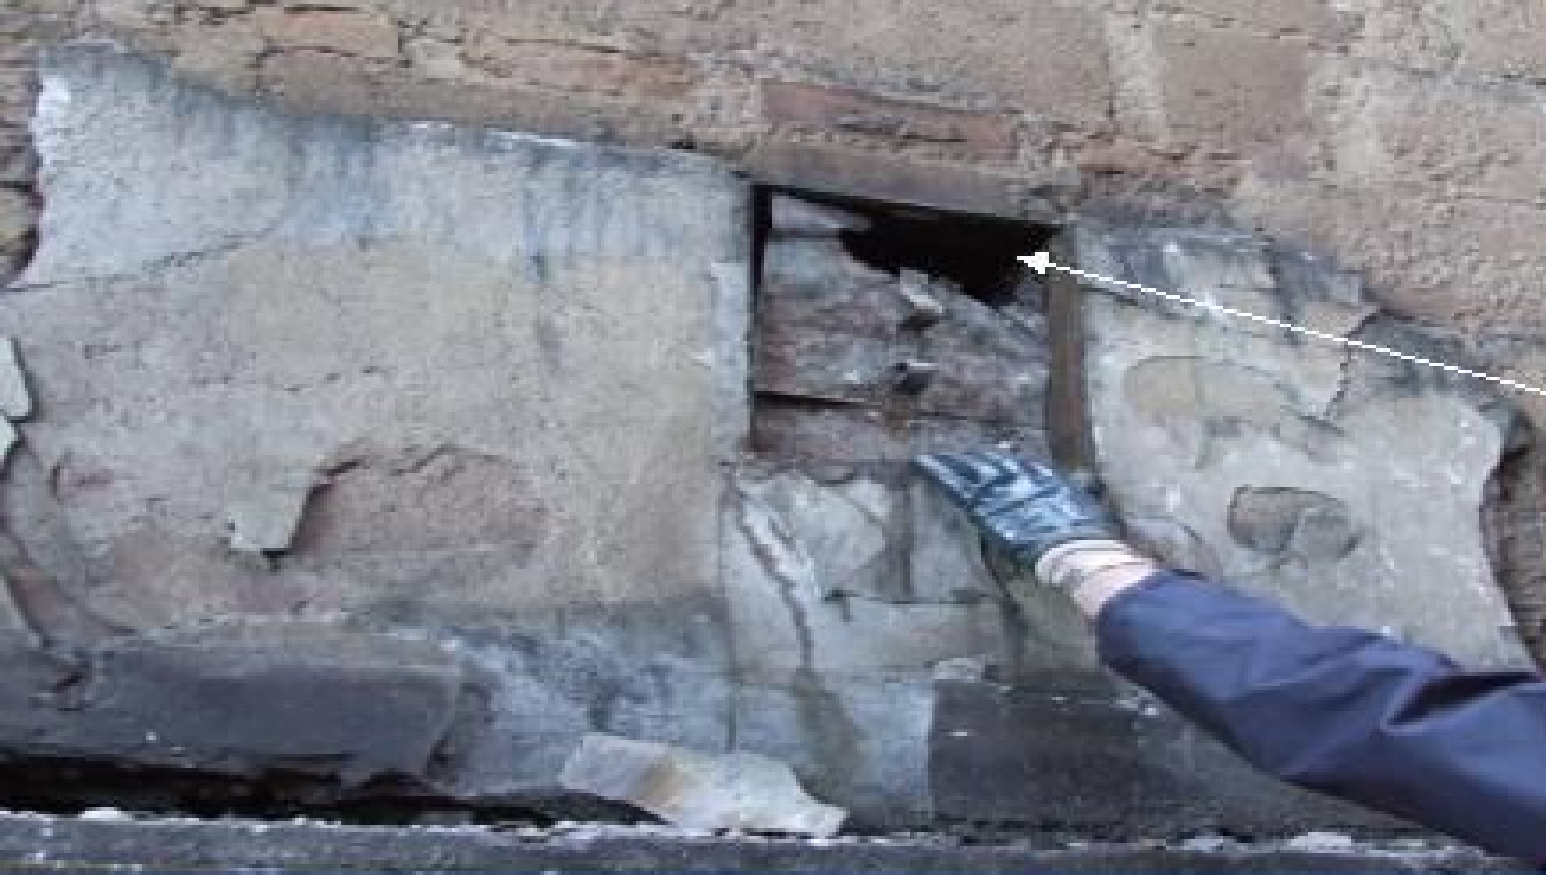
- Burning embers escaped through old worn inspection hatch doors into the priests sacristy igniting combustible materials therein
- Both the central heating boiler and burner were found in good condition and had been correctly maintained and serviced

Clear evidence of corrosion in top quarter of inner inspection door located in priests sacristy

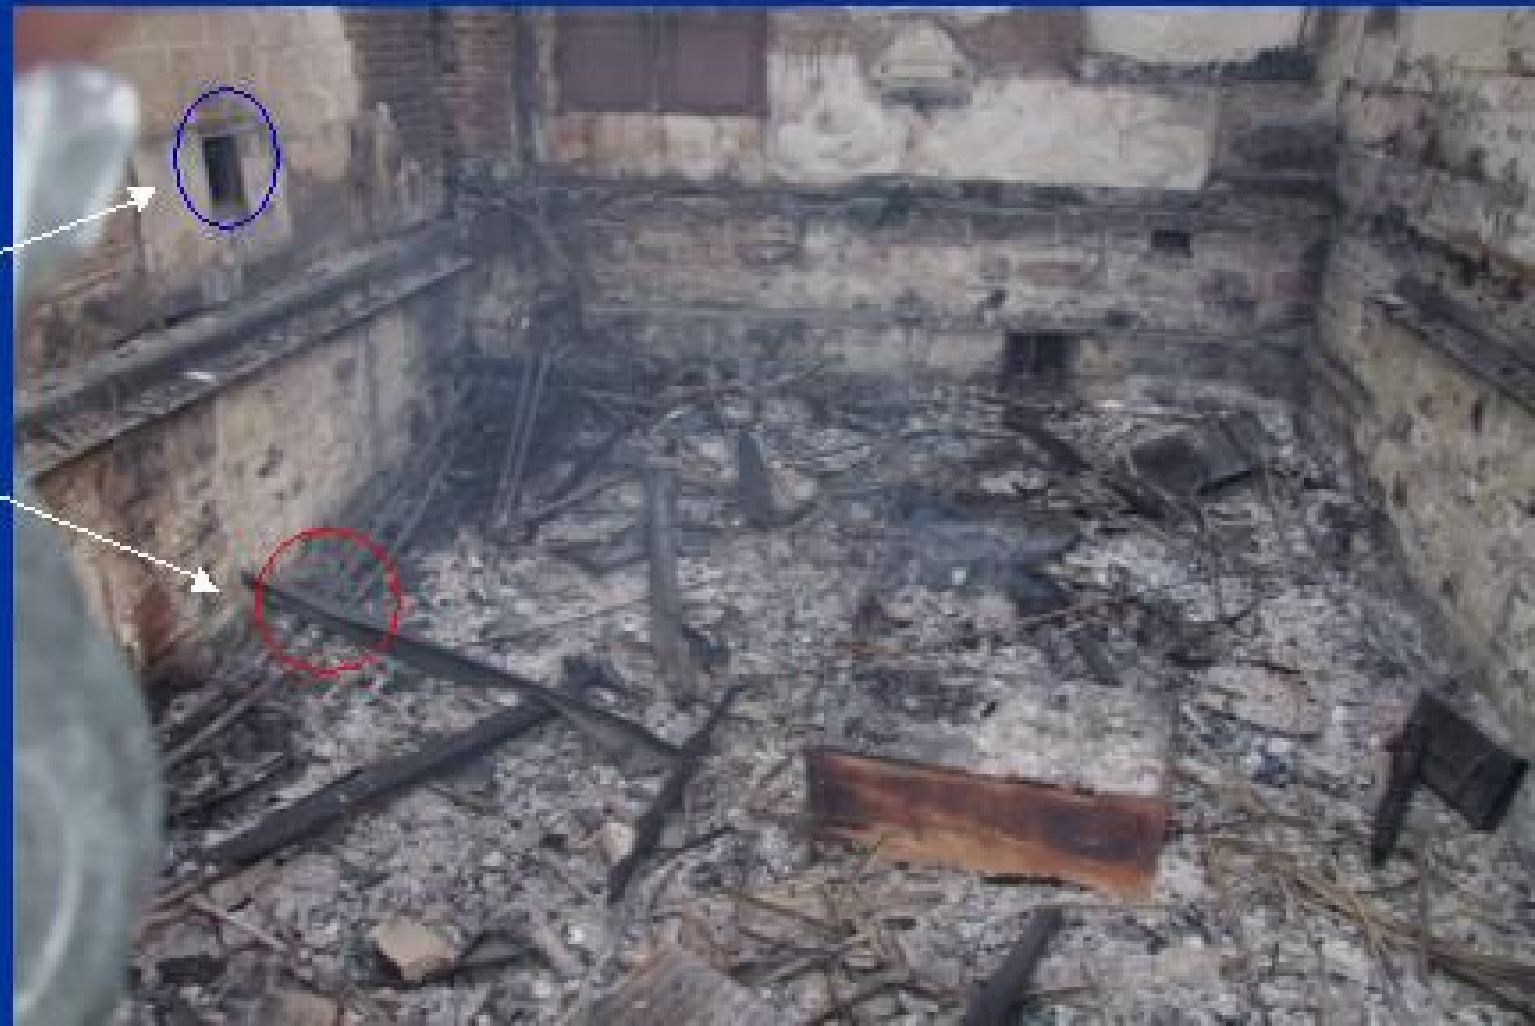
Overview of original outer hatch position and location found post-fire
