St Mel's Cathedral Longford – Fire 25th December 2009

Summary of Nature & Extent of Damage

Presentation to the Diocese of Ardagh & Clonmacnois

Saturday 10th April 2010

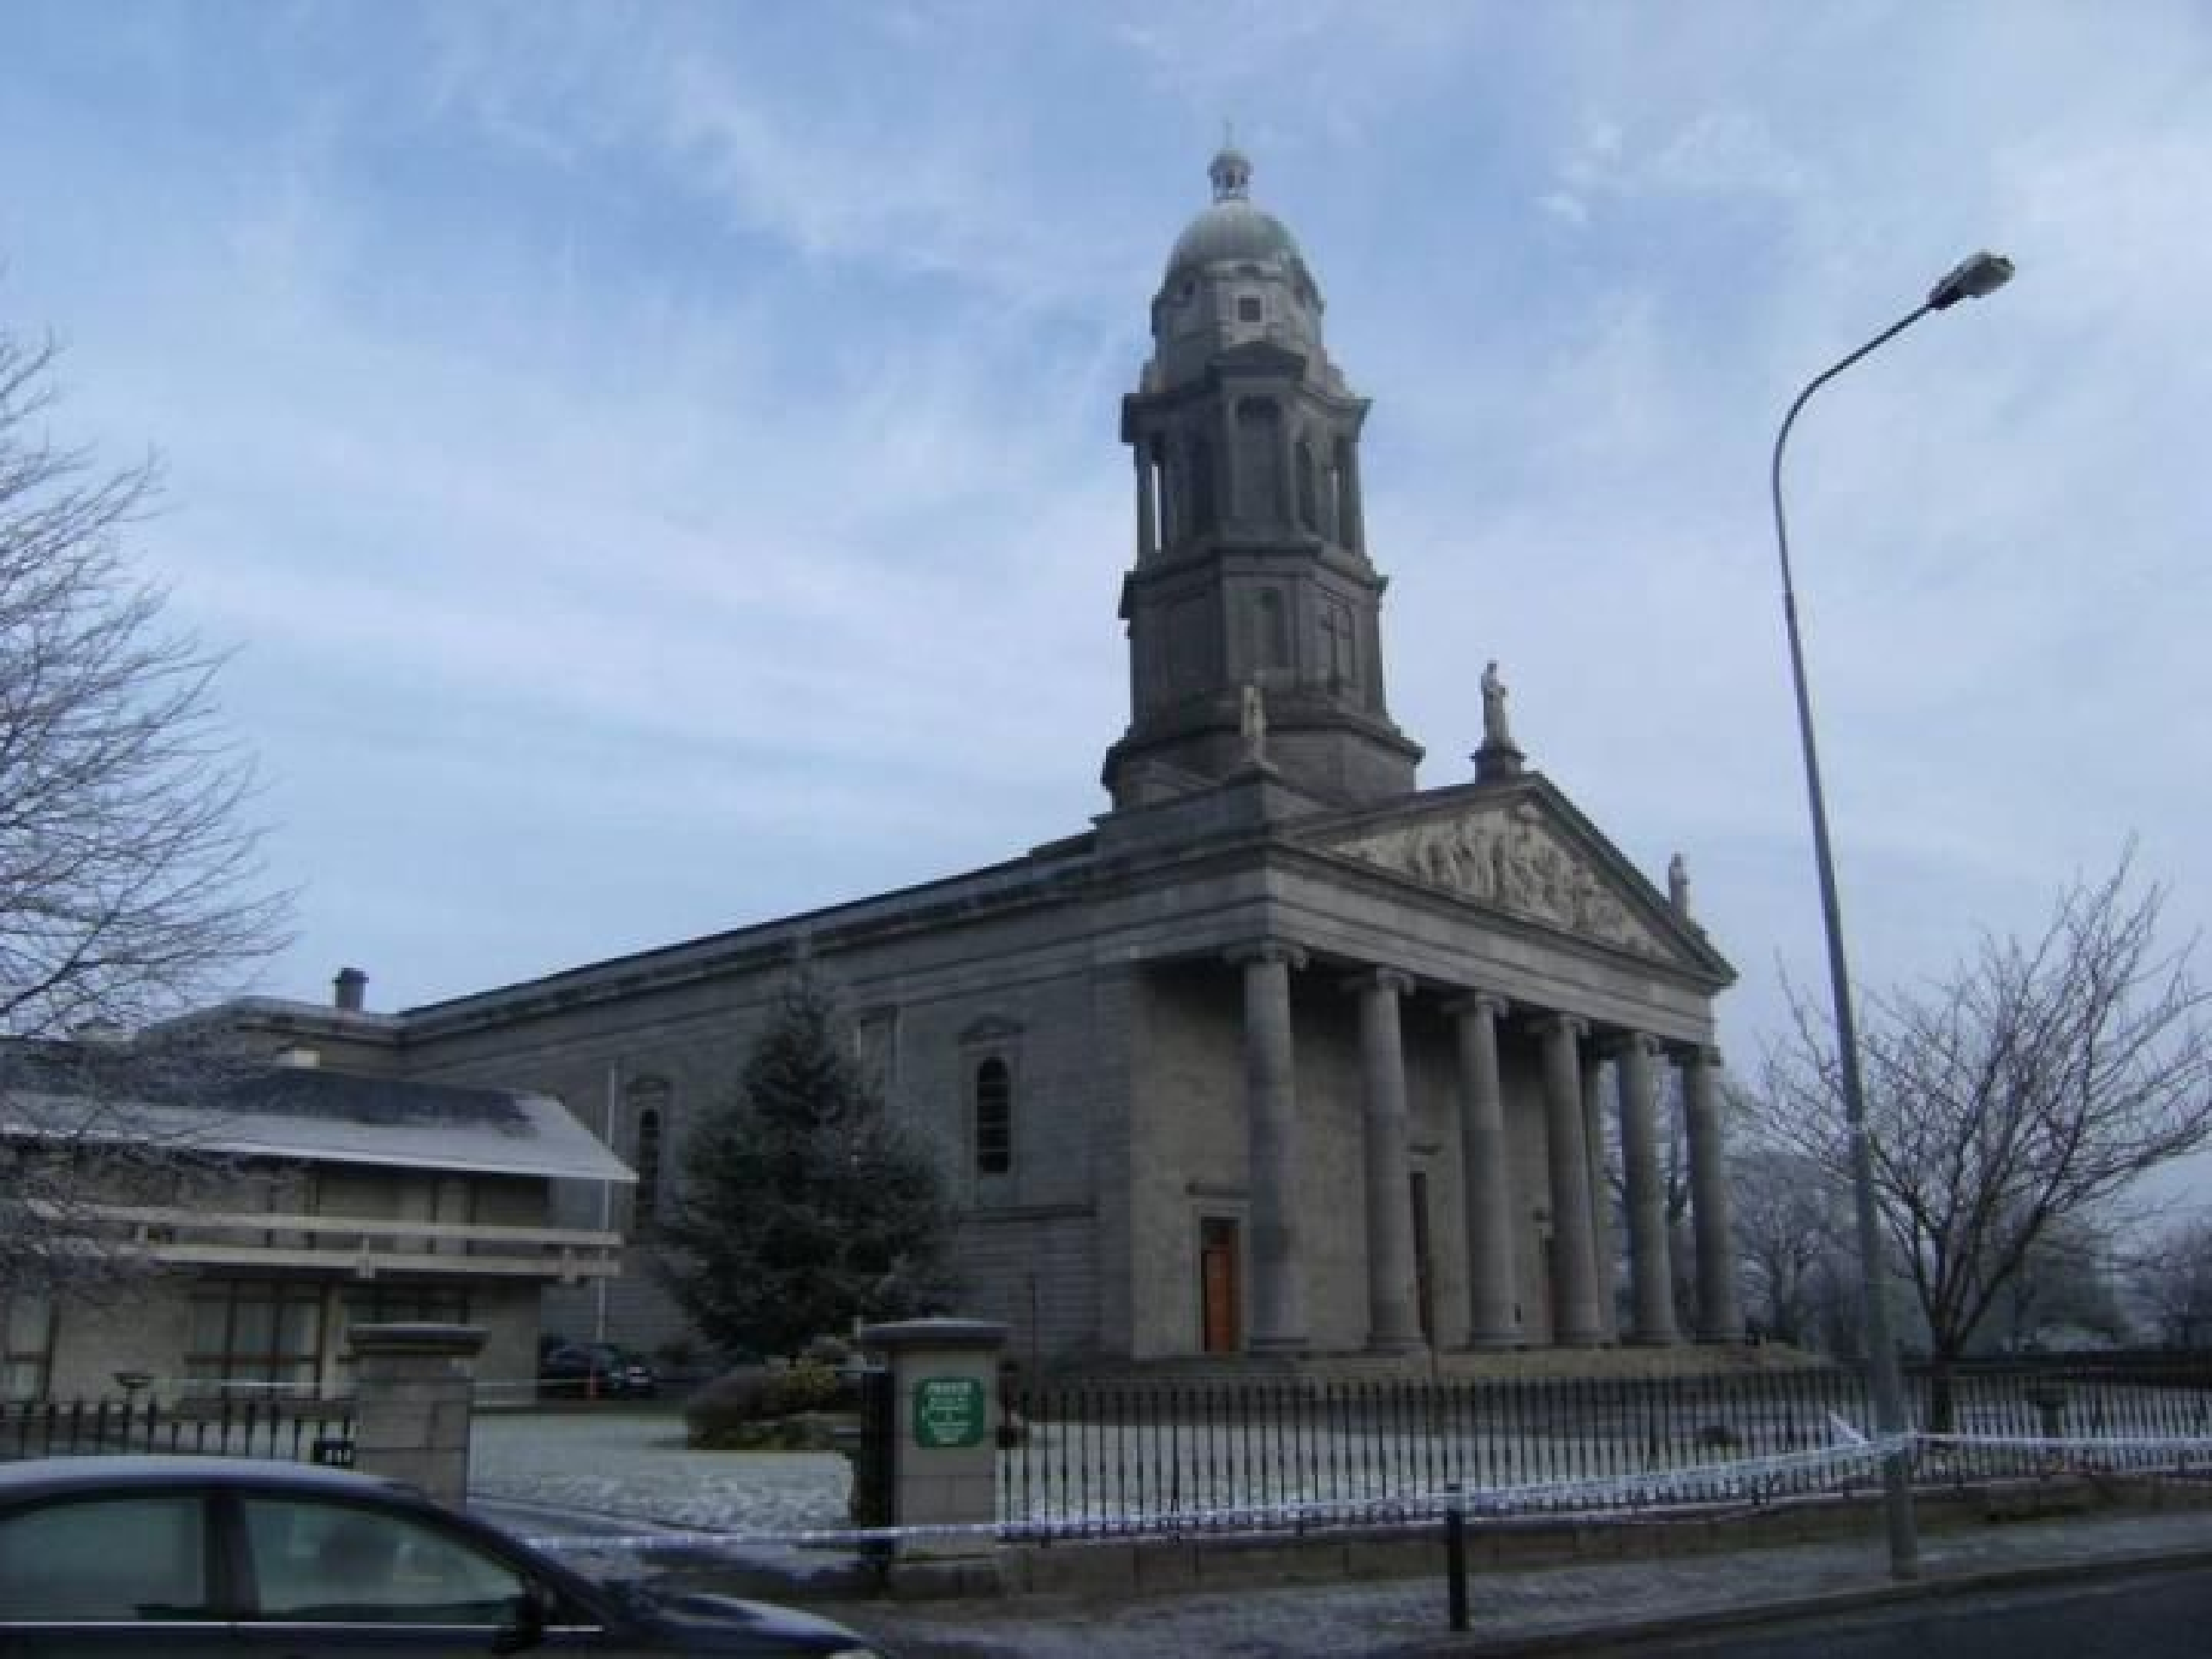
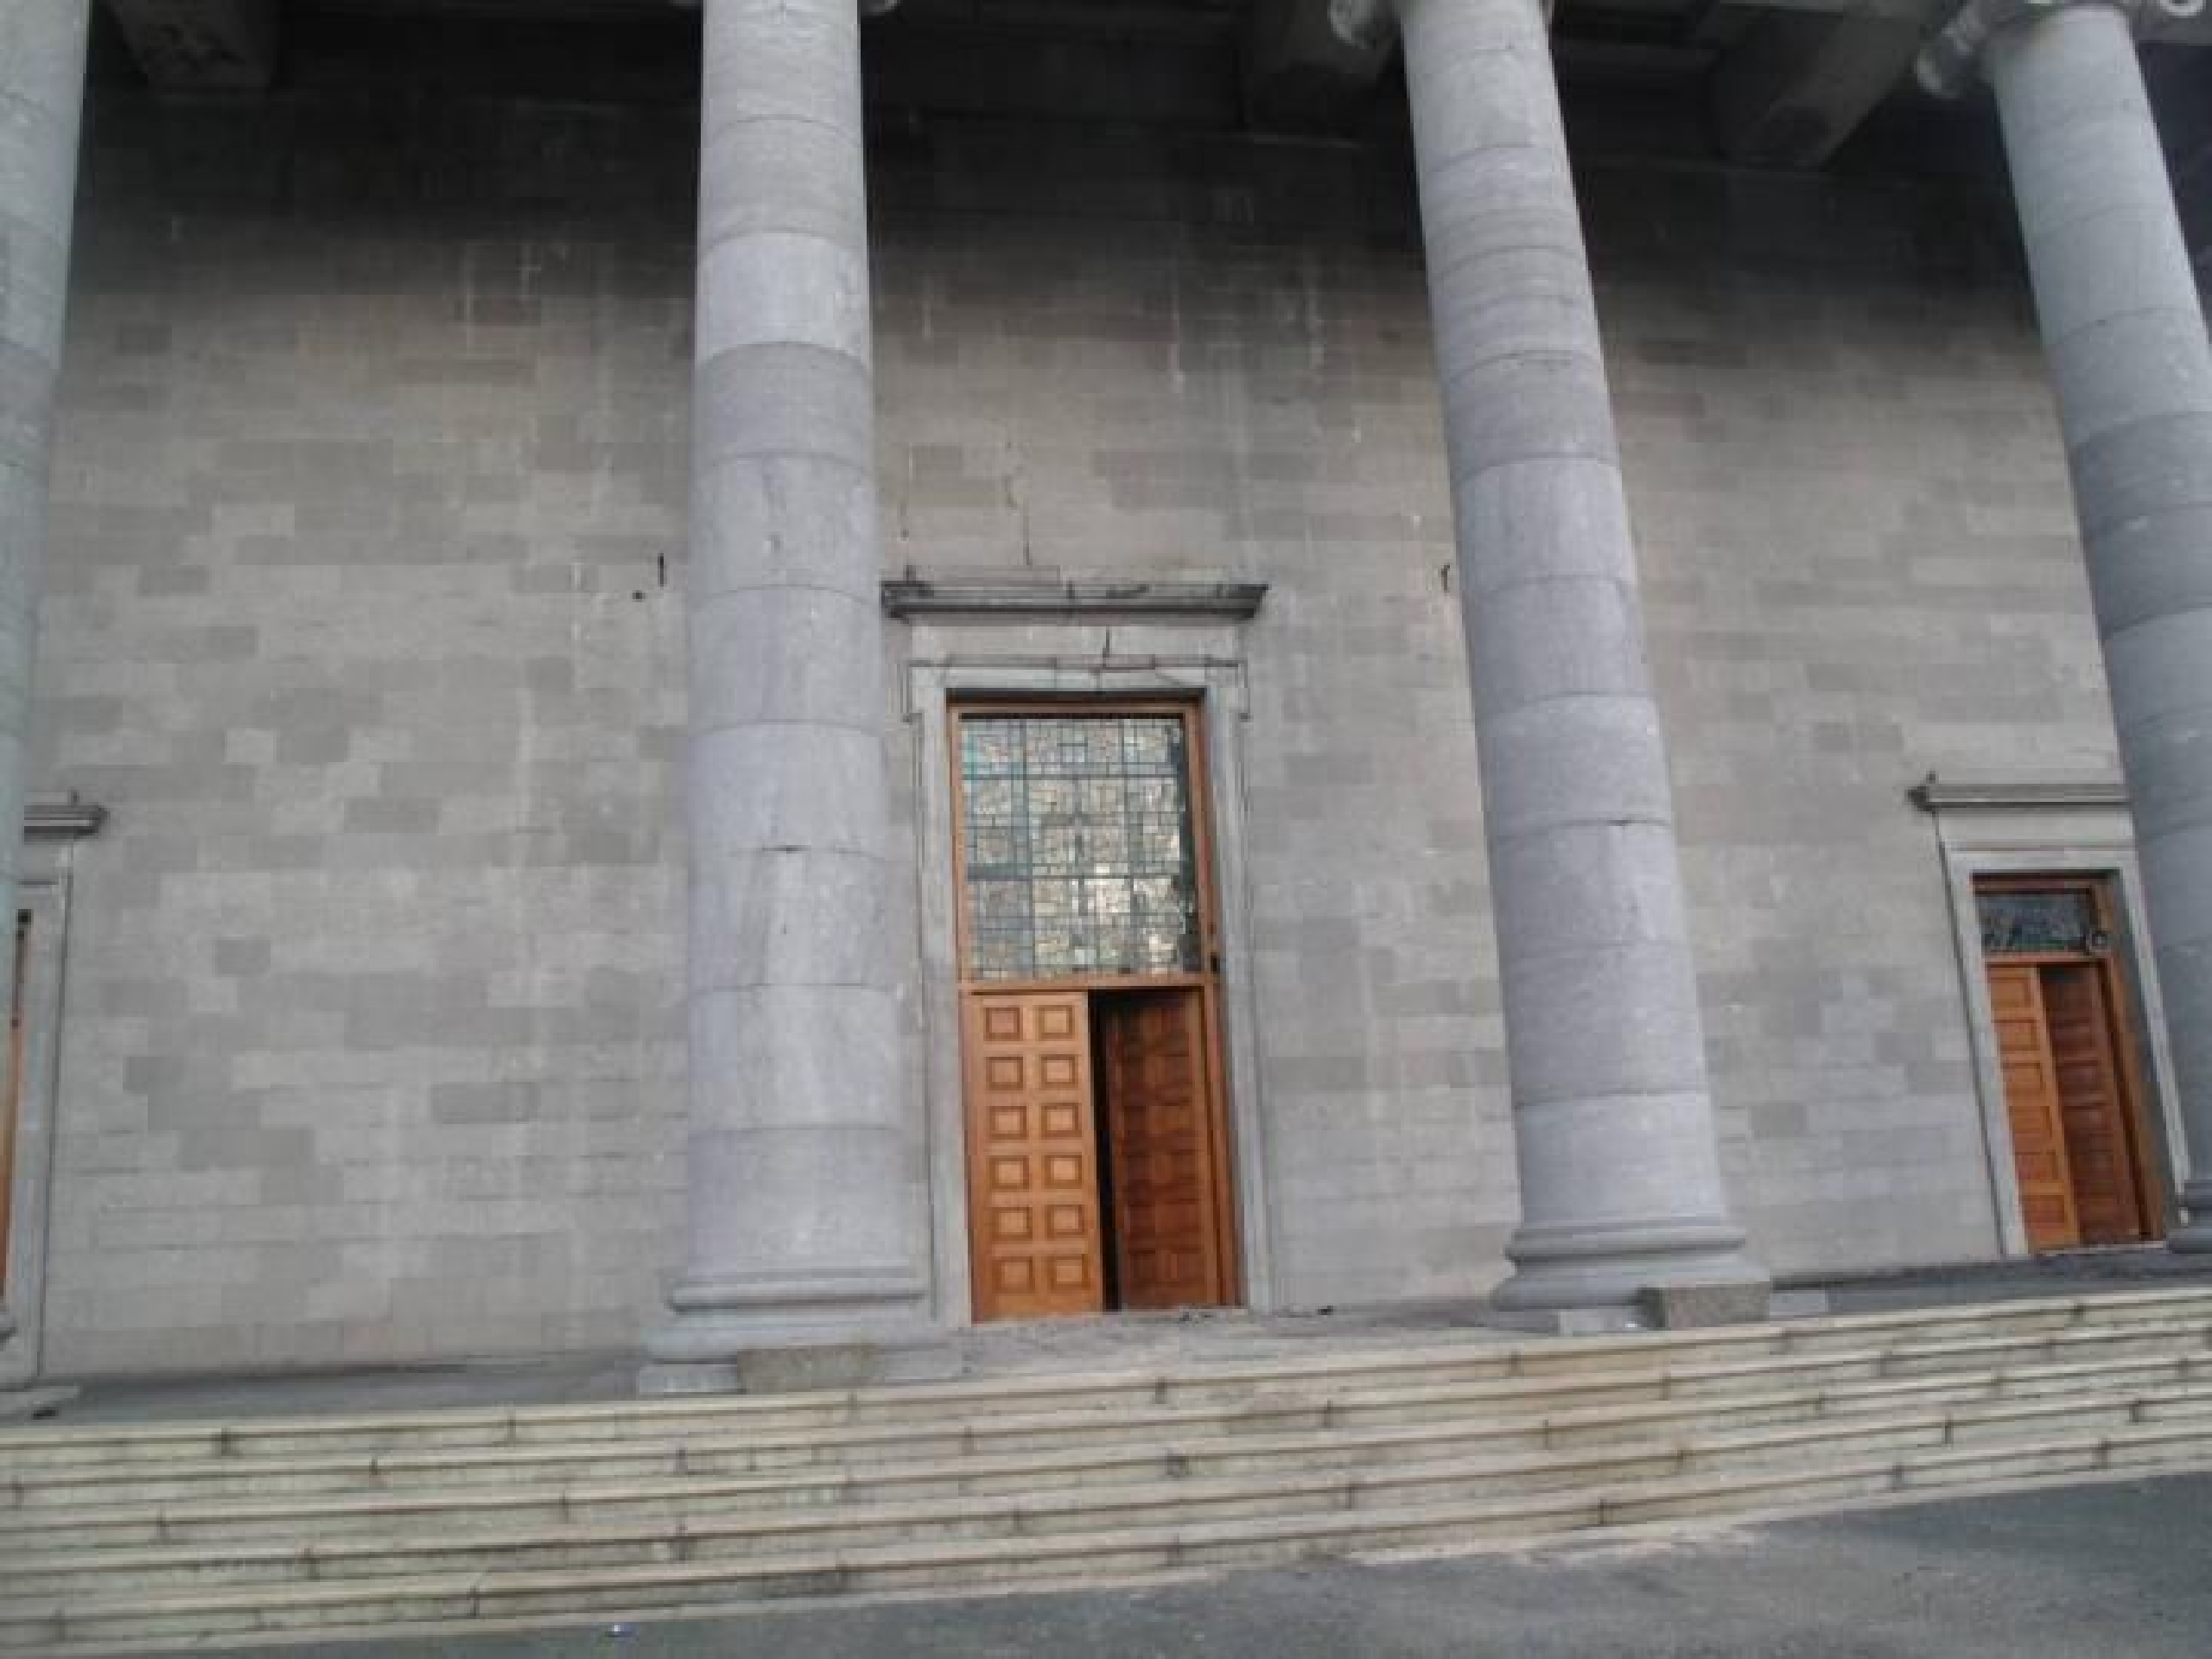
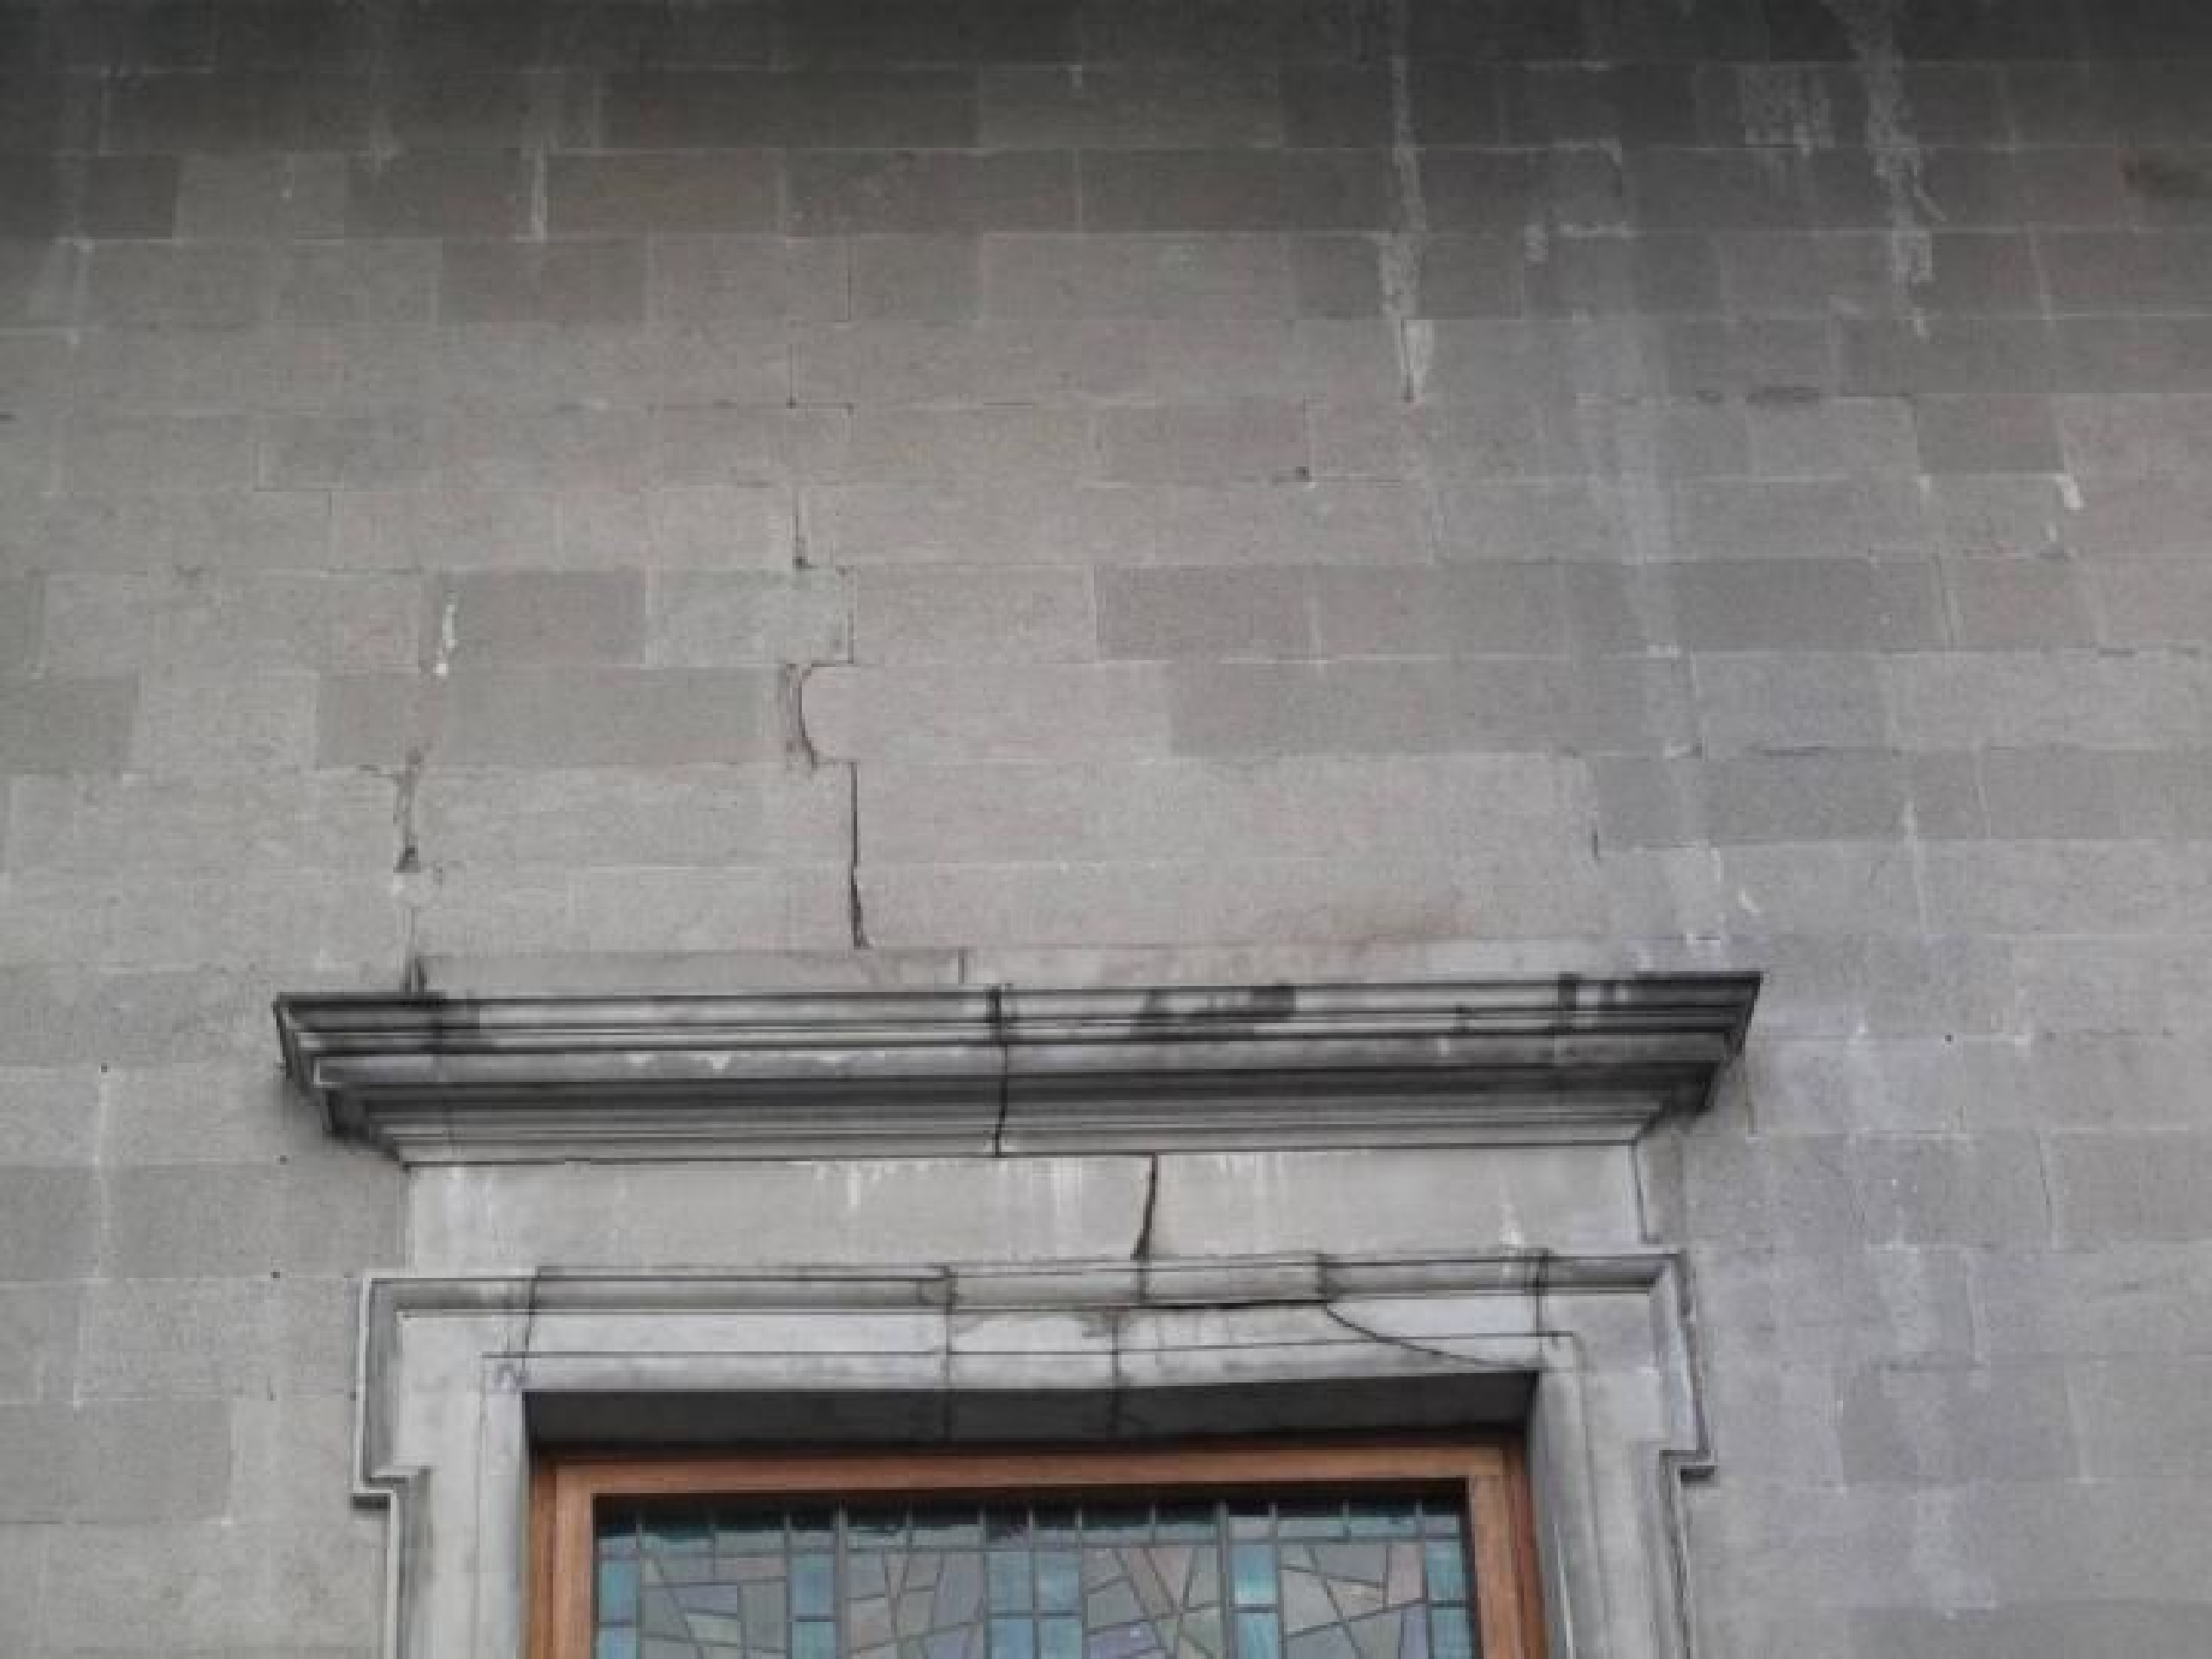
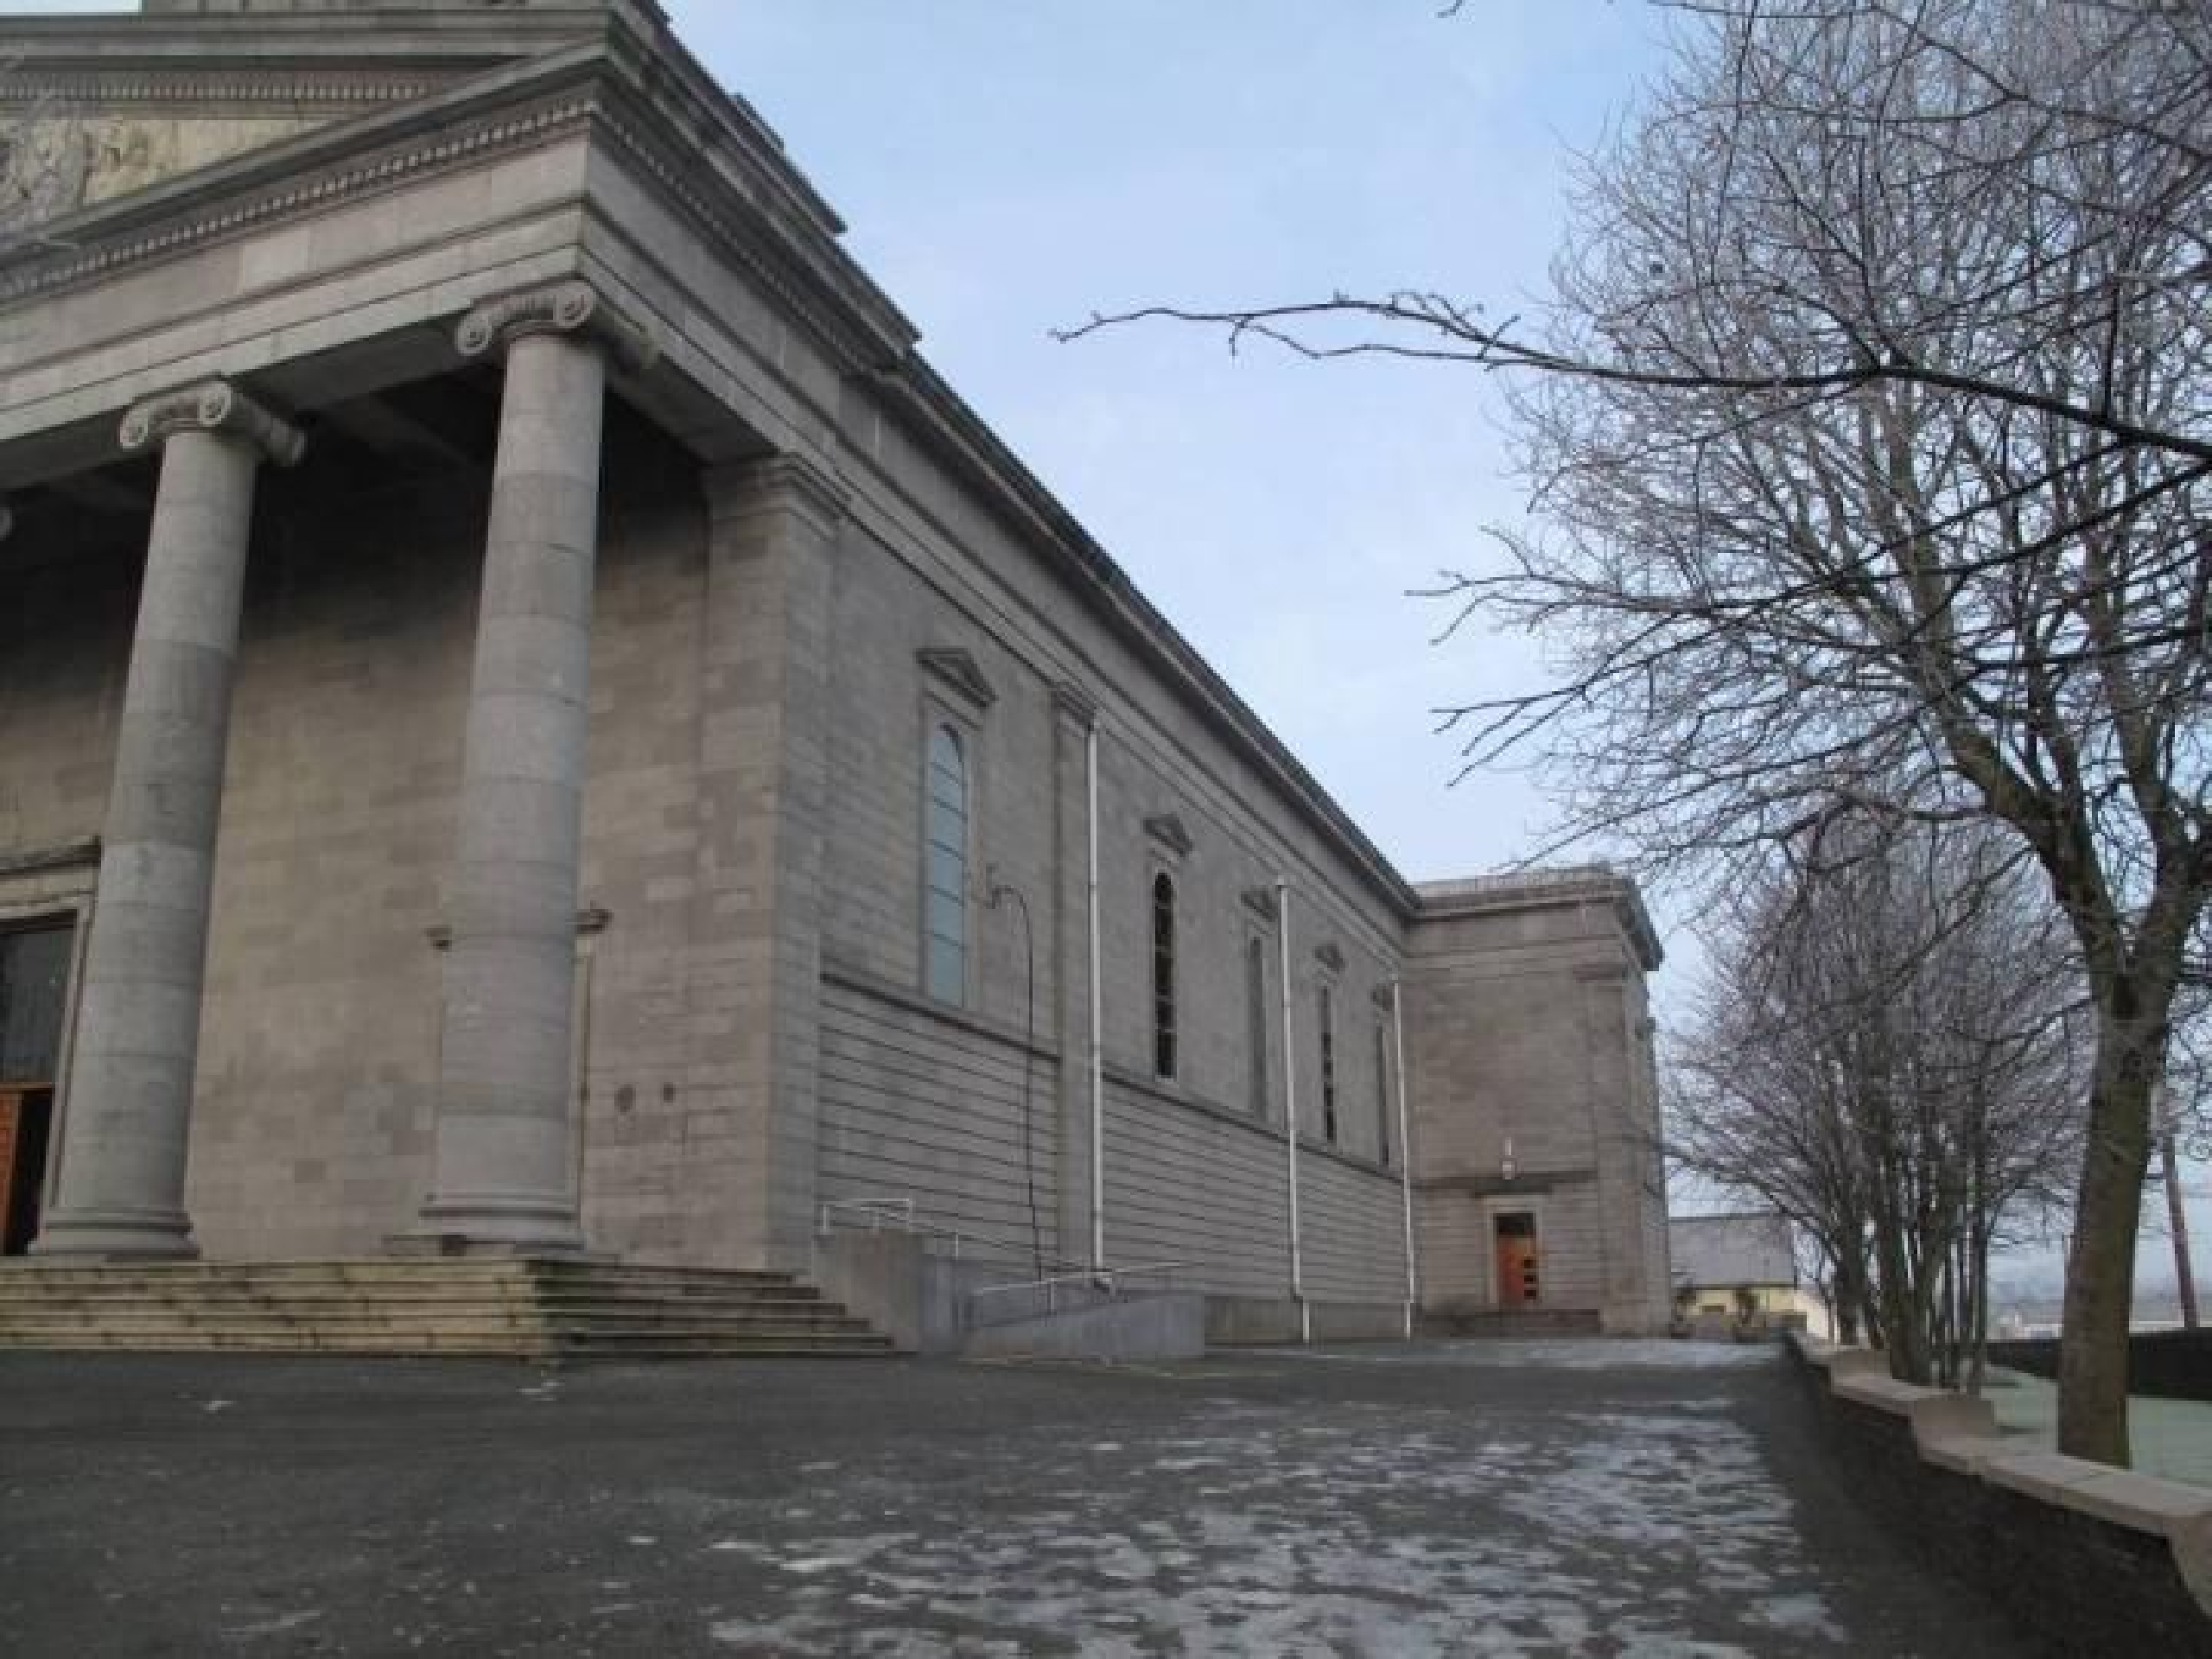
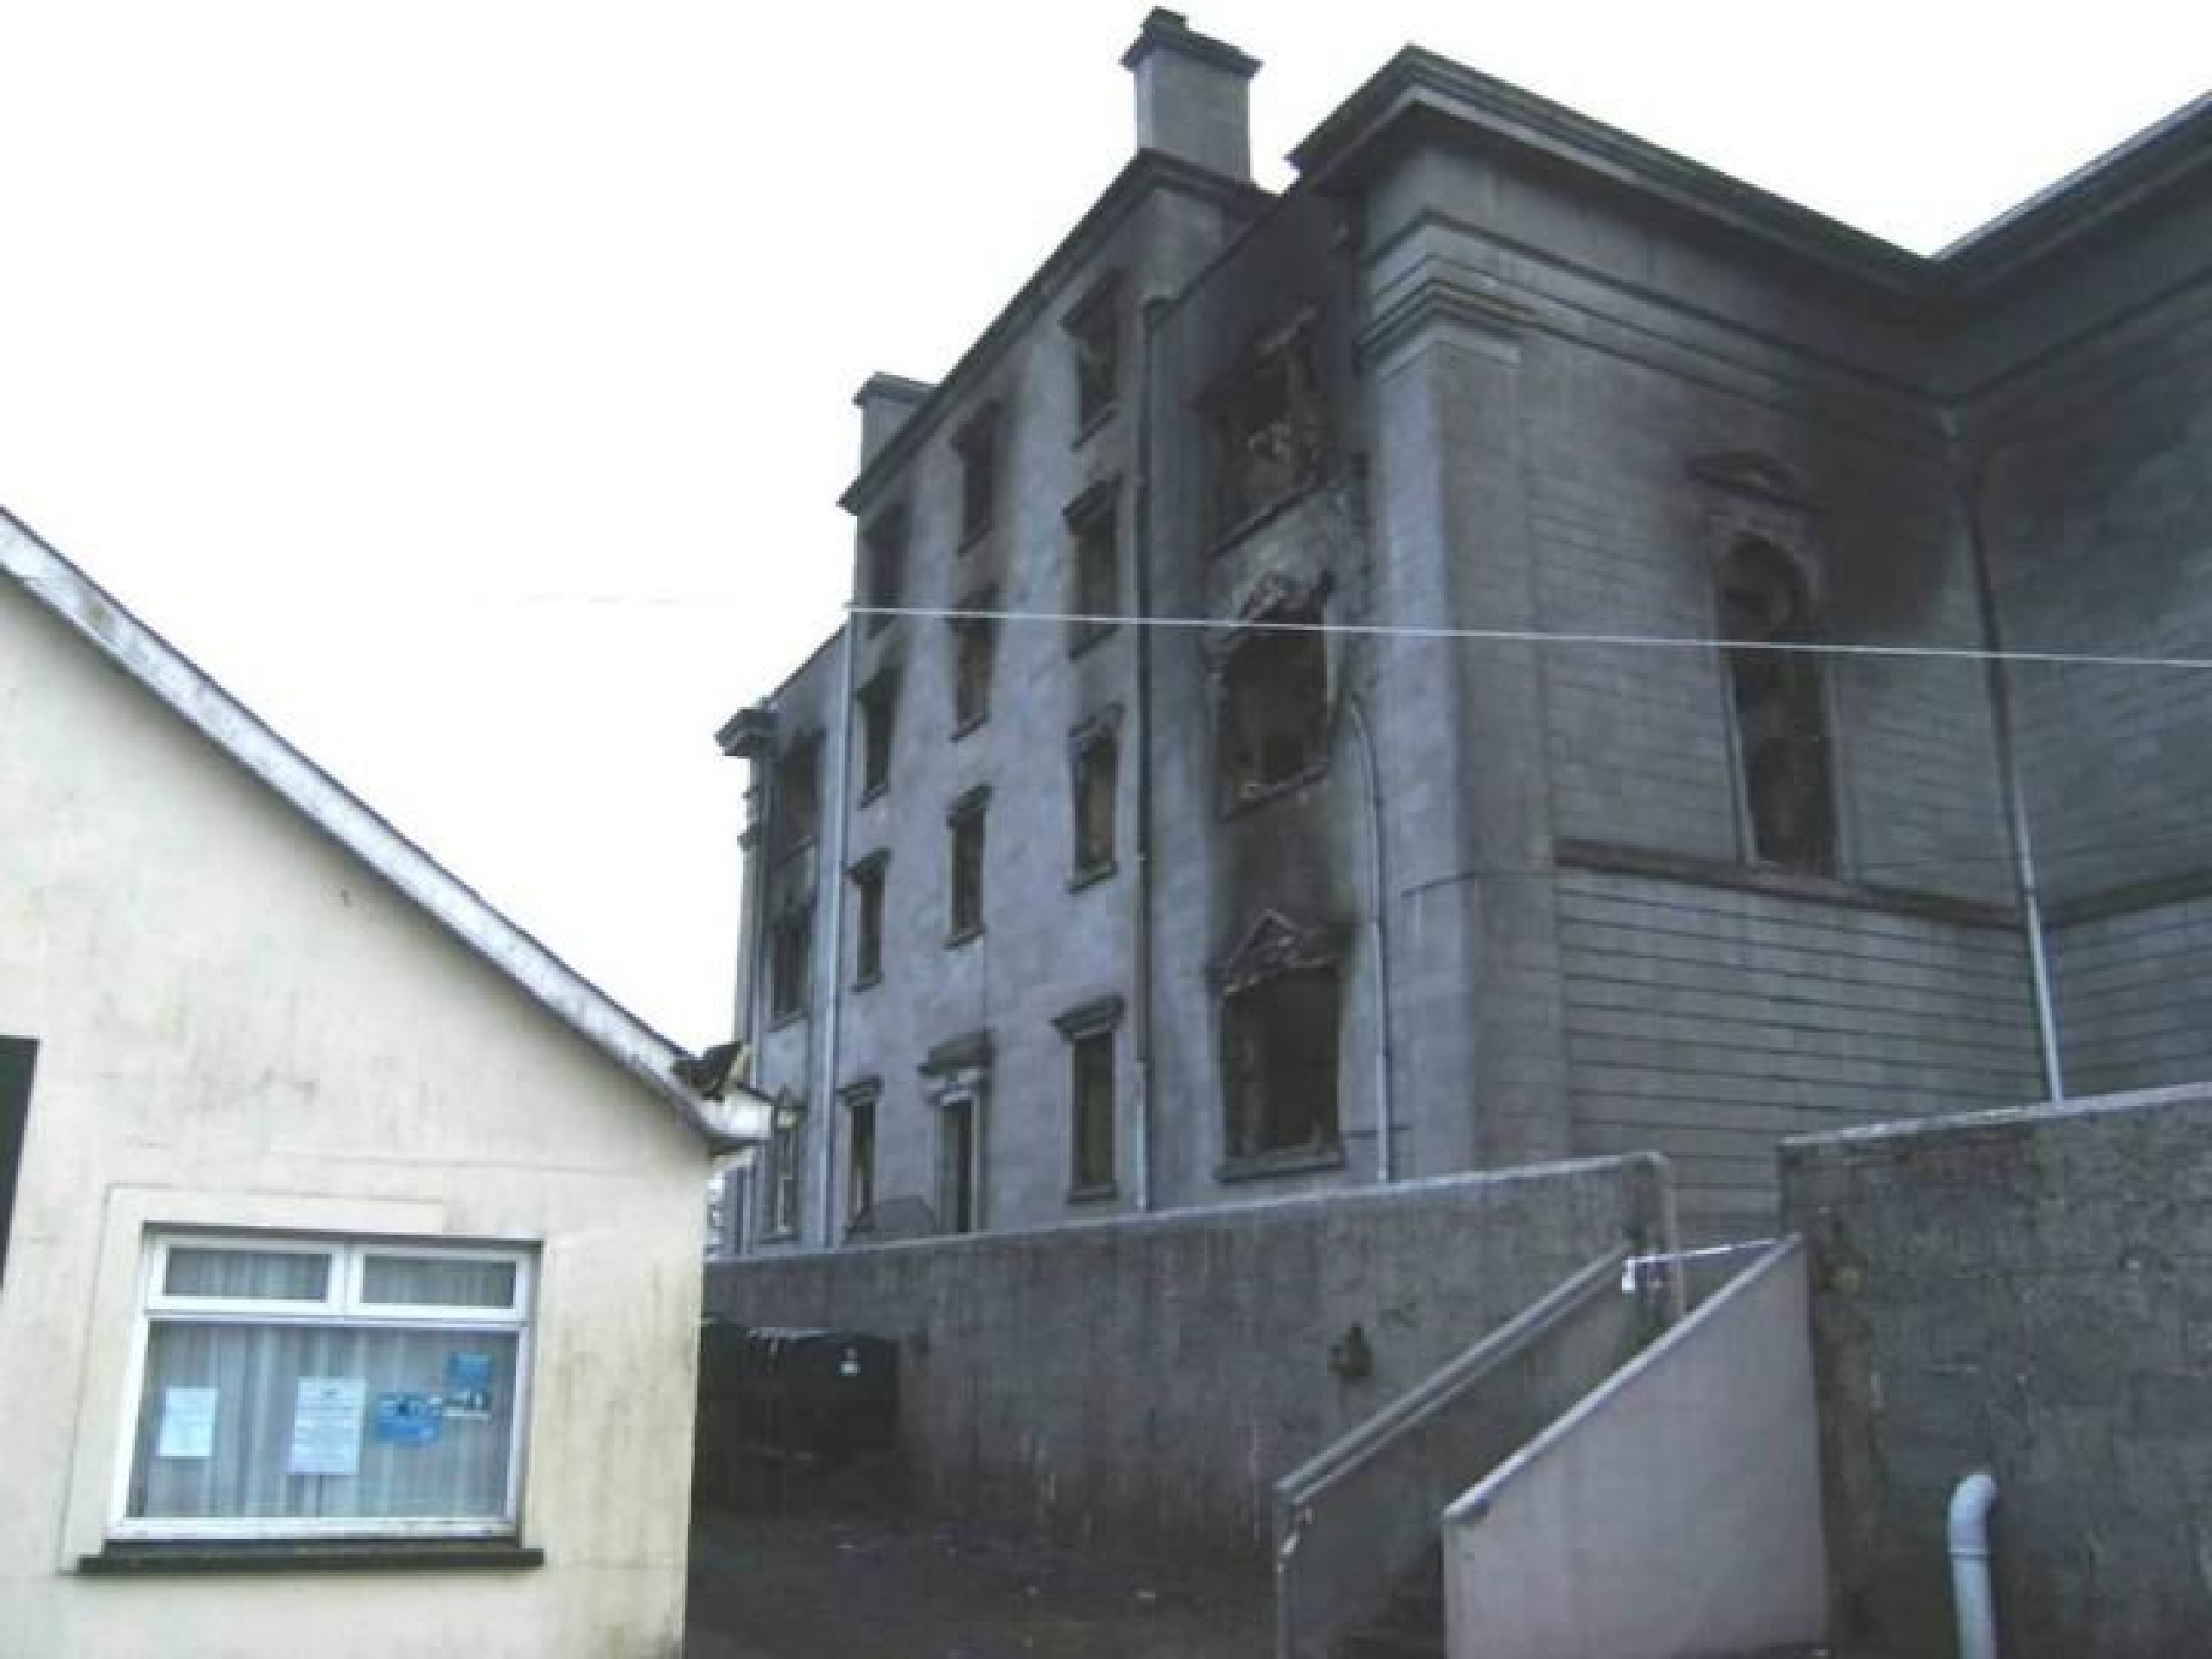
- The external walls and main campanile tower whilst damaged, have largely survived the fire.
- External hairline cracking is apparent in many areas though this is relatively minor and localised.
- The inner face of external walls has suffered more significant impact through direct fire attack though is expected to respond well to repair.
- There are varying levels of damage to window and door surrounds / sills most particularly on the rear north elevation.
