St Mel's Cathedral Longford – Fire 25th December 2009

Summary of Nature & Extent of Damage

Presentation to the Diocese of Ardagh & Clonmacnois

Saturday 10th April 2010

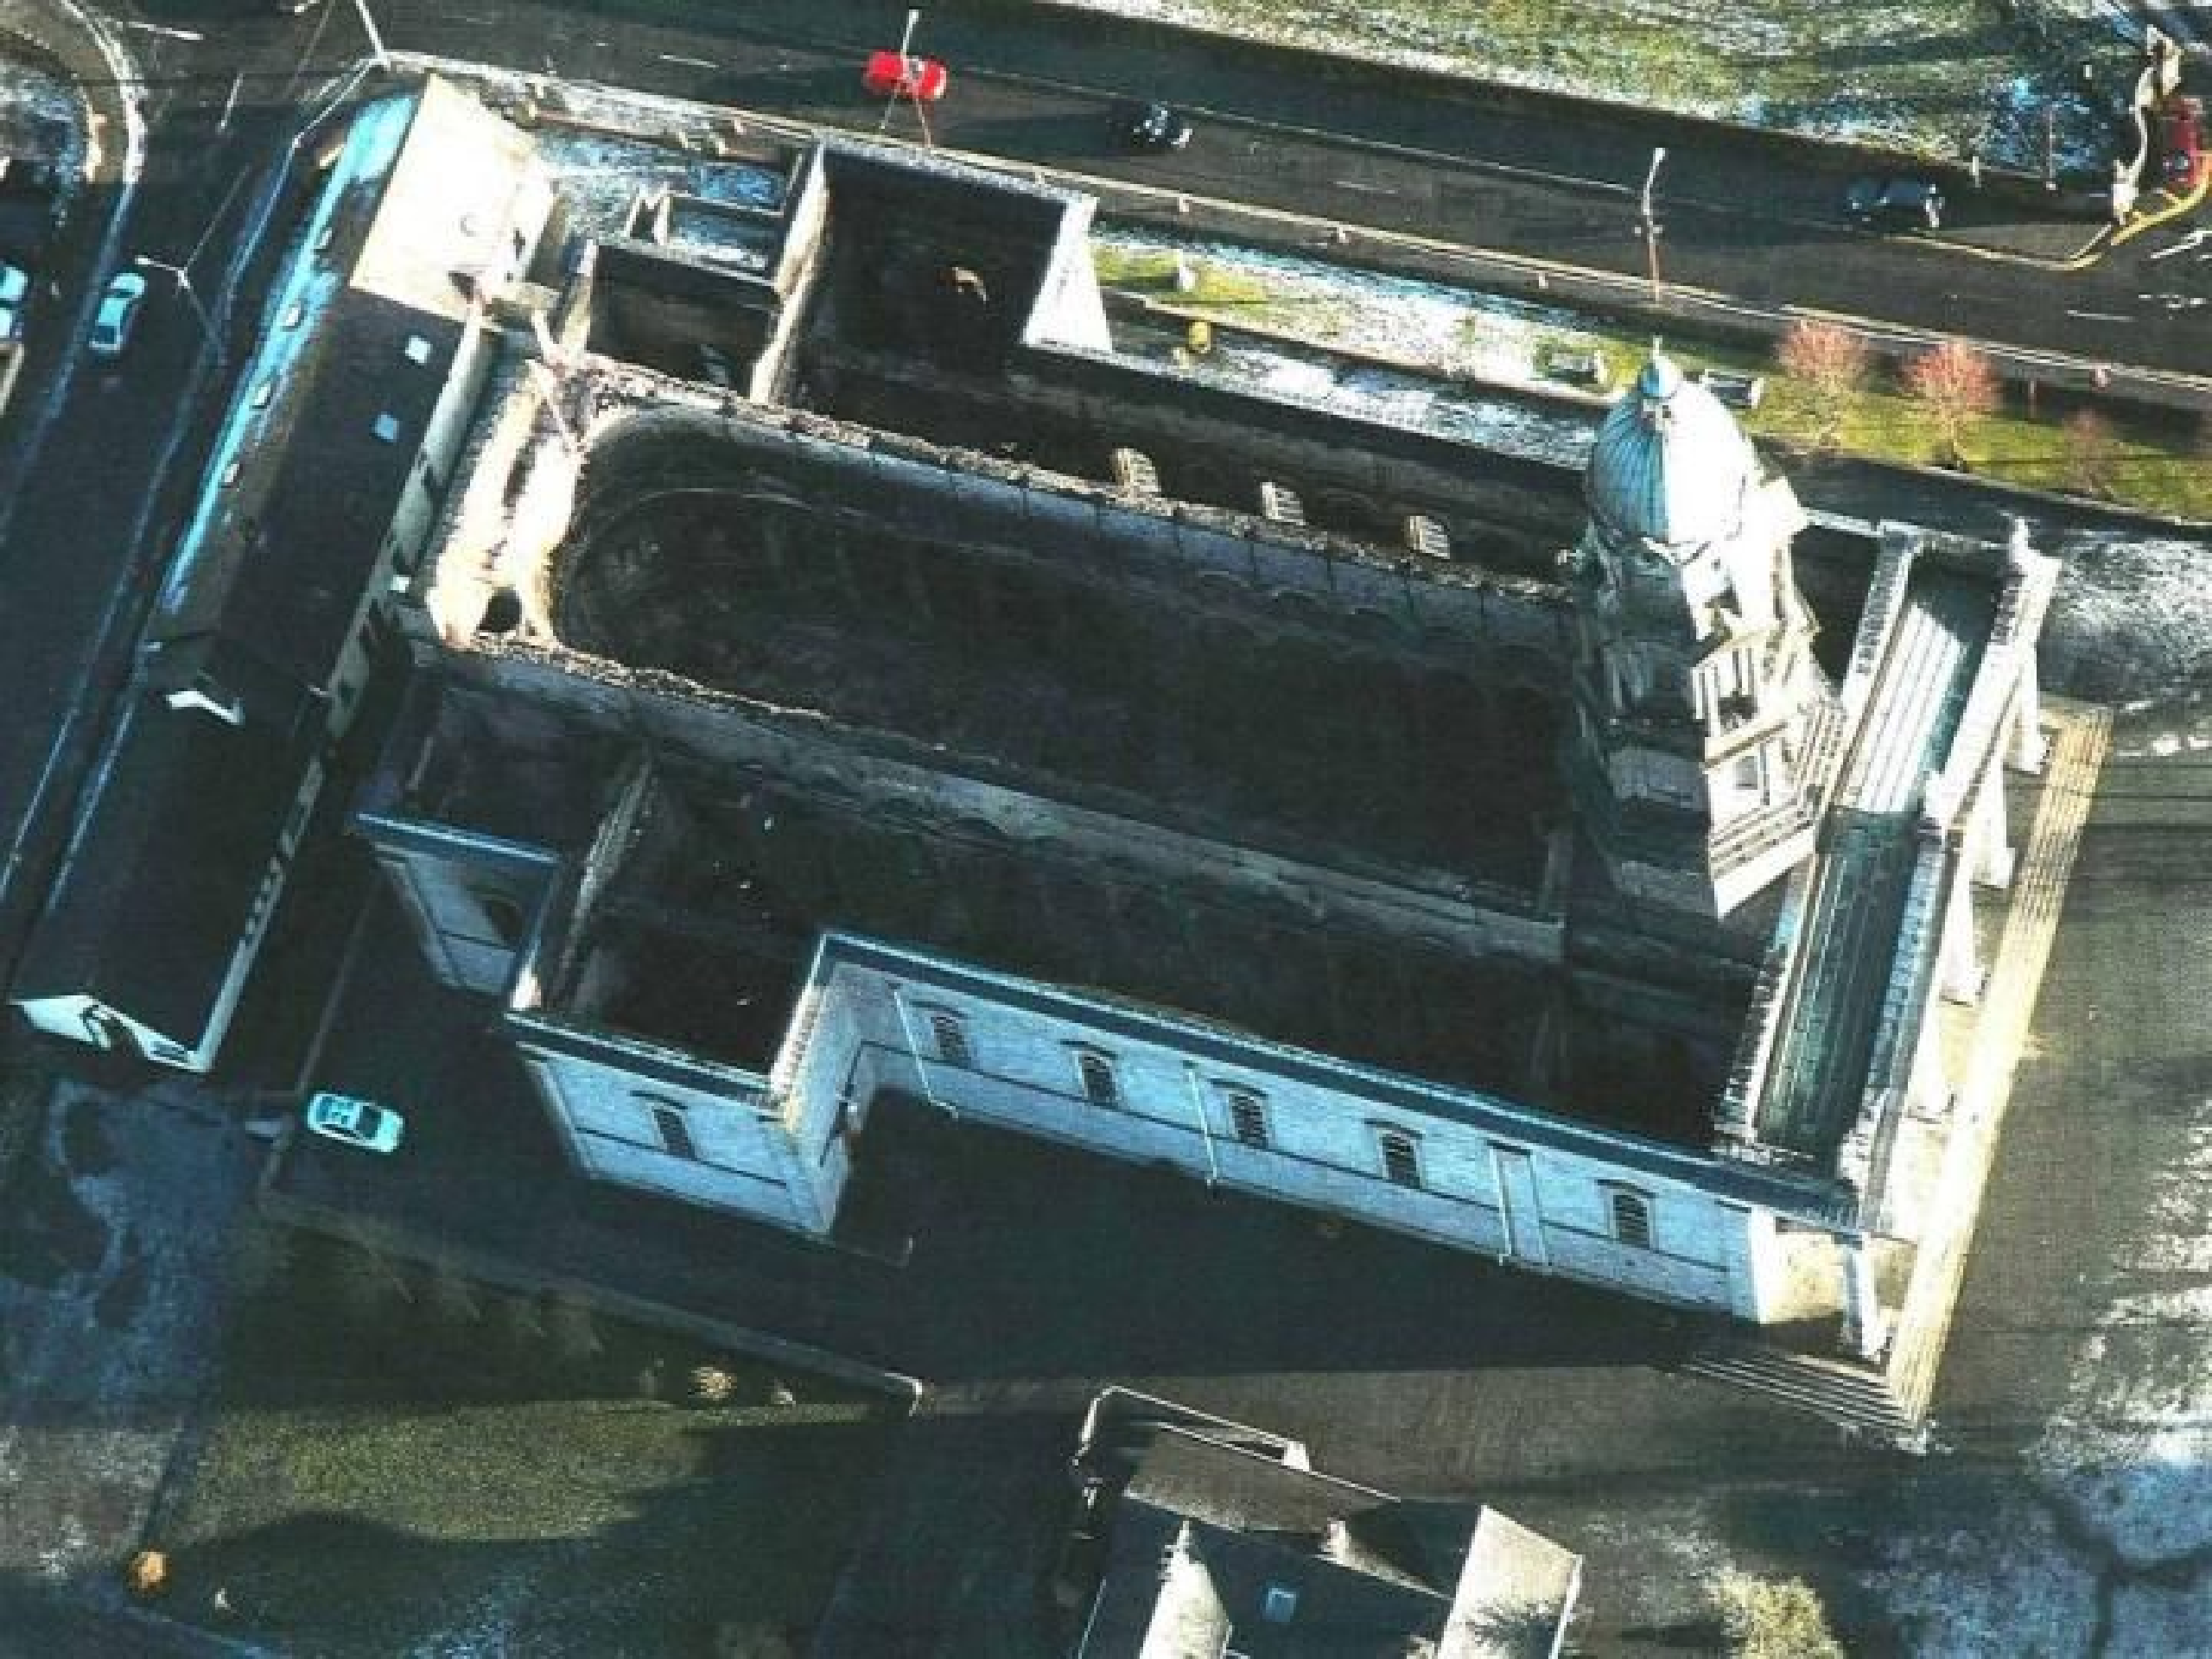
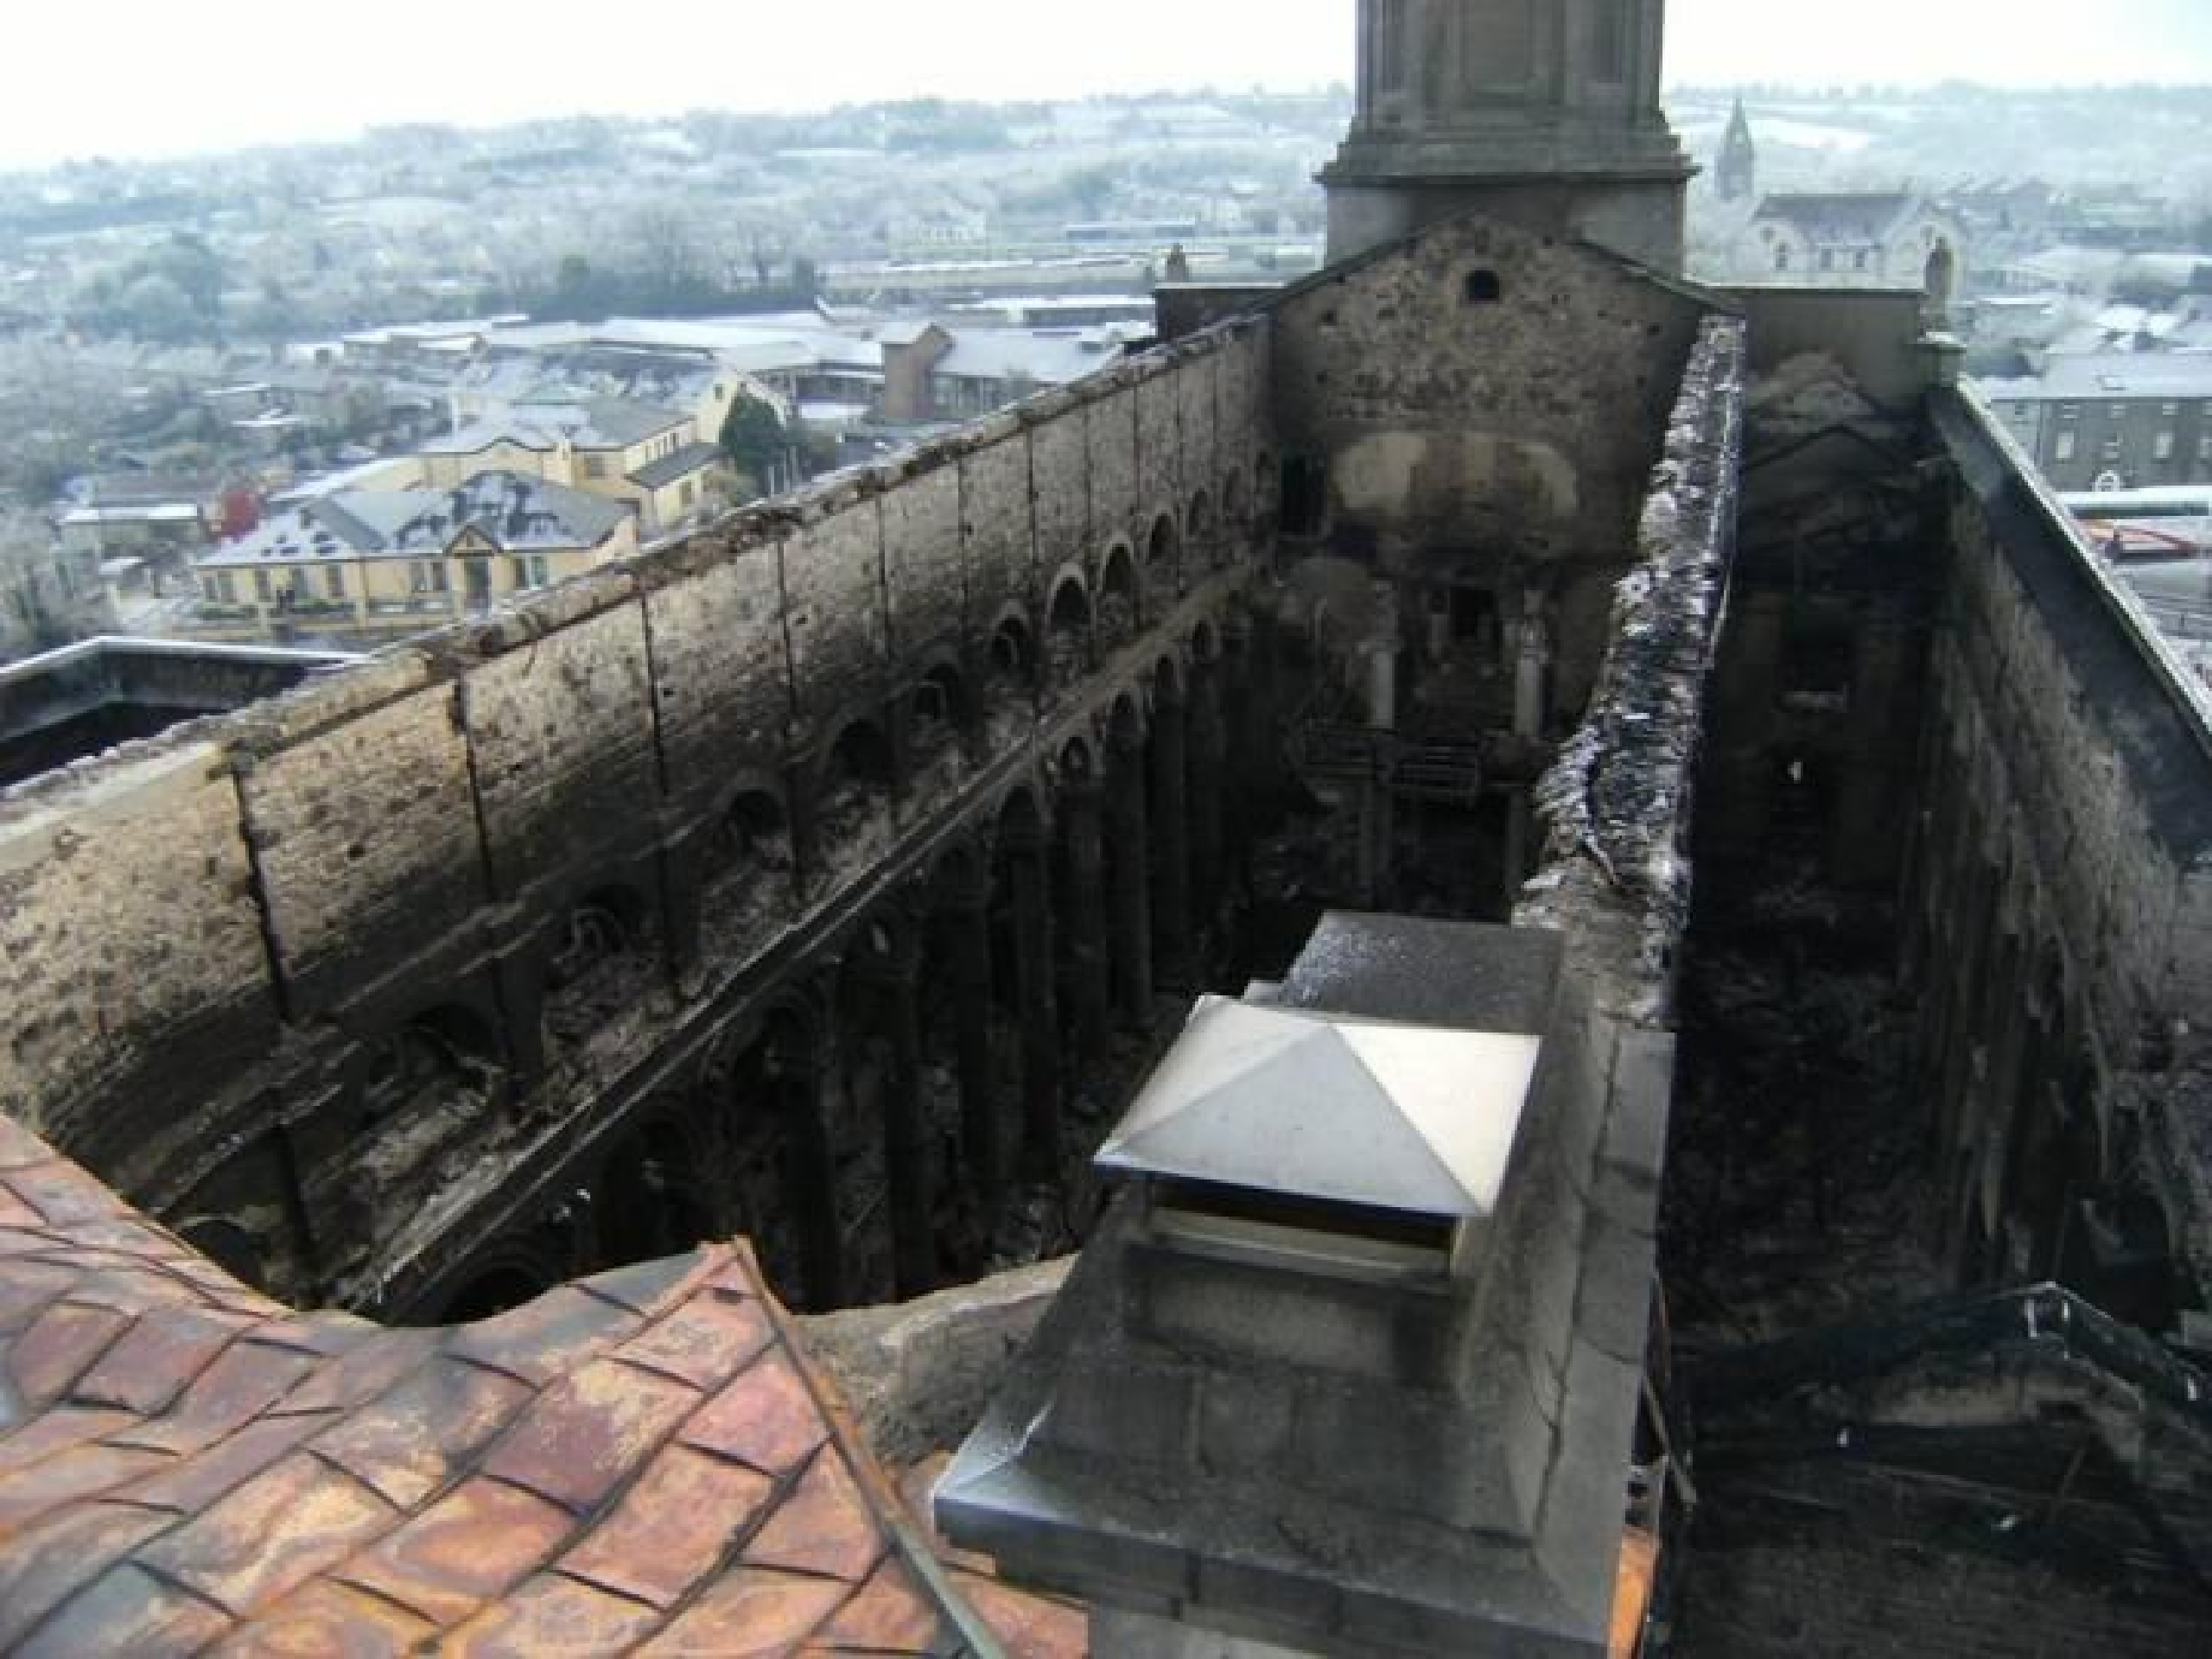
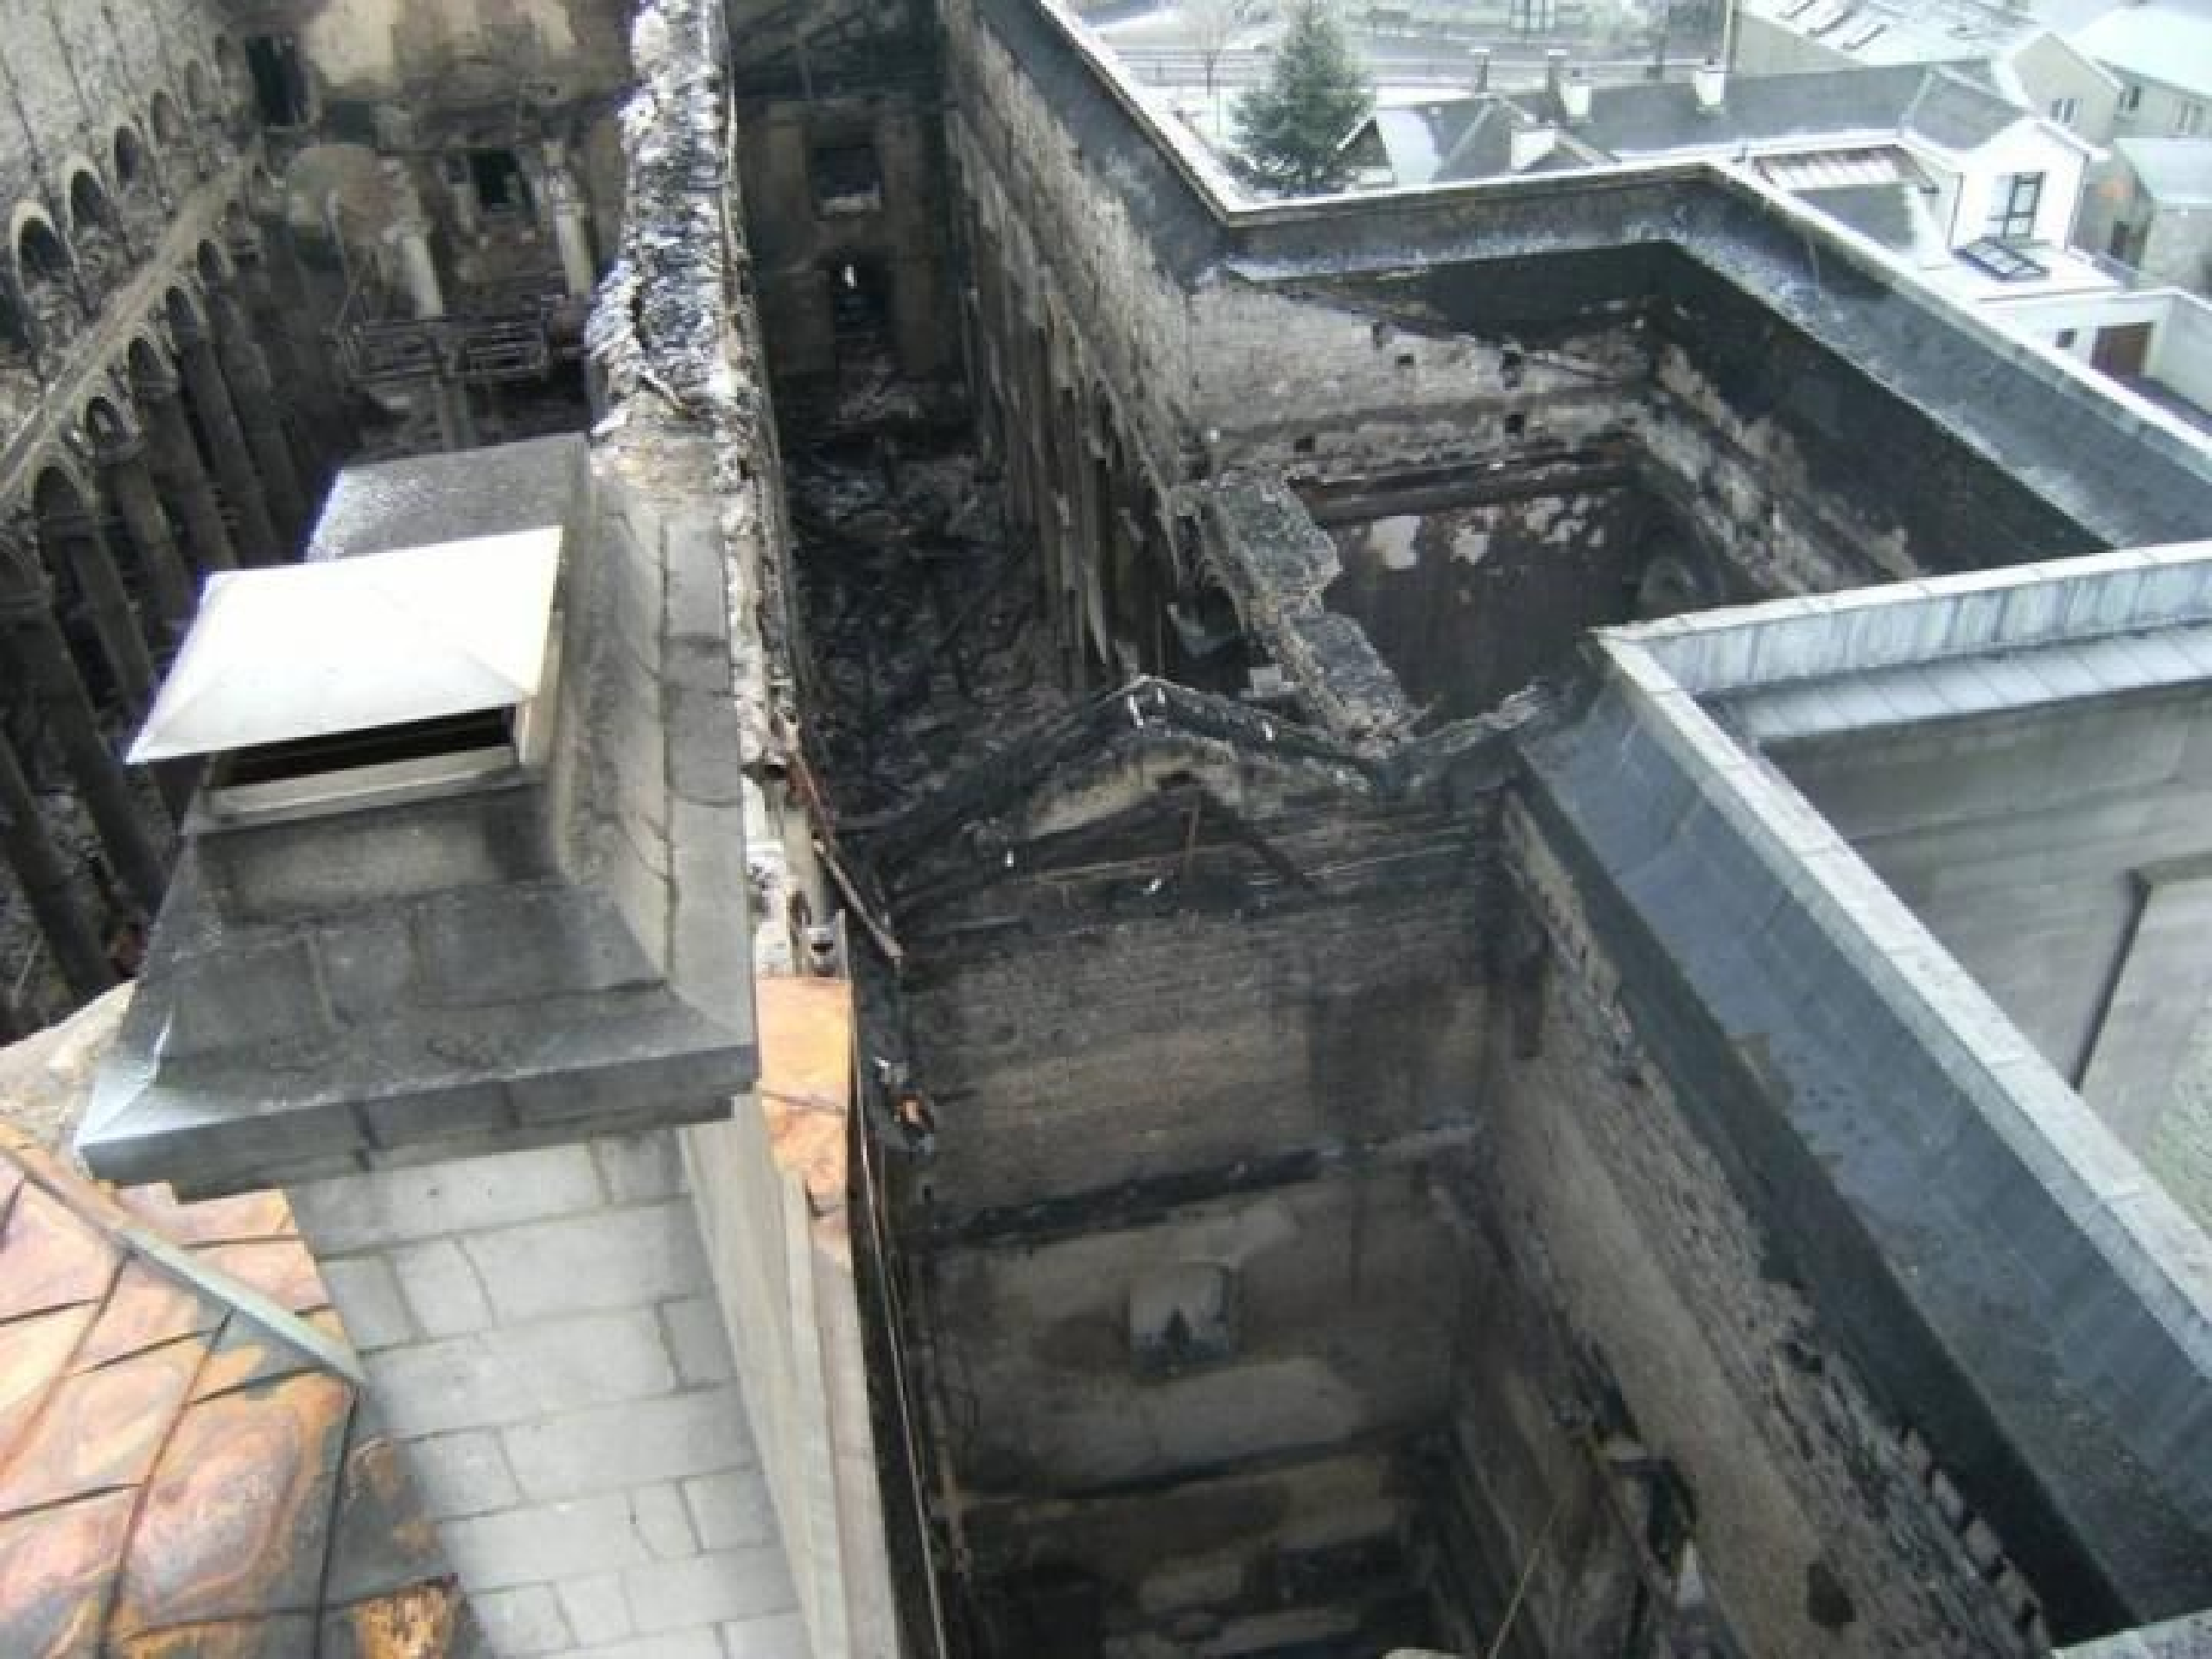
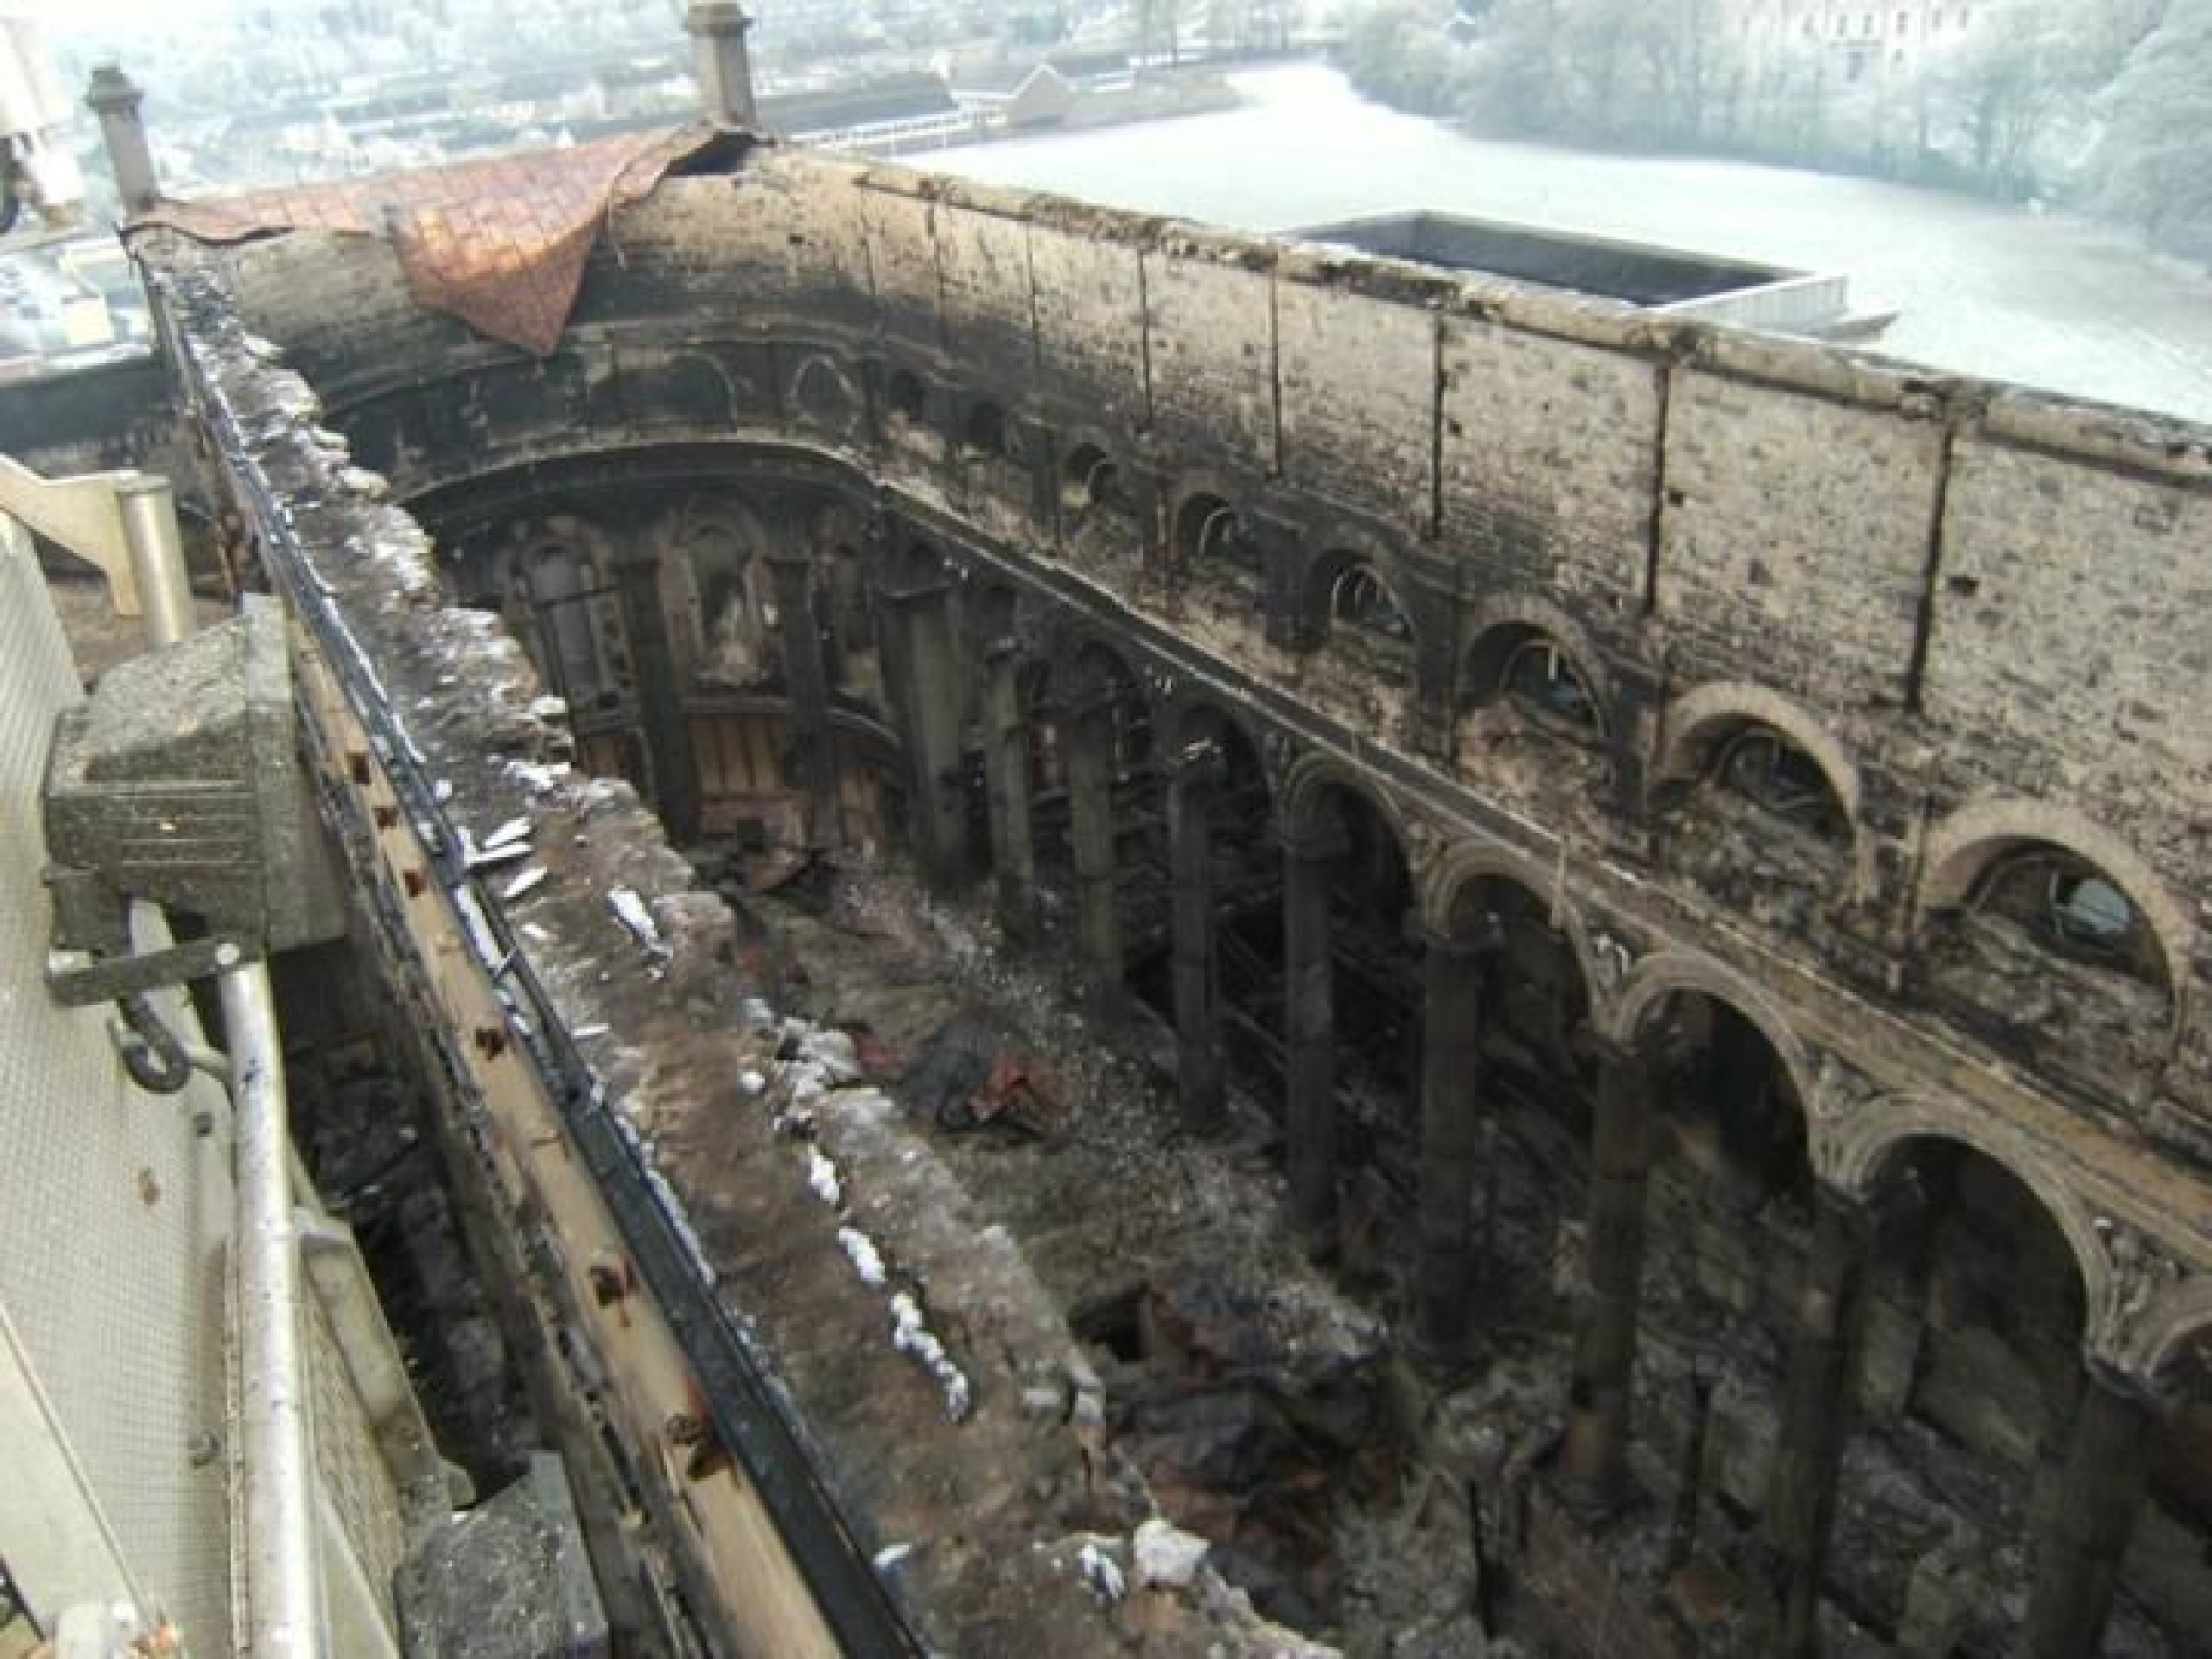
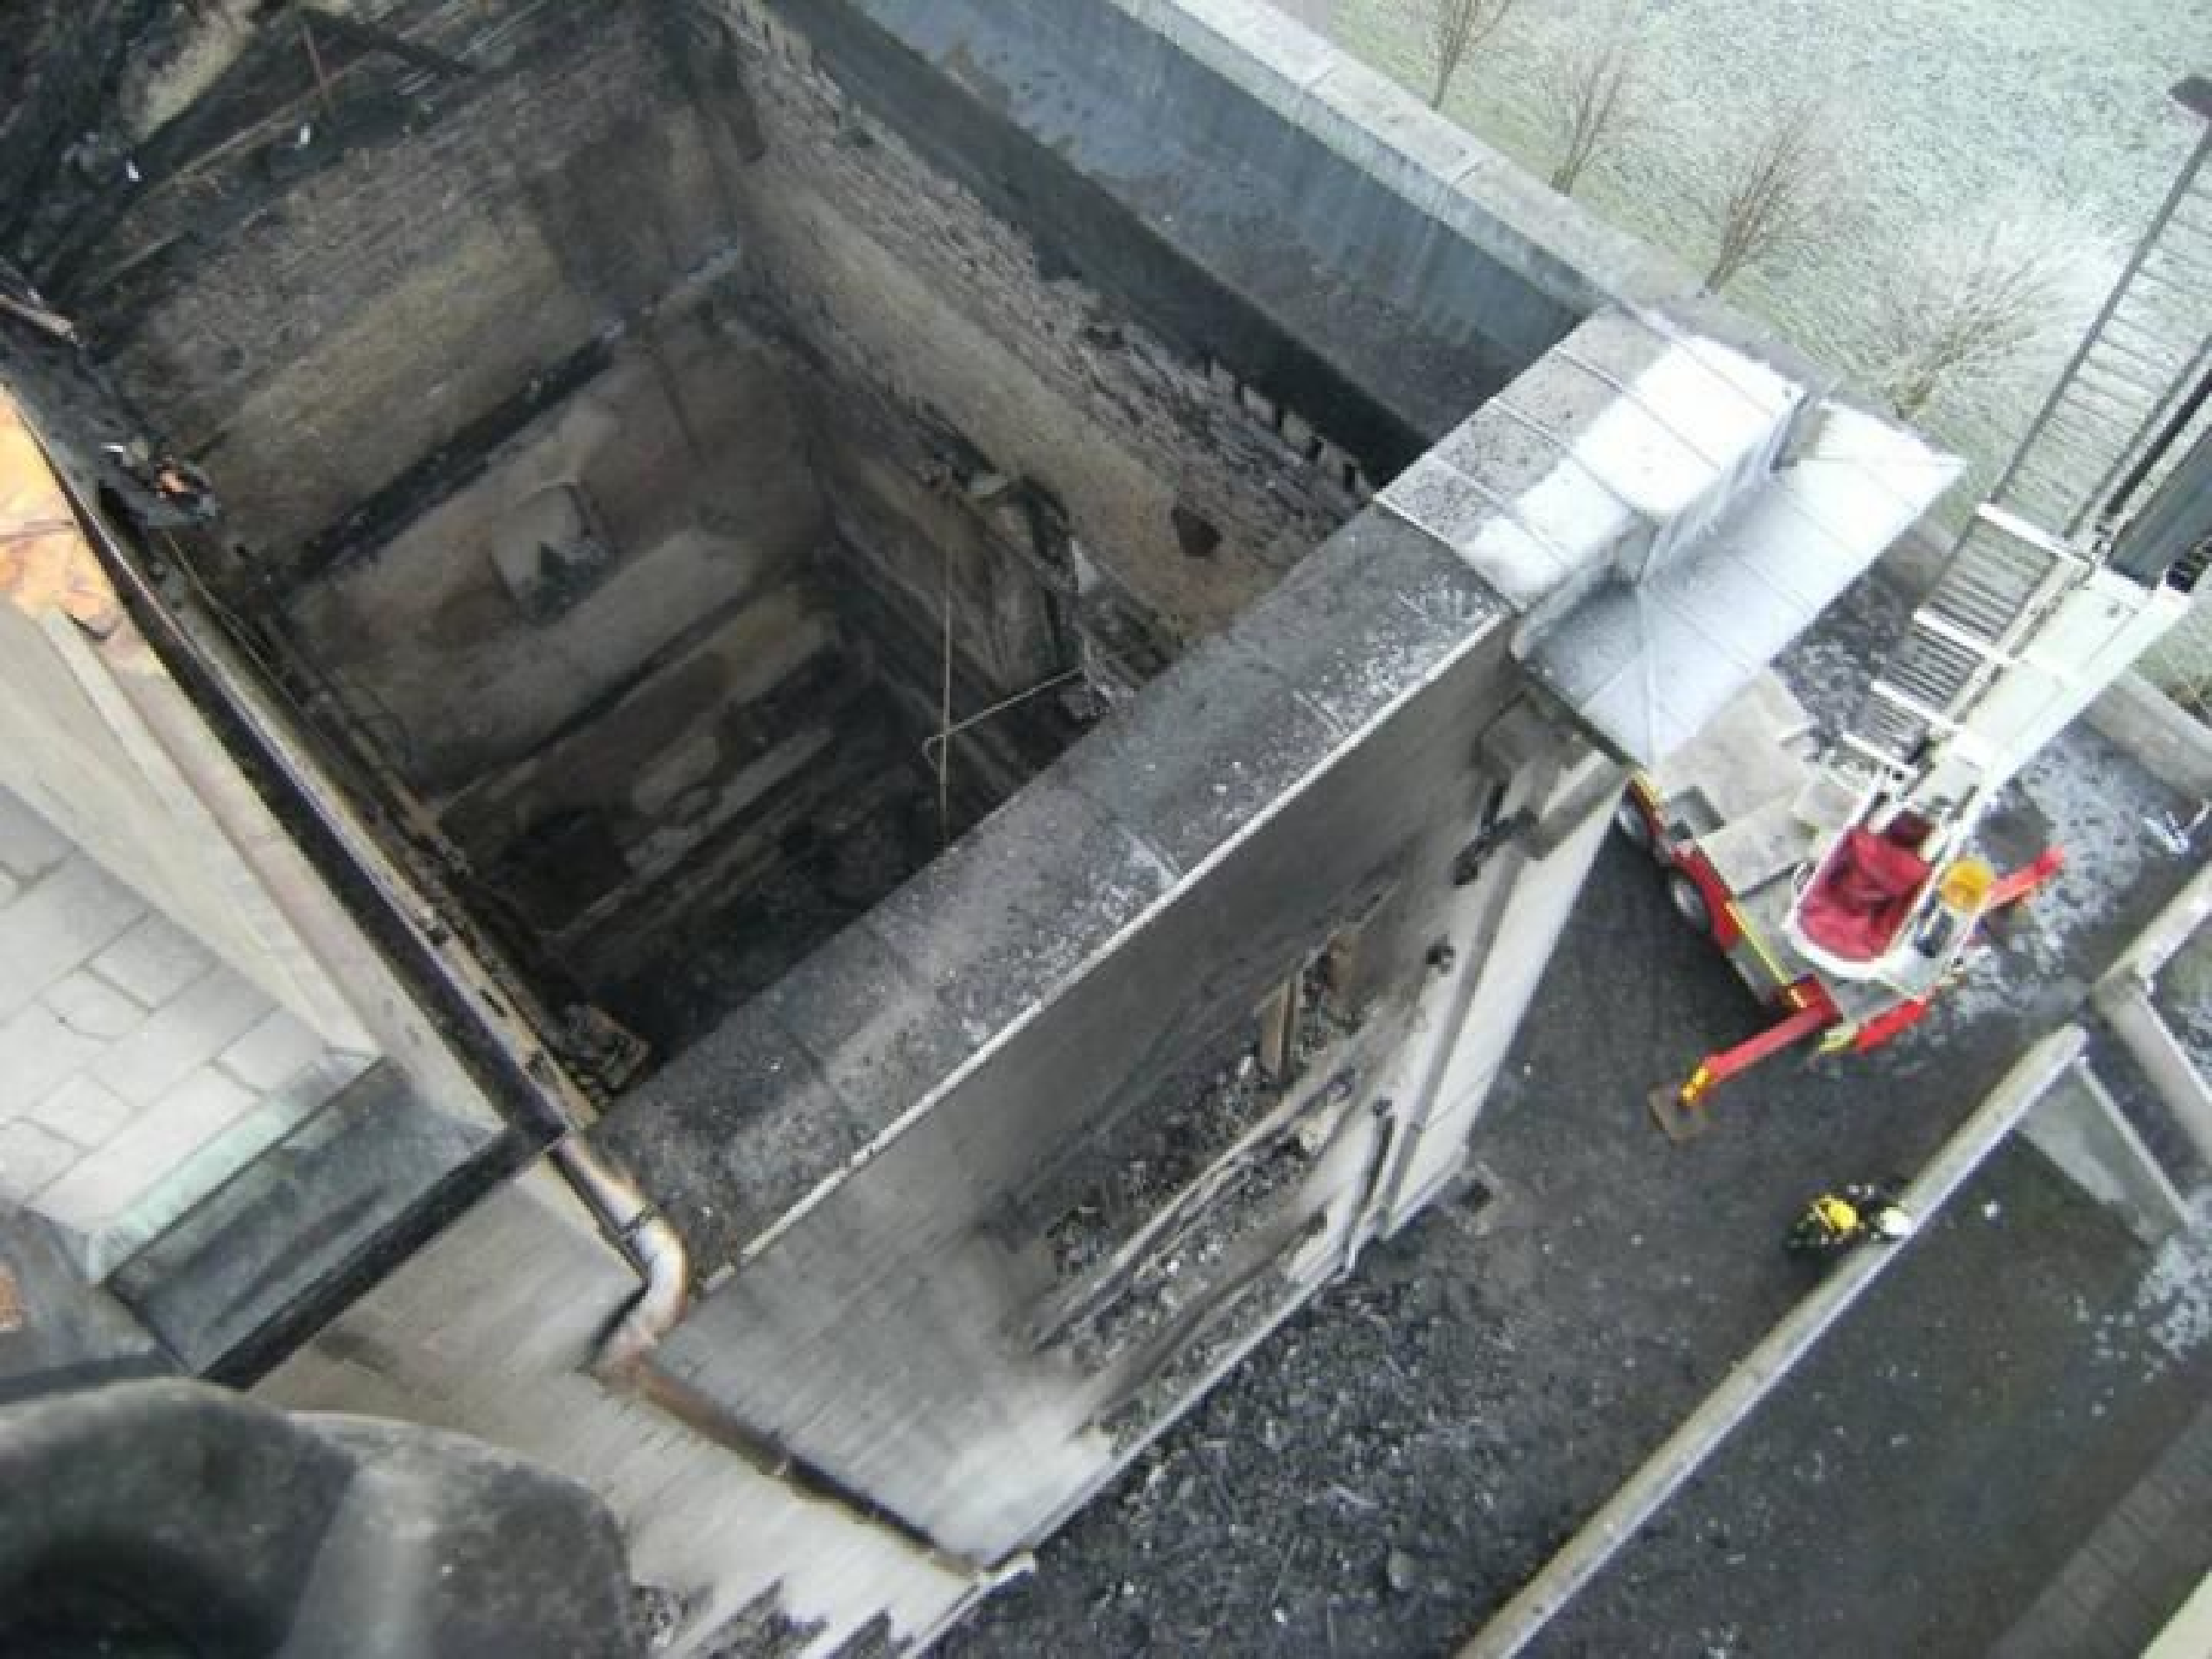
- The main roof to the central nave & dome which was formed in timber overlaid with copper has been completely destroyed.
- Flat roofing to the side aisles and transepts, which were constructed using a butyl membrane overlaid on timber decking, has also been totally consumed.
