St Mel's Cathedral Longford – Fire 25th December 2009

Summary of Nature & Extent of Damage

Presentation to the Diocese of Ardagh & Clonmacnois

Saturday 10th April 2010

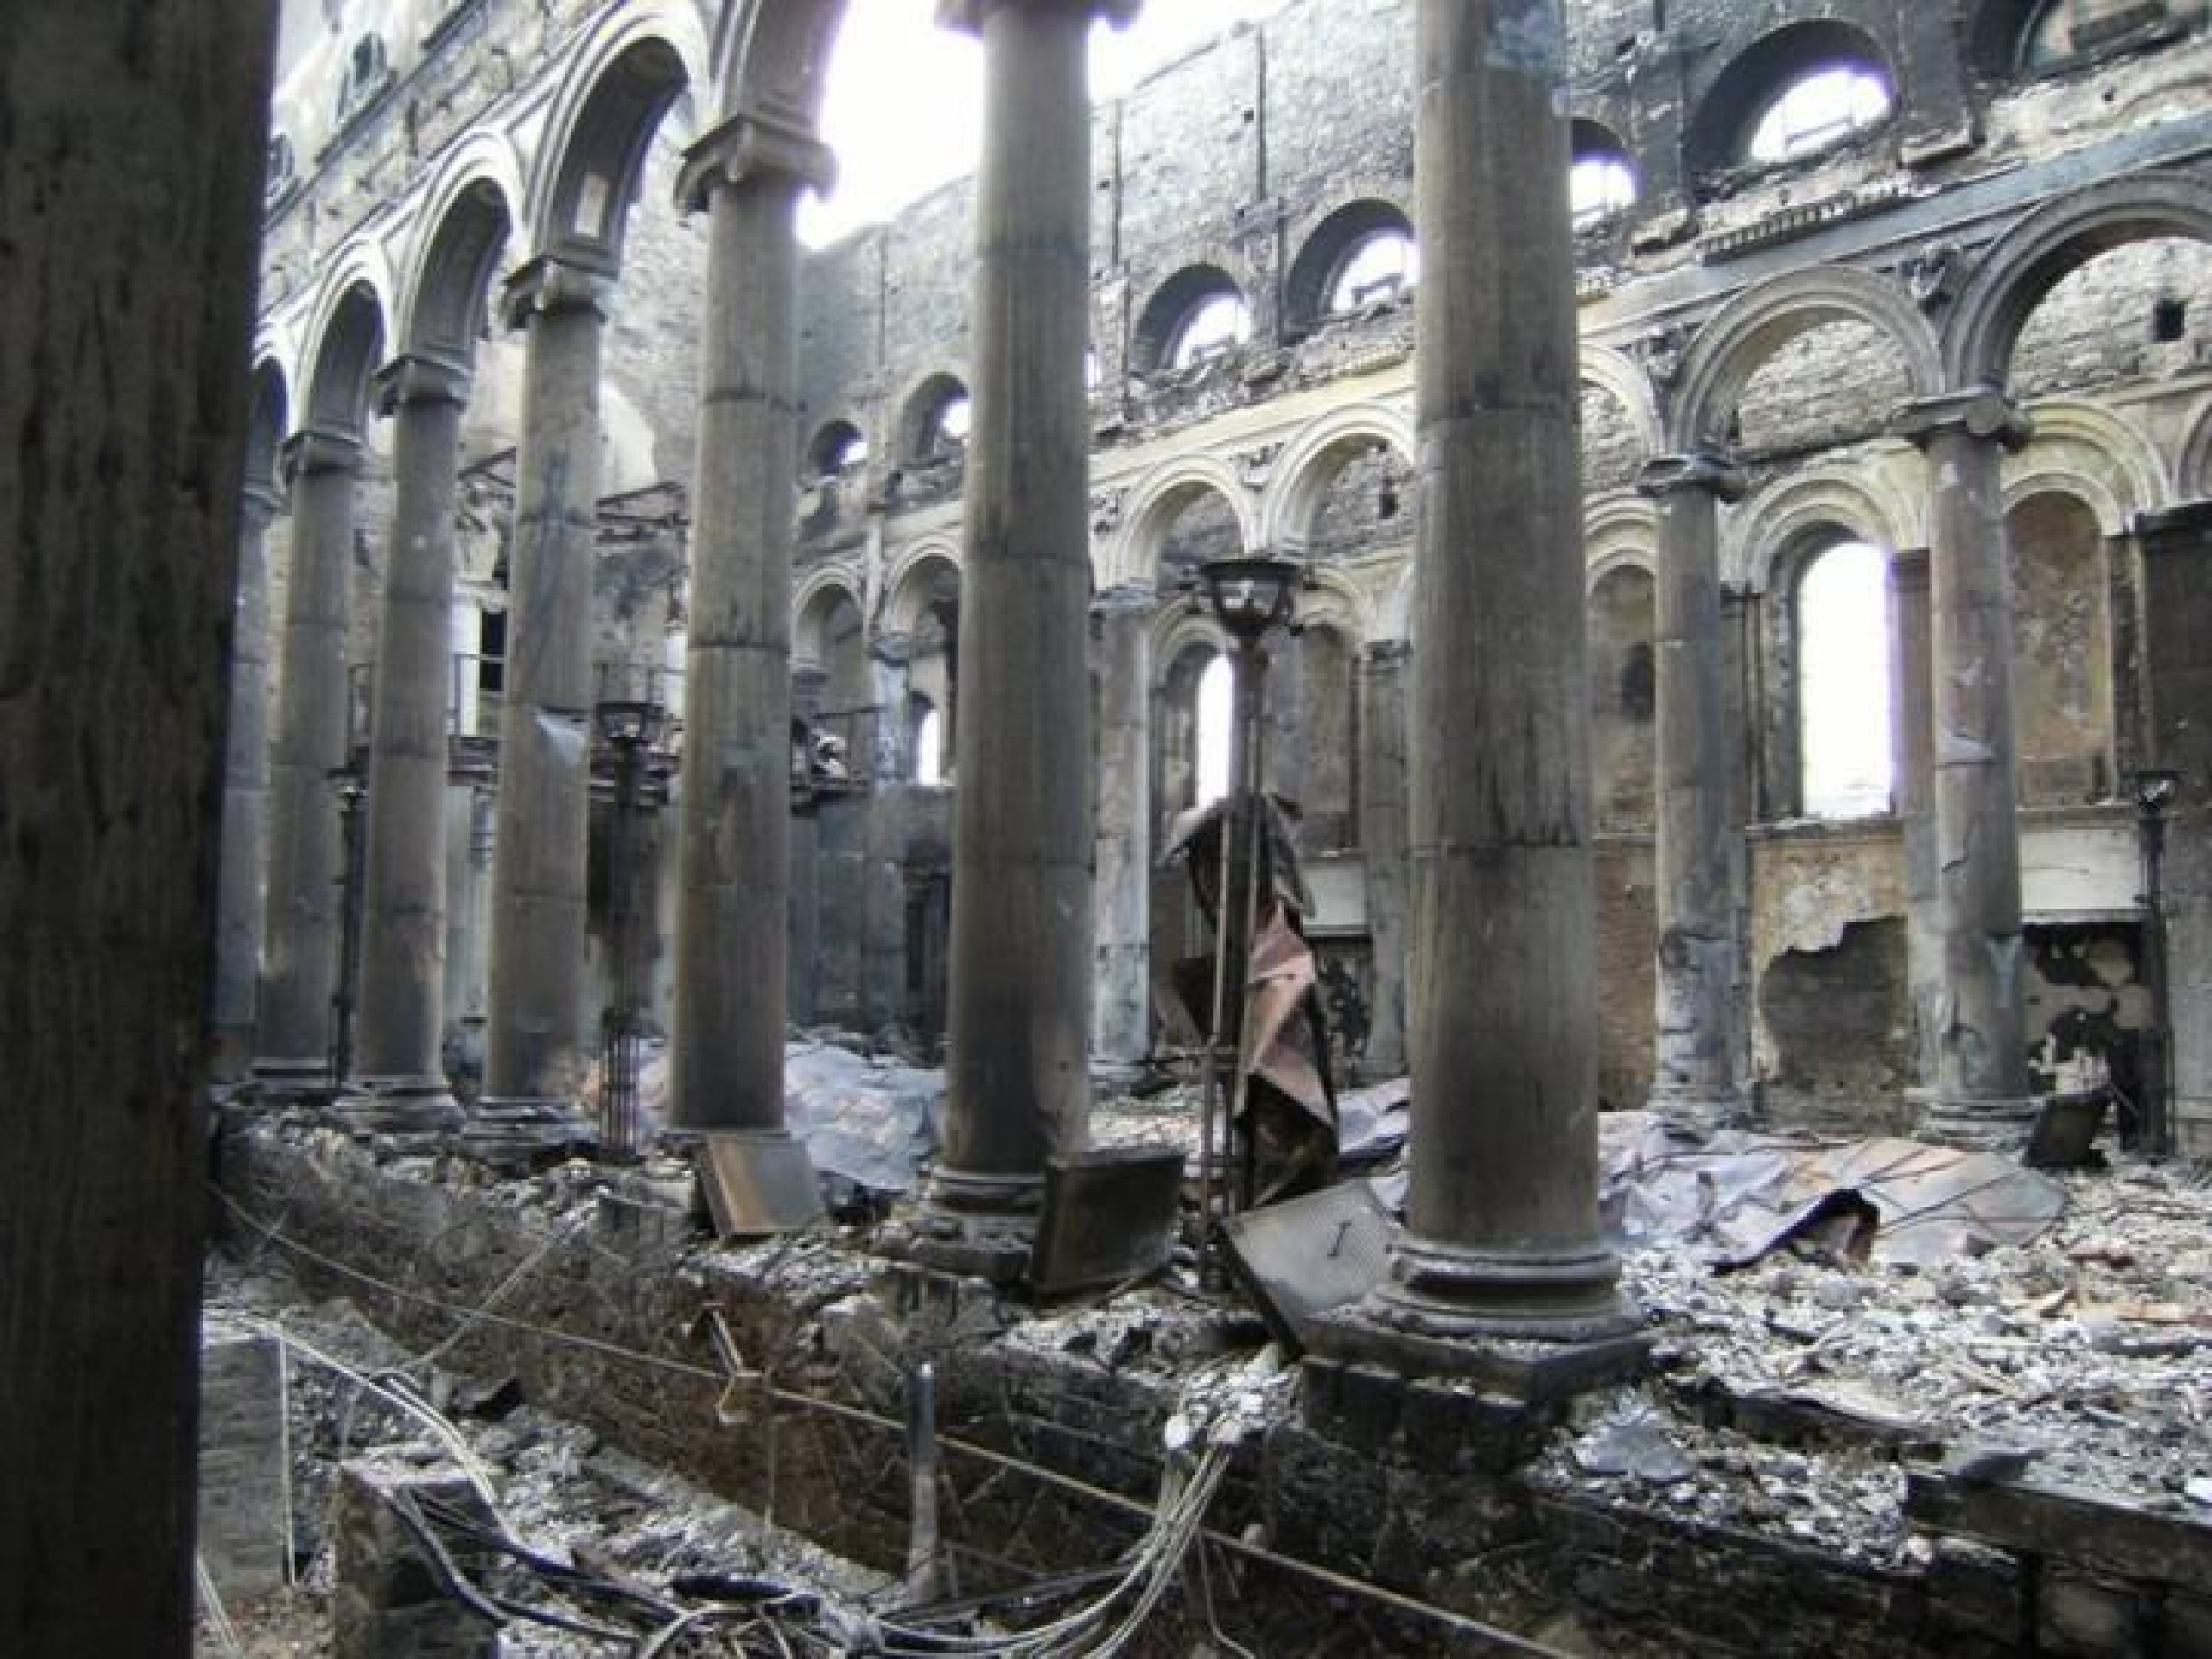
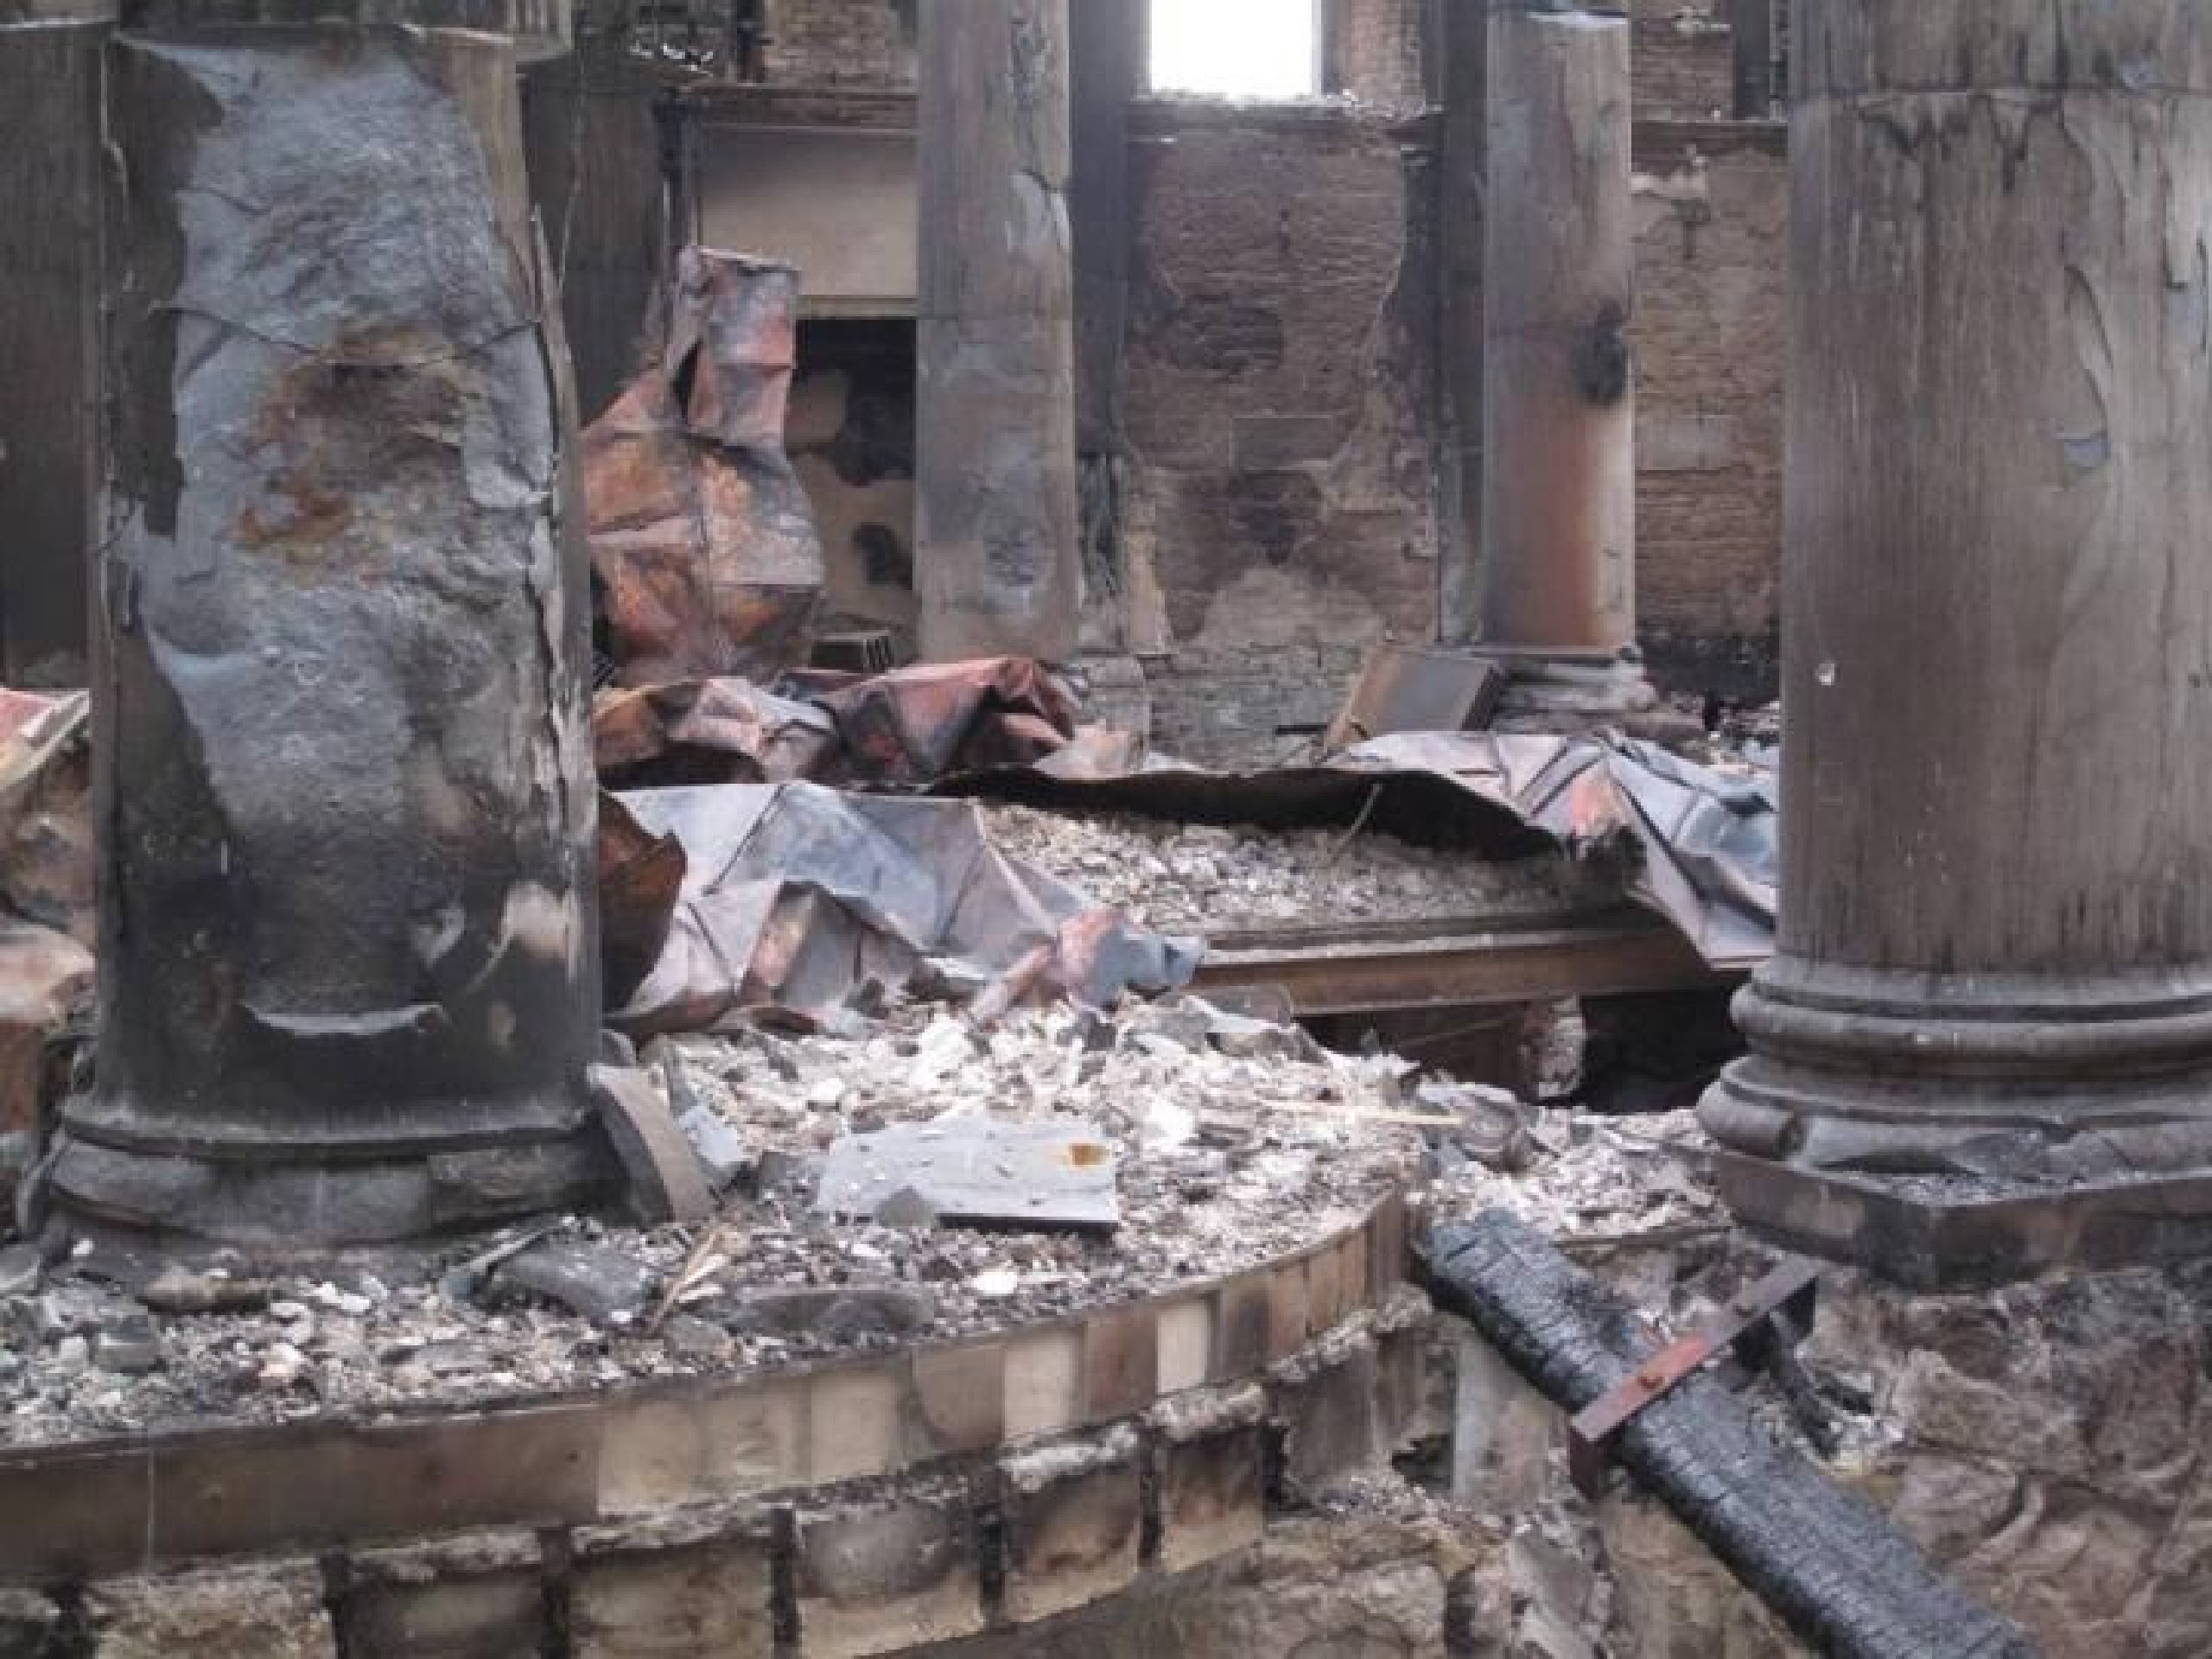
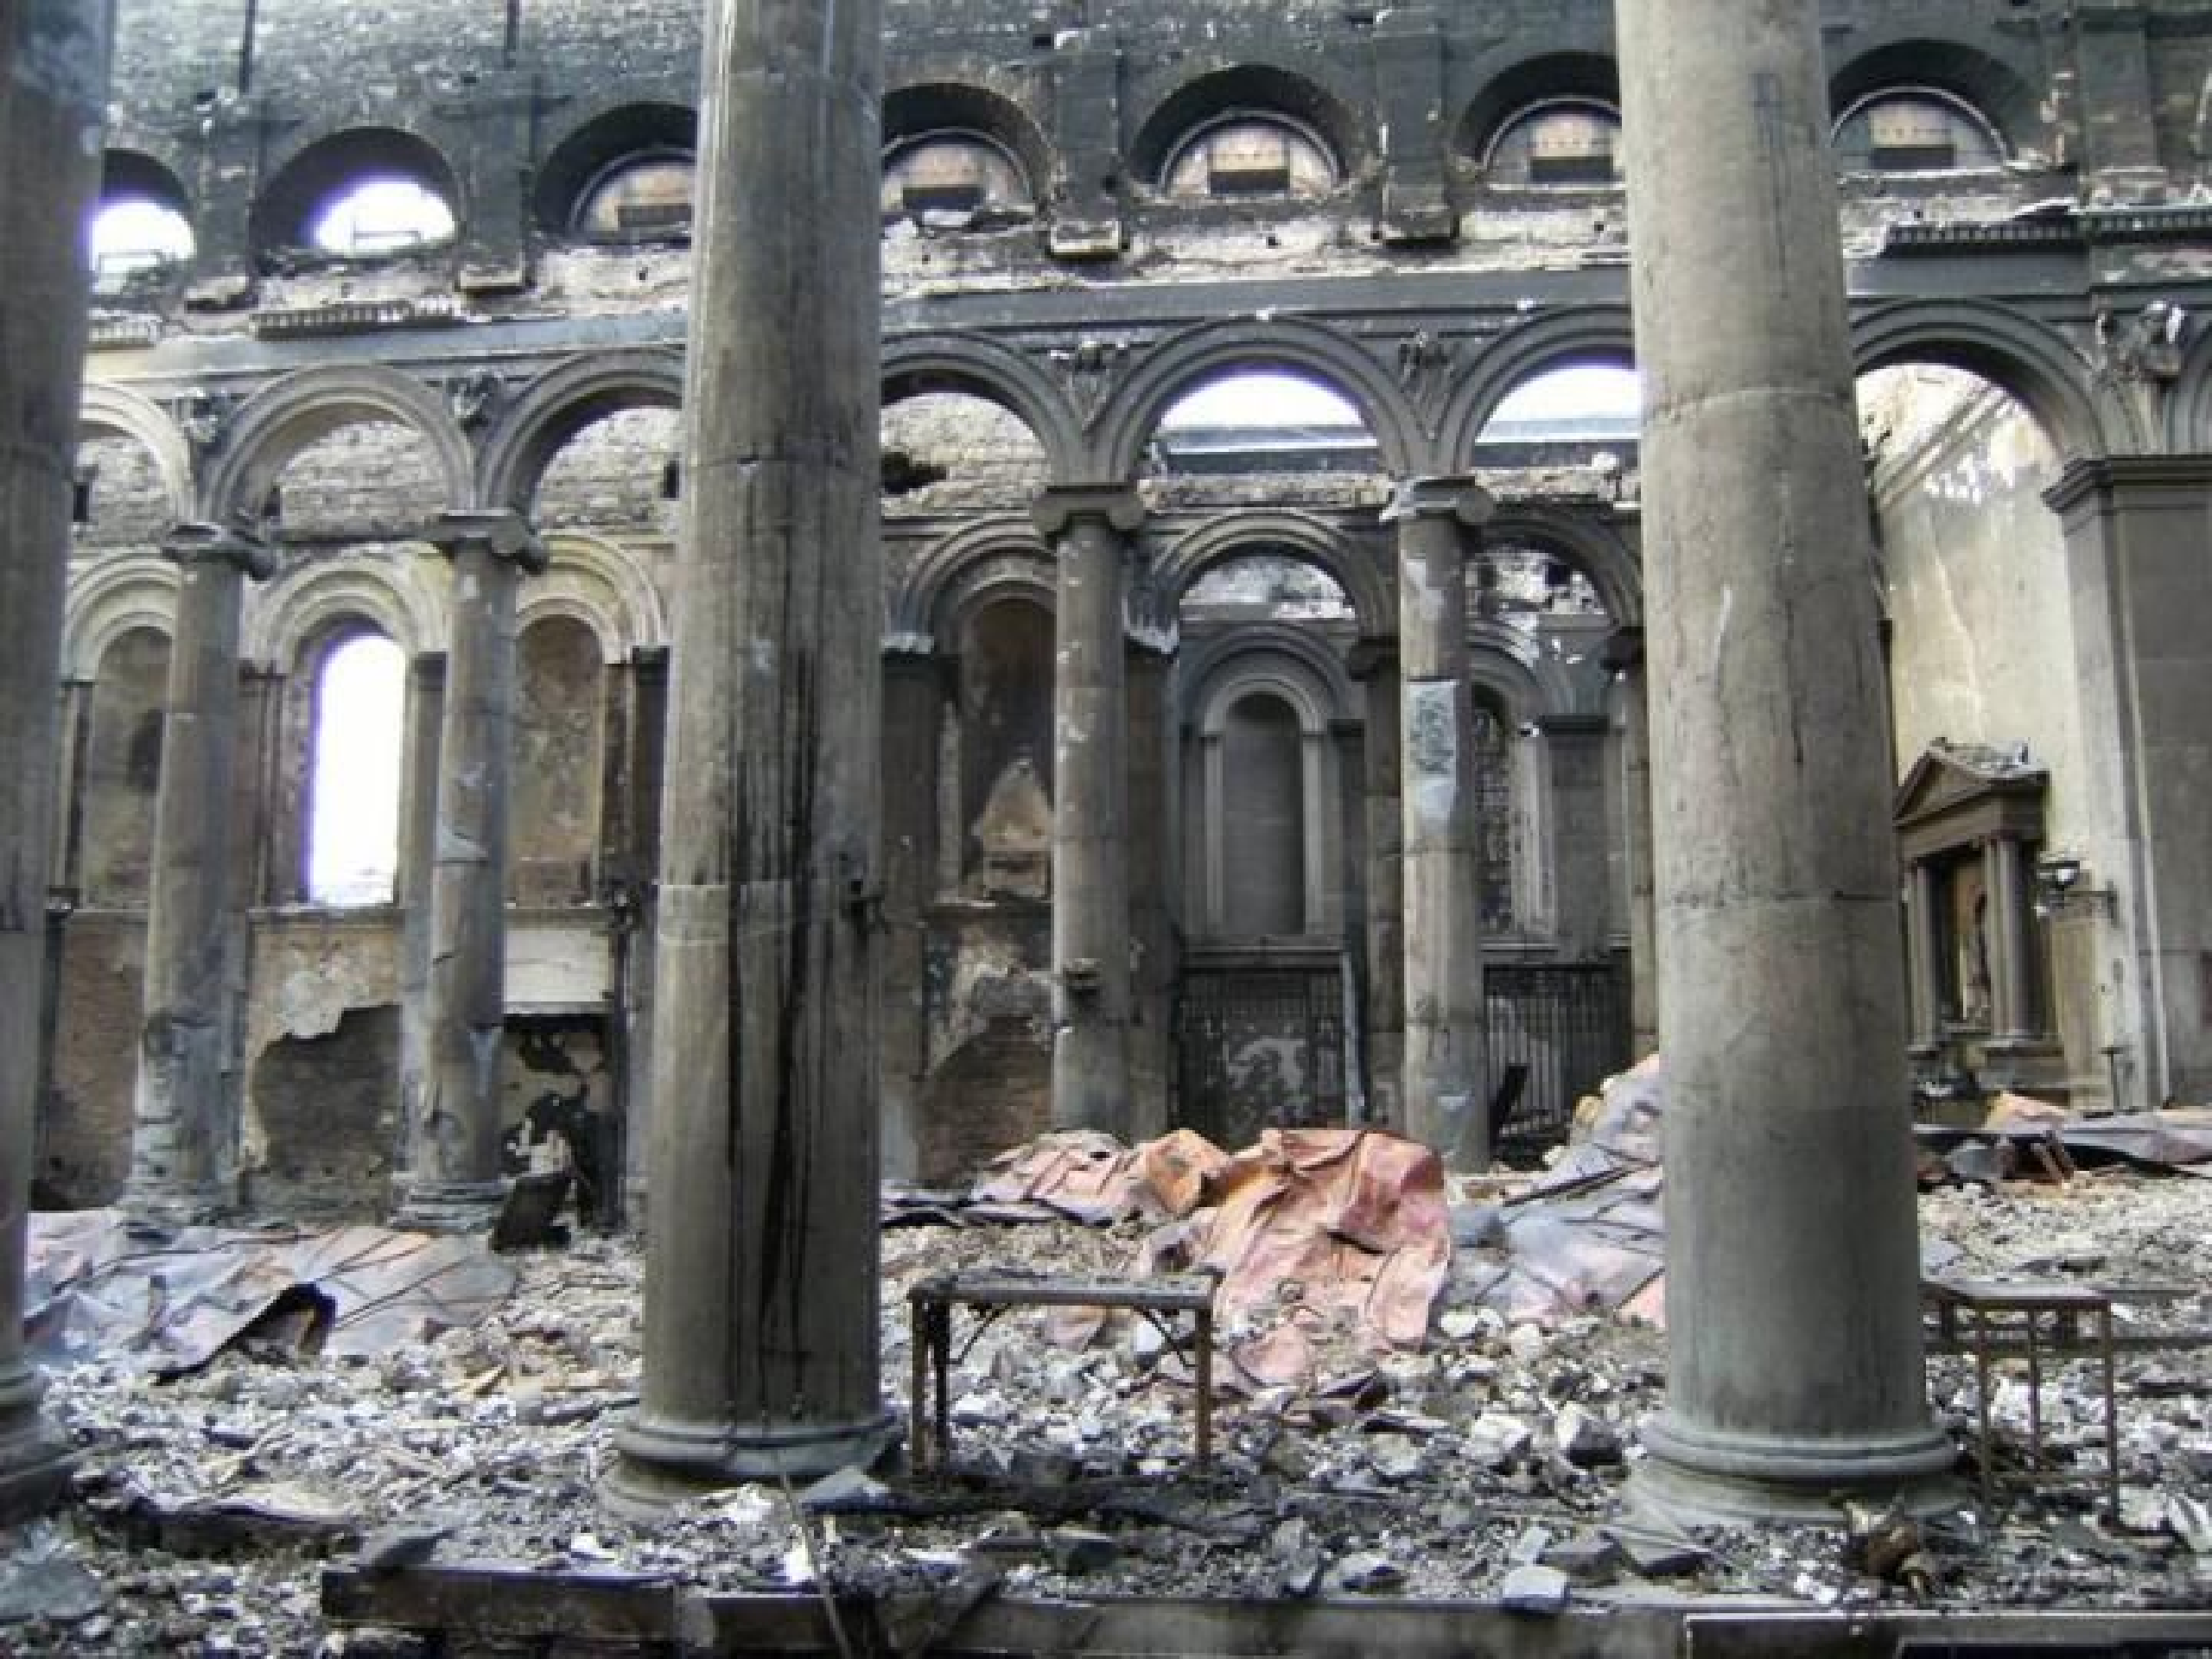
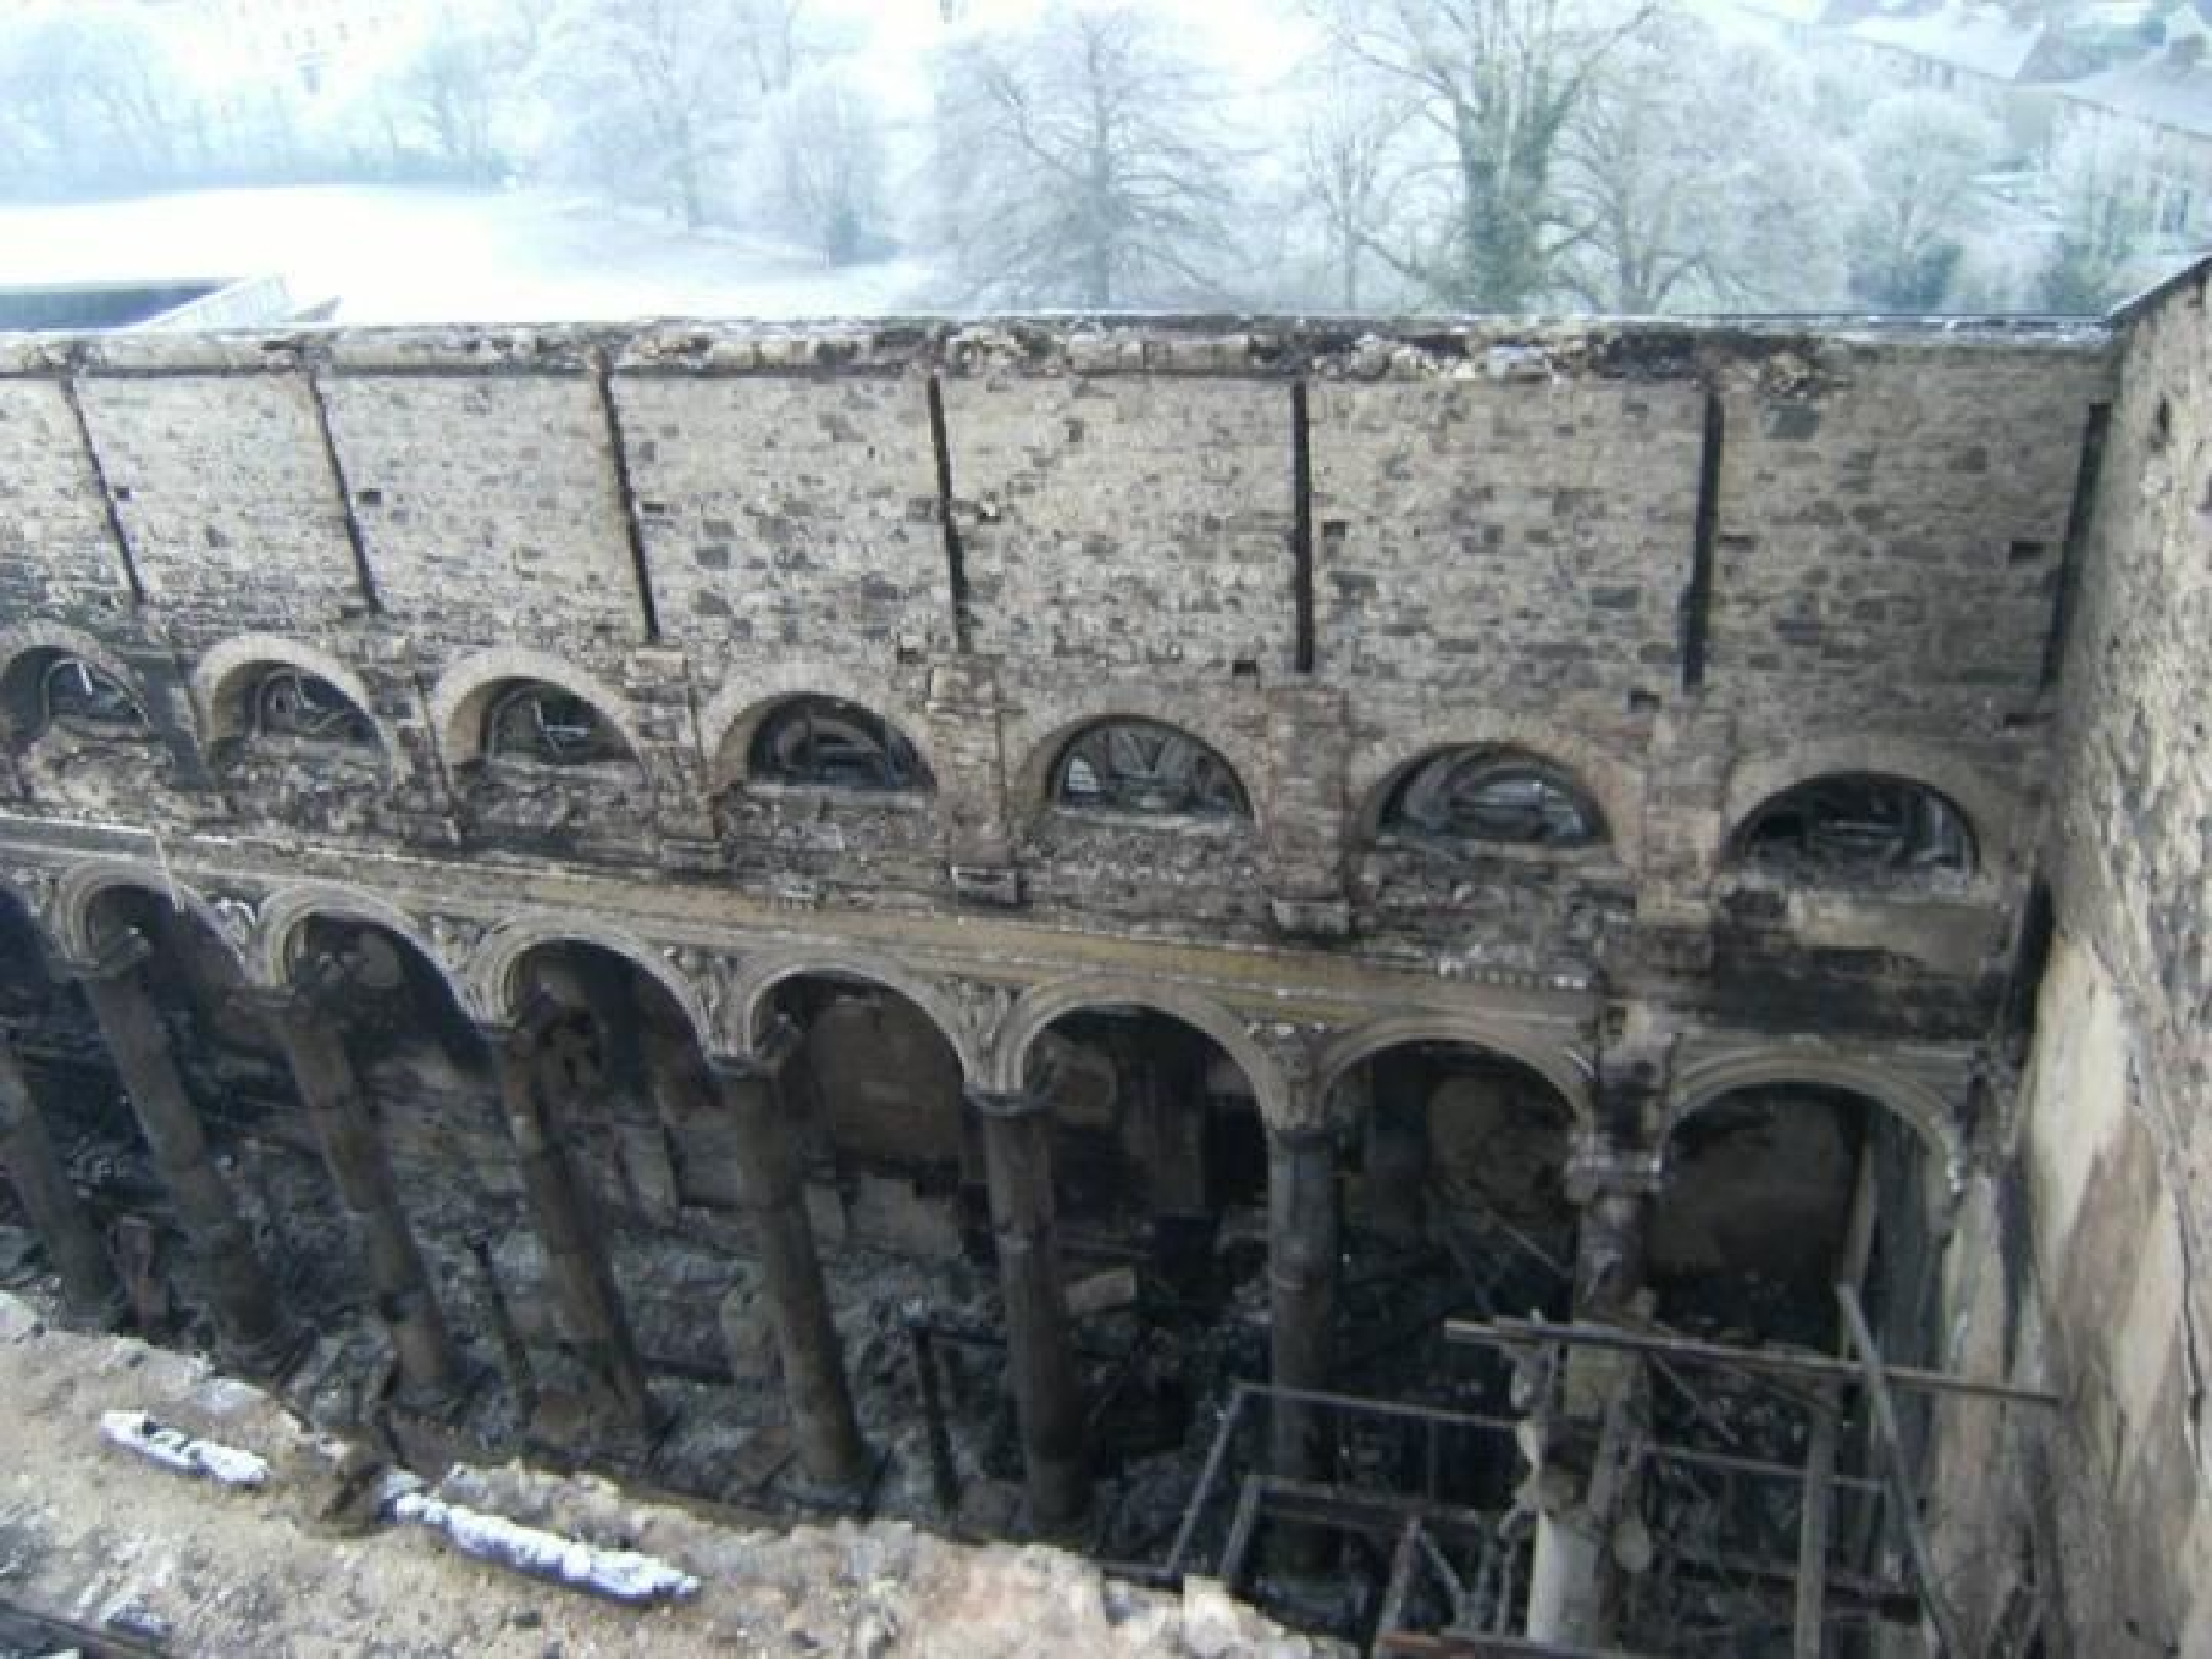
- Internal large circular limestone columns with arched brickwork walls above have suffered very severe levels of damage.
- The stonework columns, capitals, bases and arches reveal severe cracking and spalling throughout.
- Other internal partition walling has also suffered severe damage through direct fire attack / thermal movement.

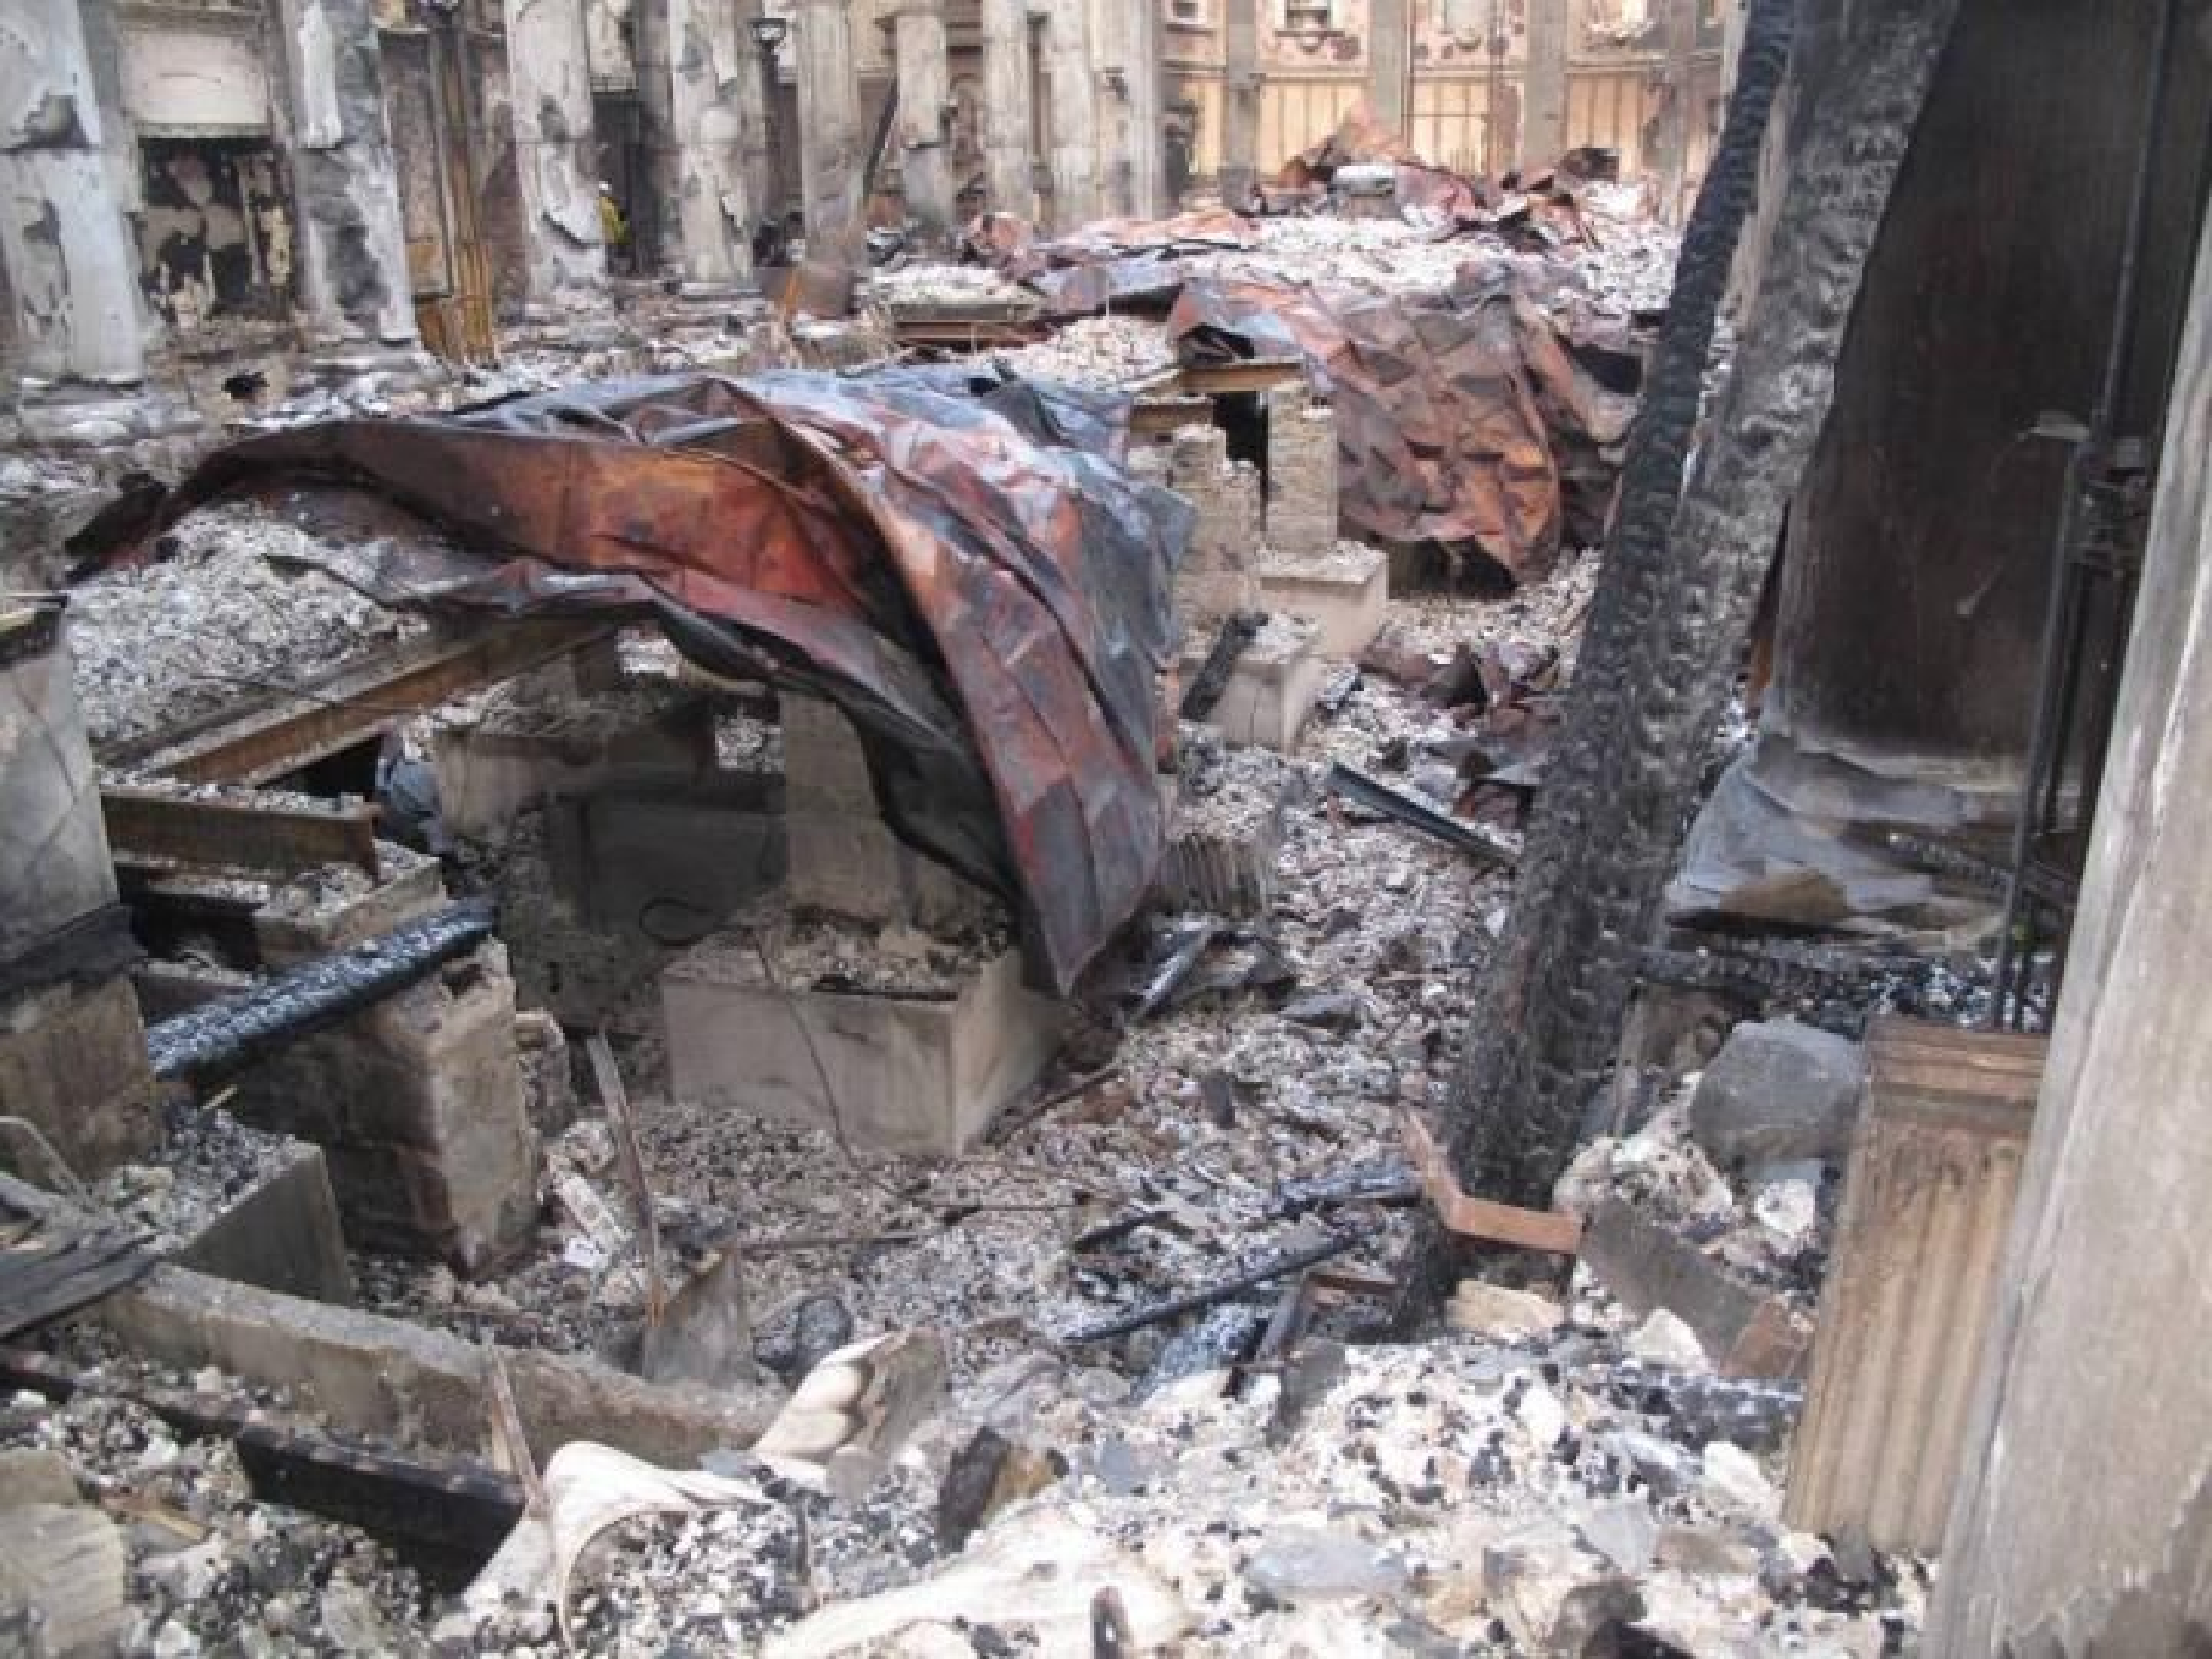
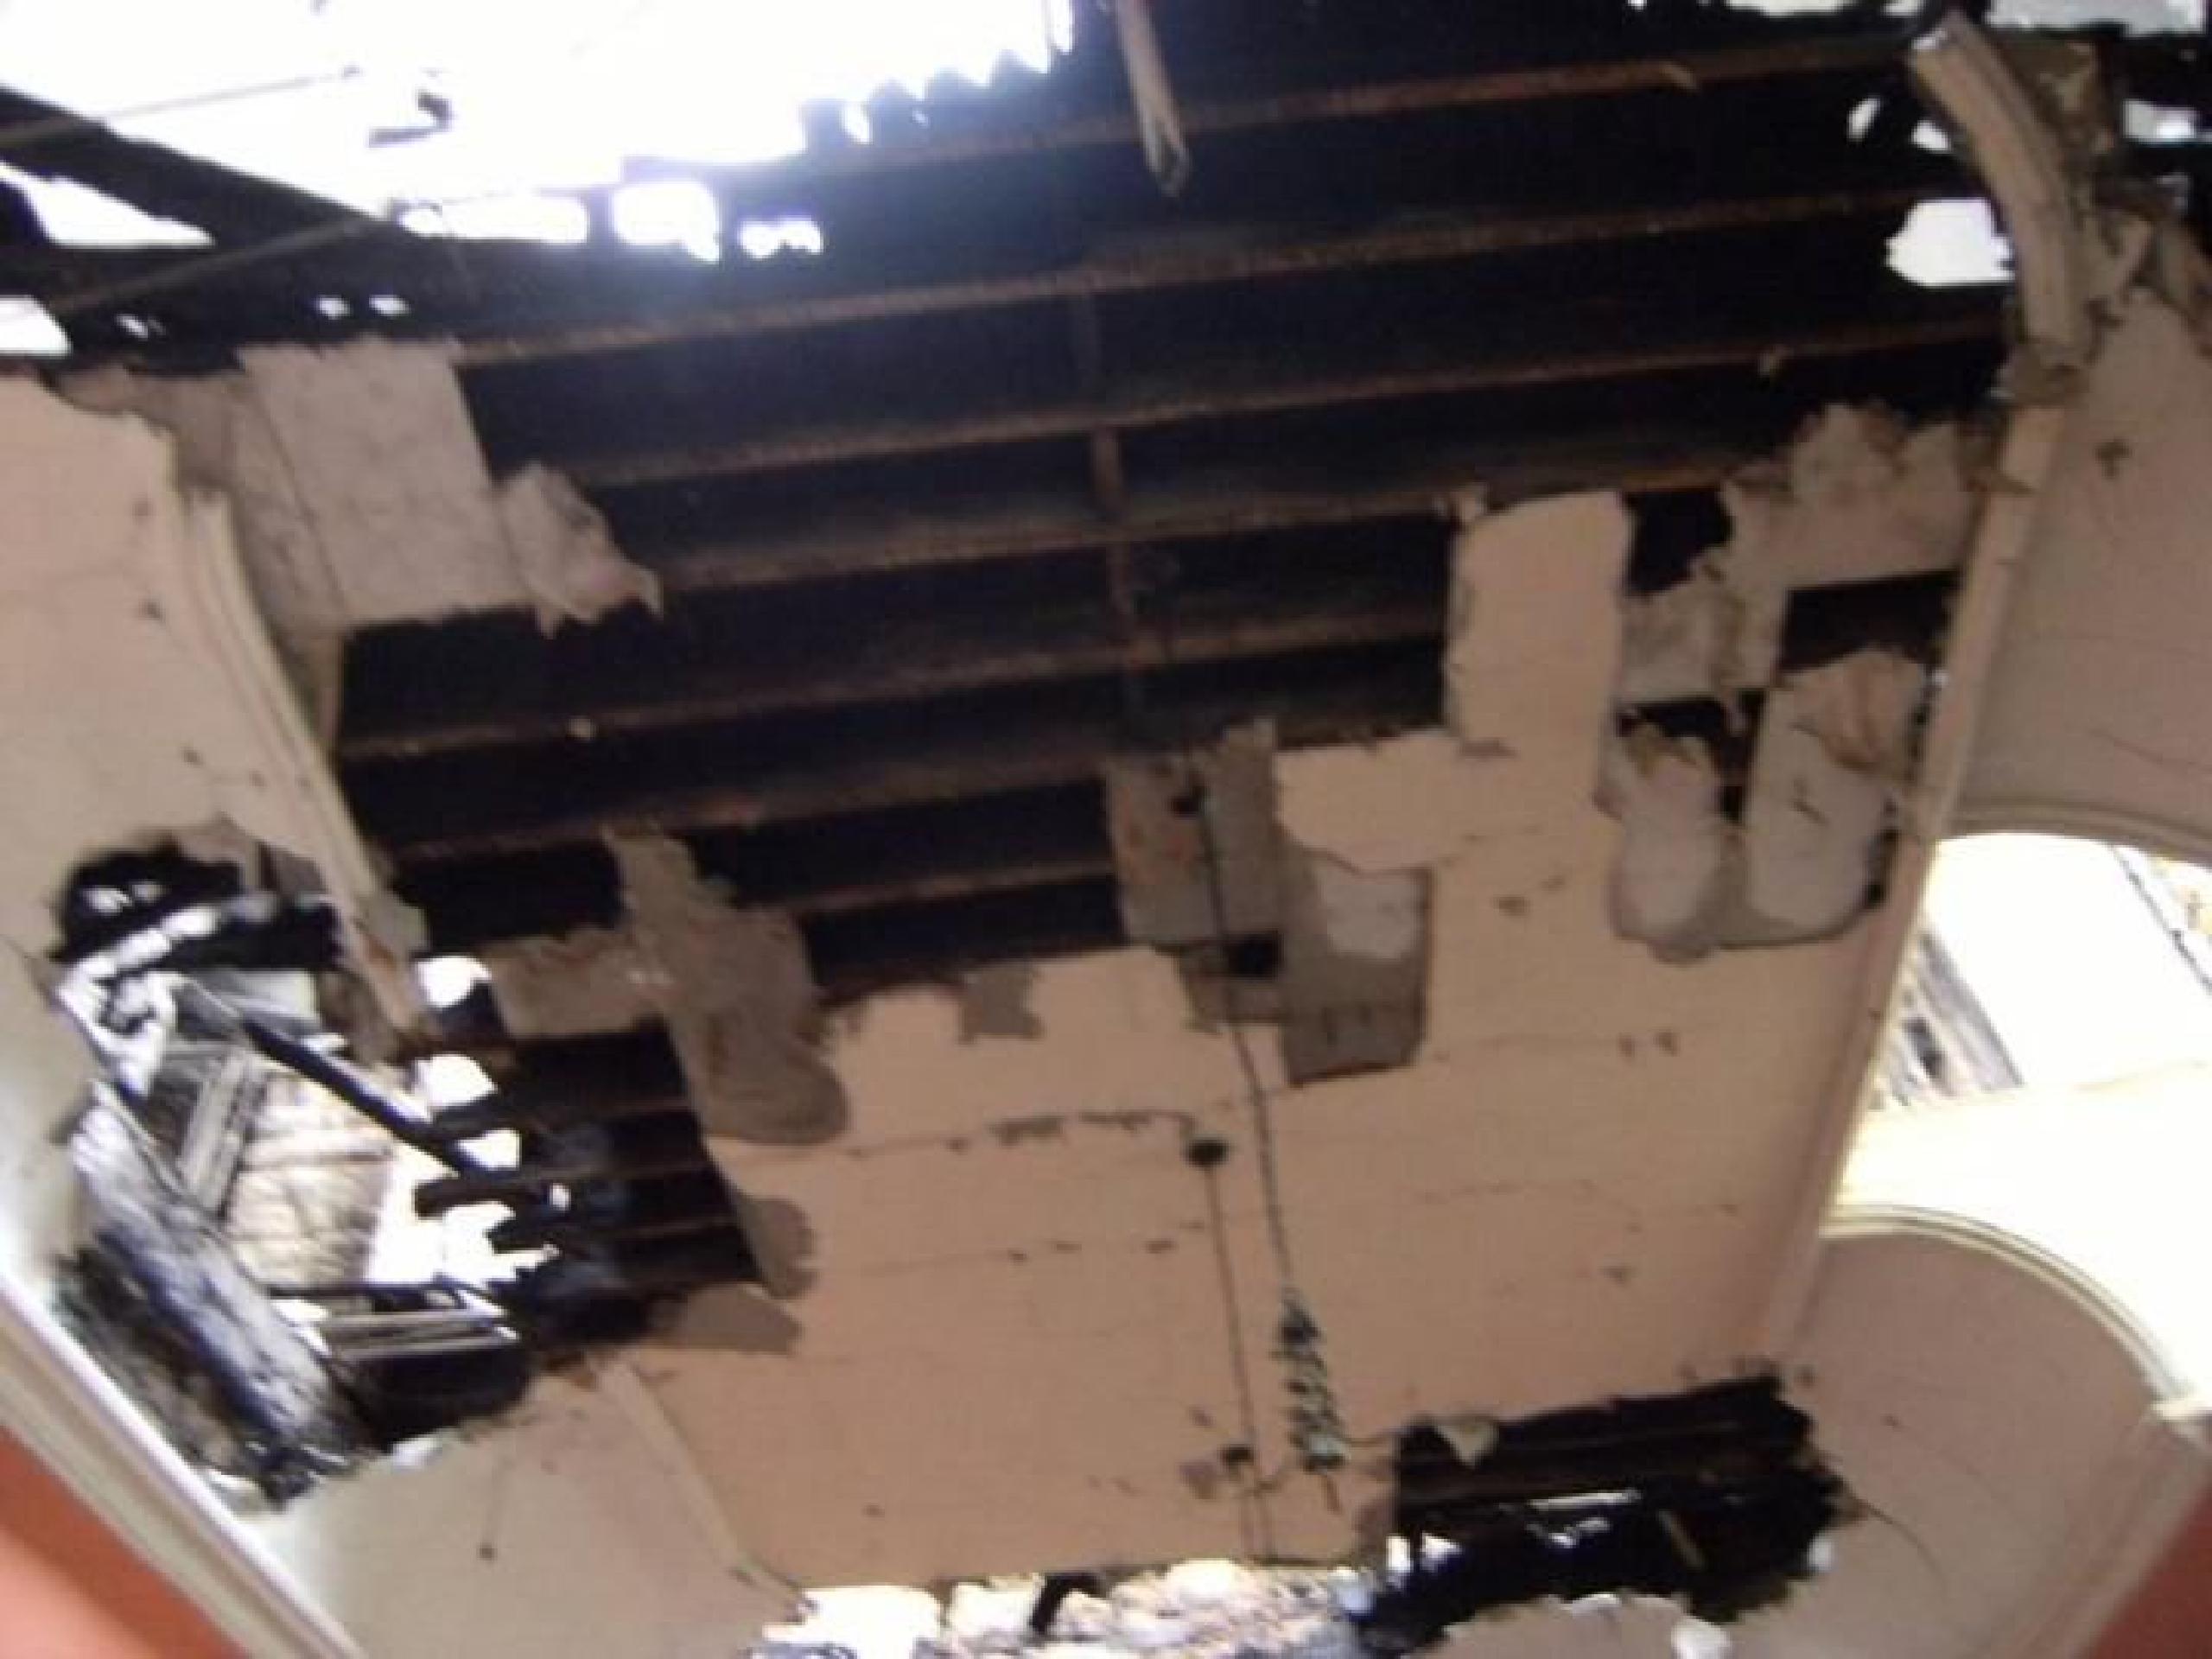
- Substantial areas of timber flooring have been lost within the body of the Cathedral, most particularly within the campanile tower, four storey accommodation to the rear and between the central nave and crypt beneath.
- Areas of flooring within entrance porches and transepts have survived the fire to some extent, though are largely destroyed.
- The majority of floor finishes to include timber strip, mosaic and marble are severely affected.
