St Mel's Cathedral Longford – Fire 25th December 2009

Summary of Nature & Extent of Damage

Presentation to the Diocese of Ardagh & Clonmacnois

Saturday 10th April 2010

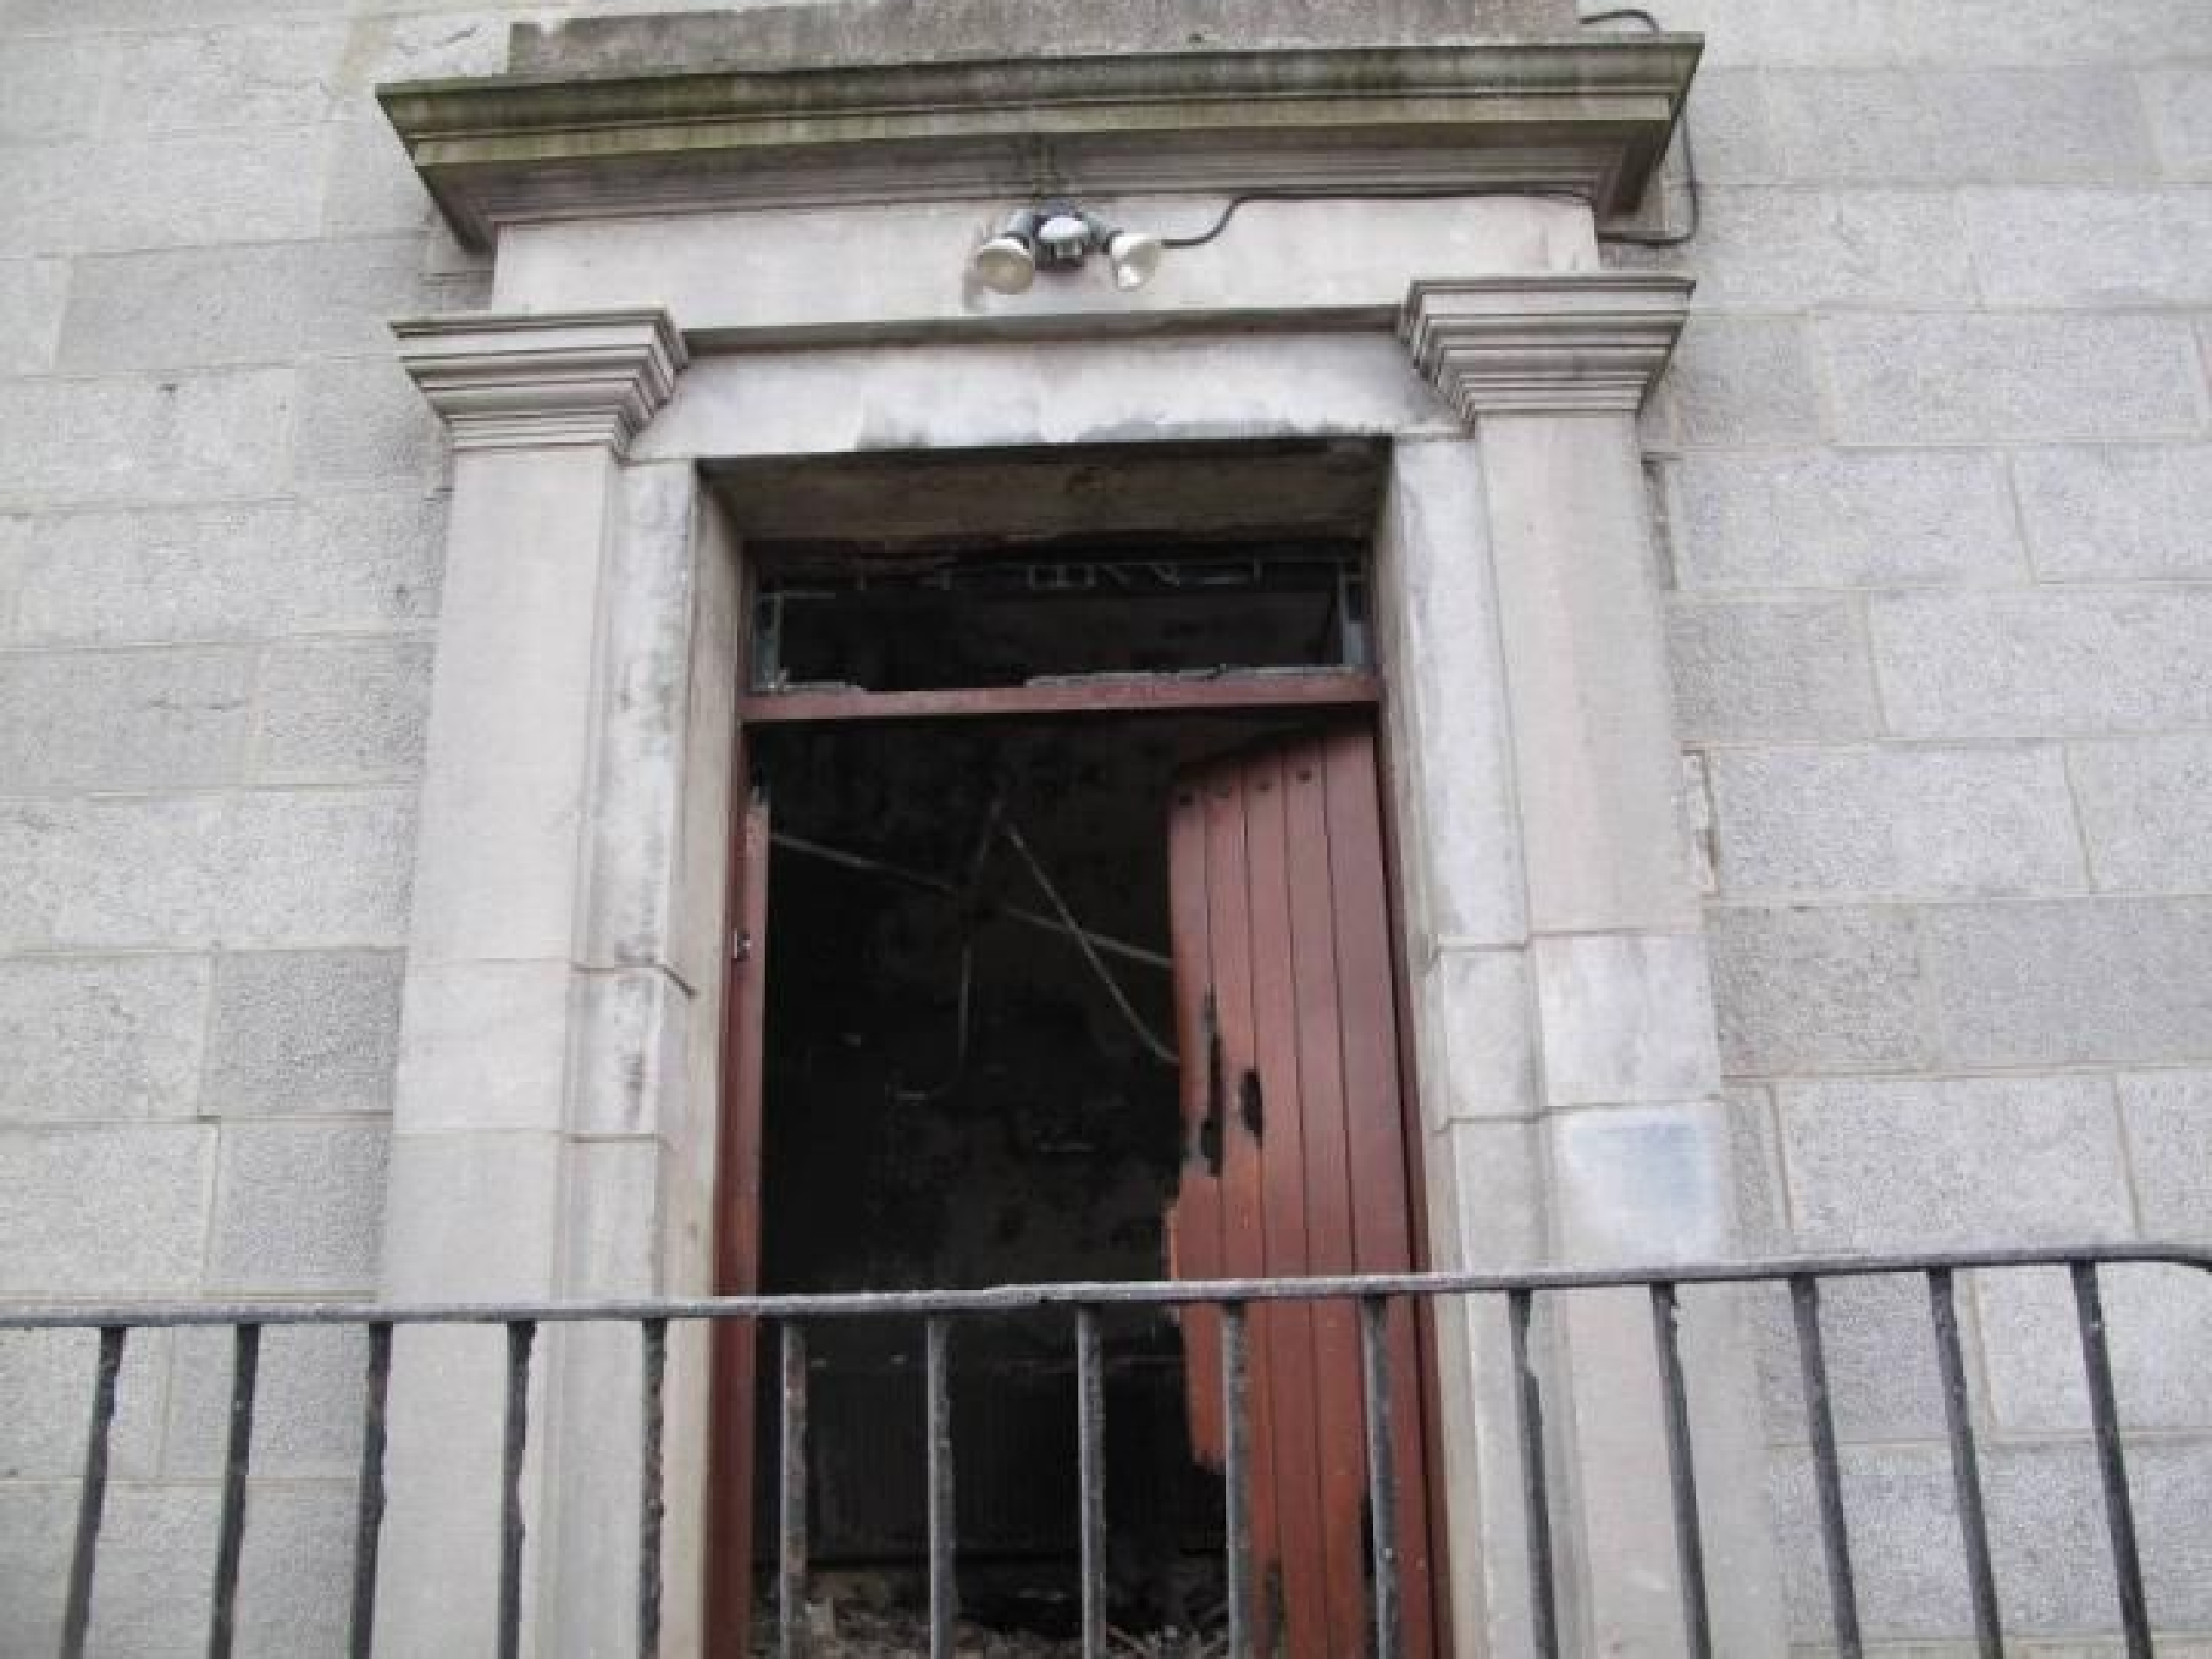
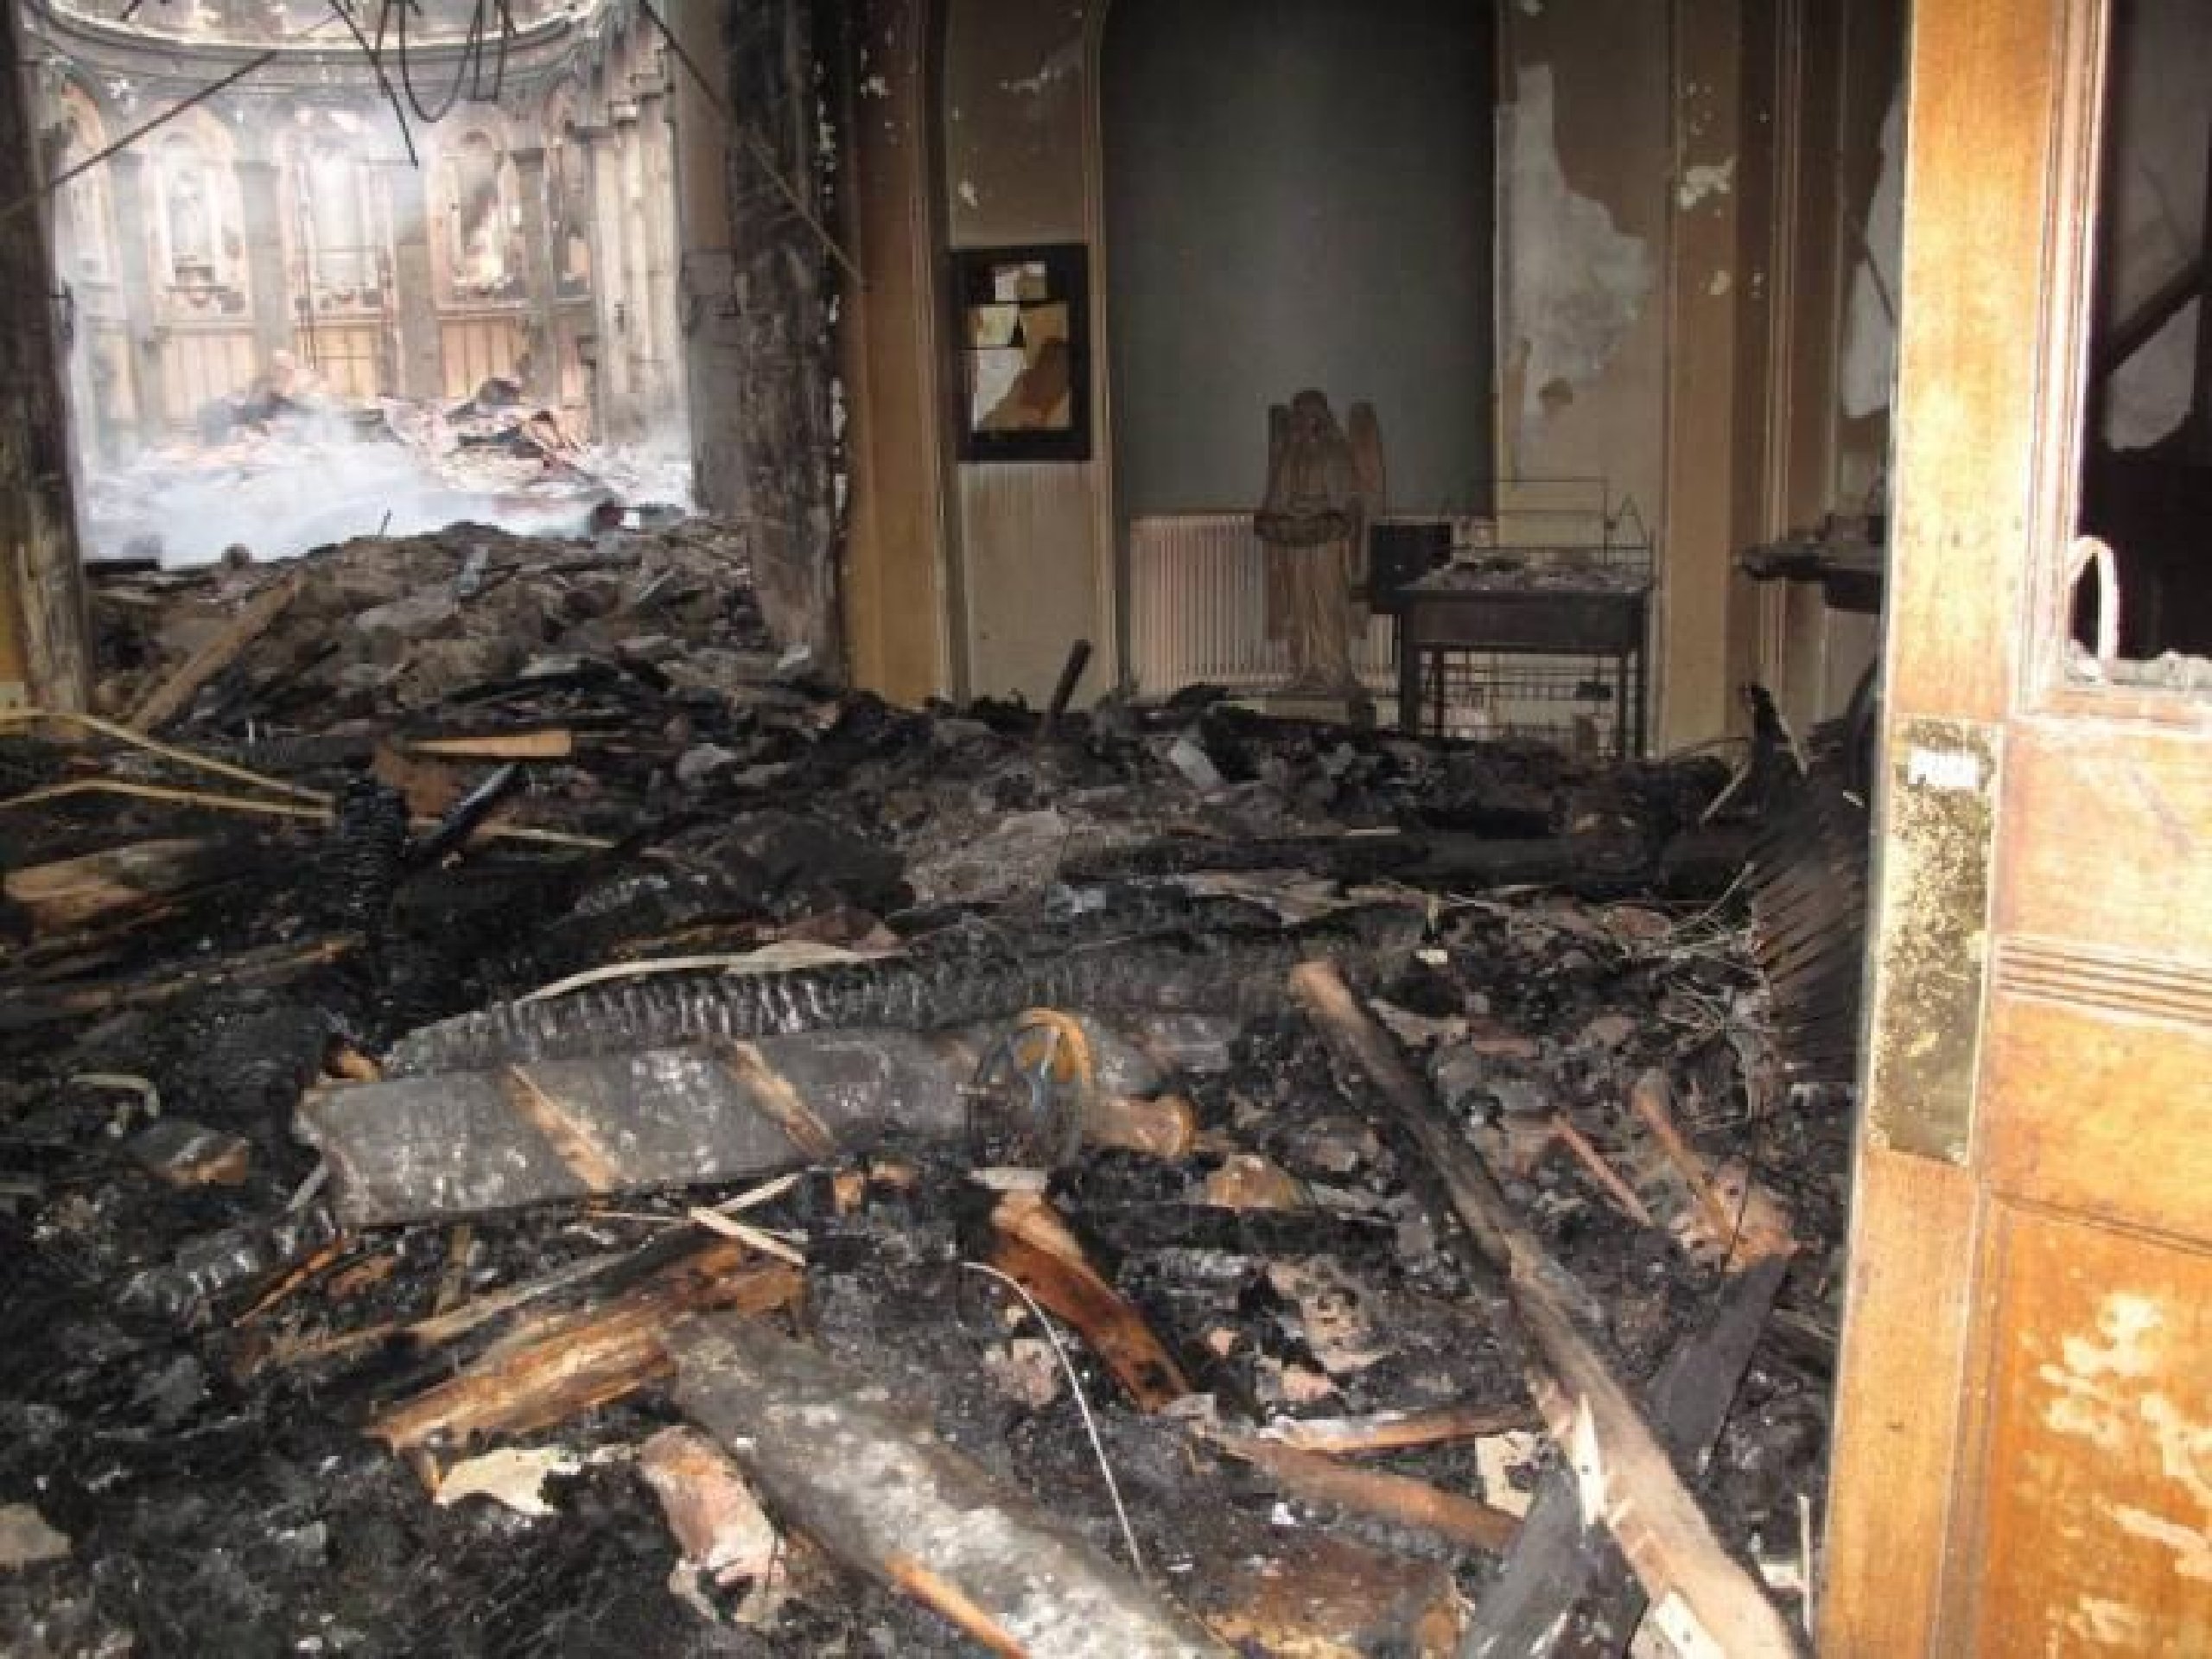
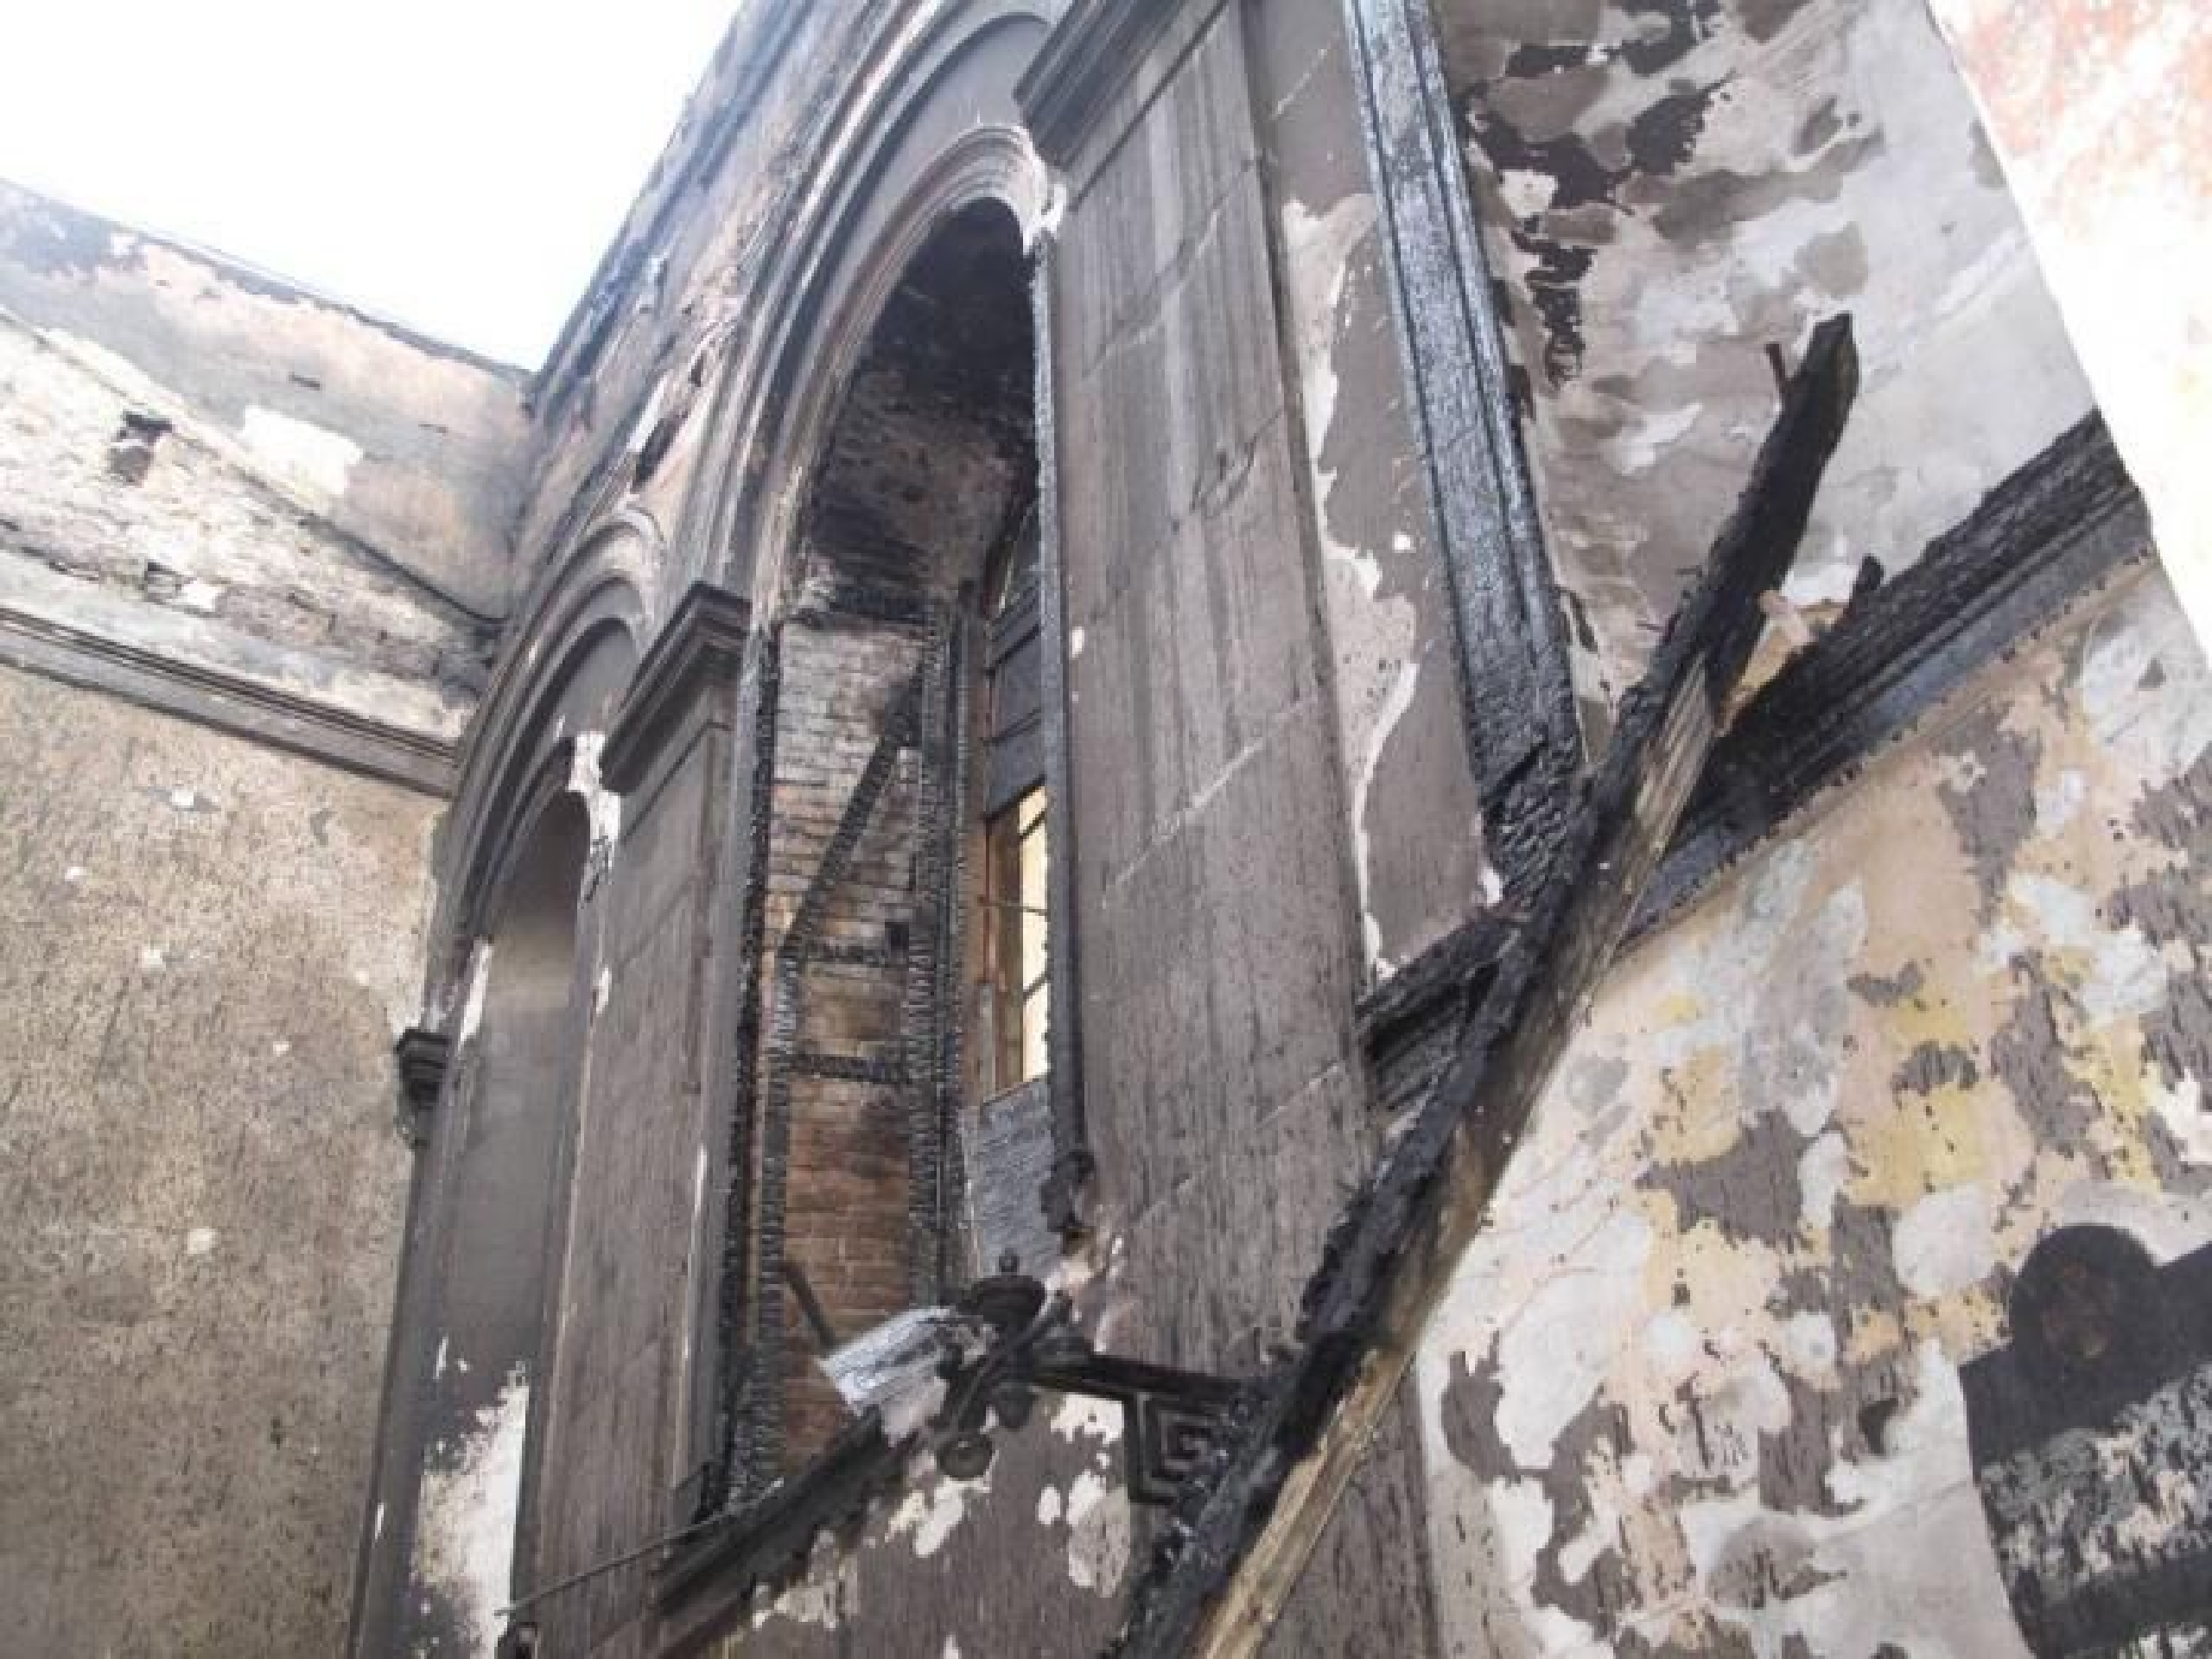
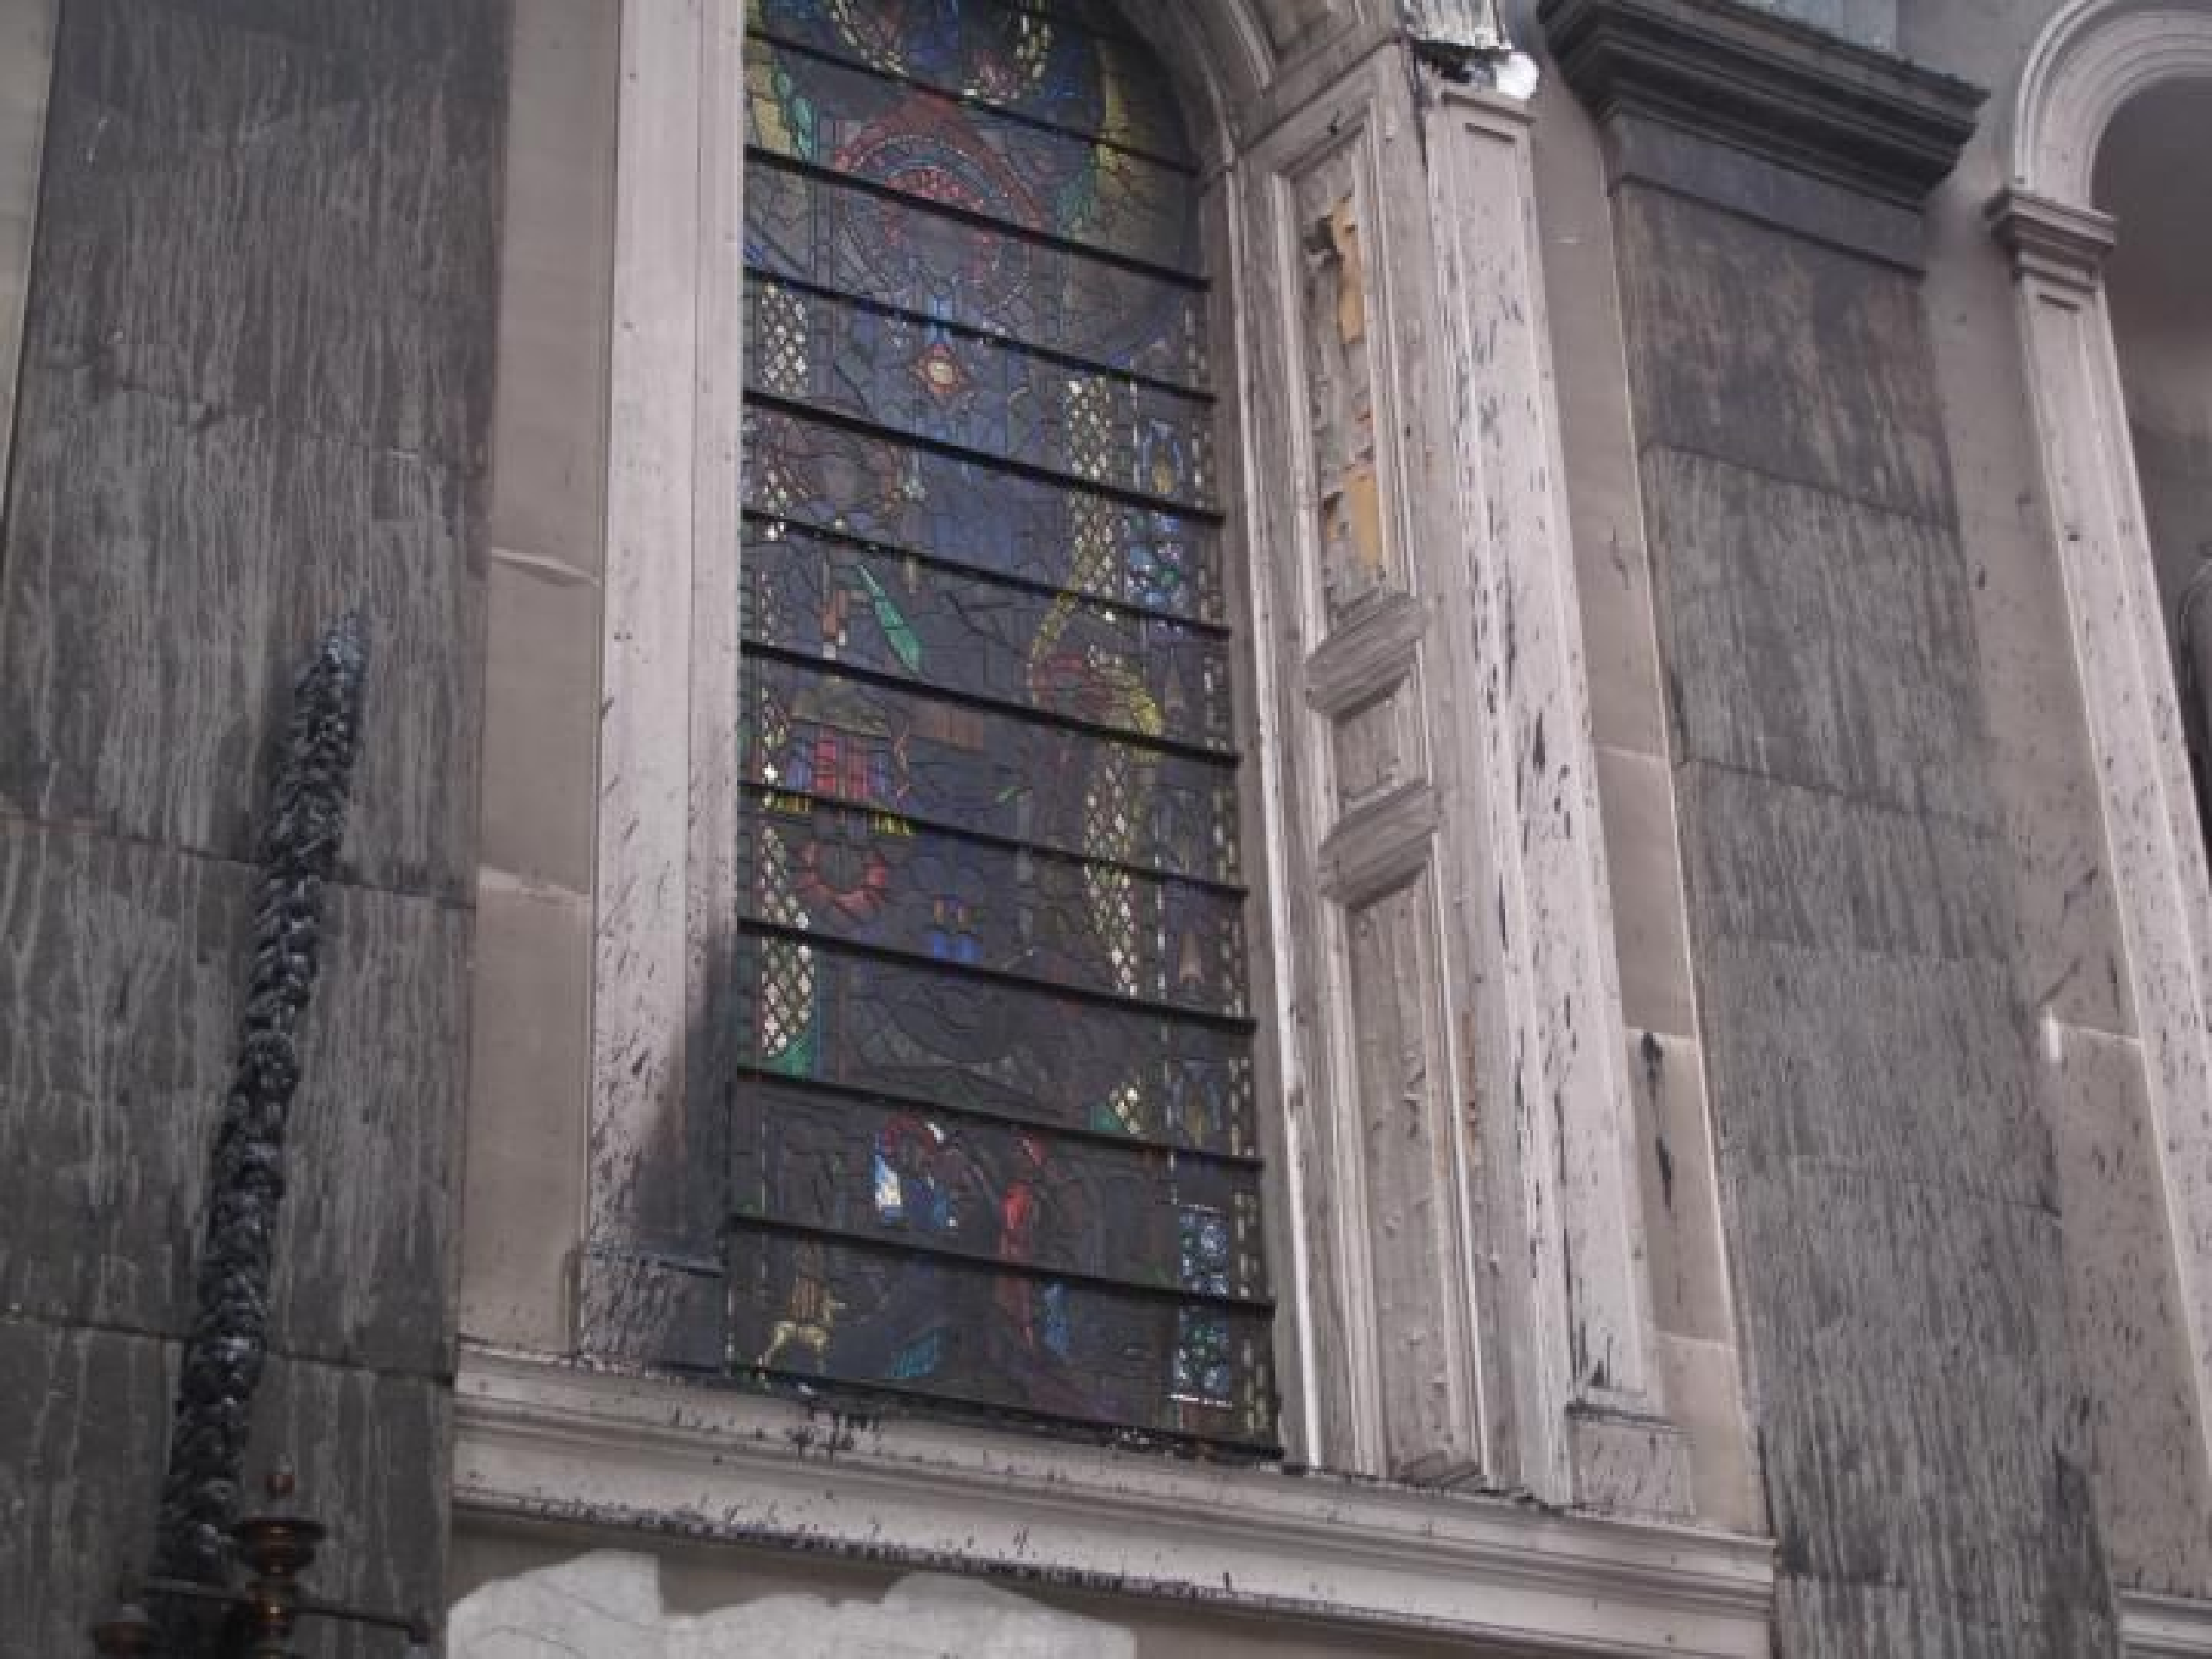
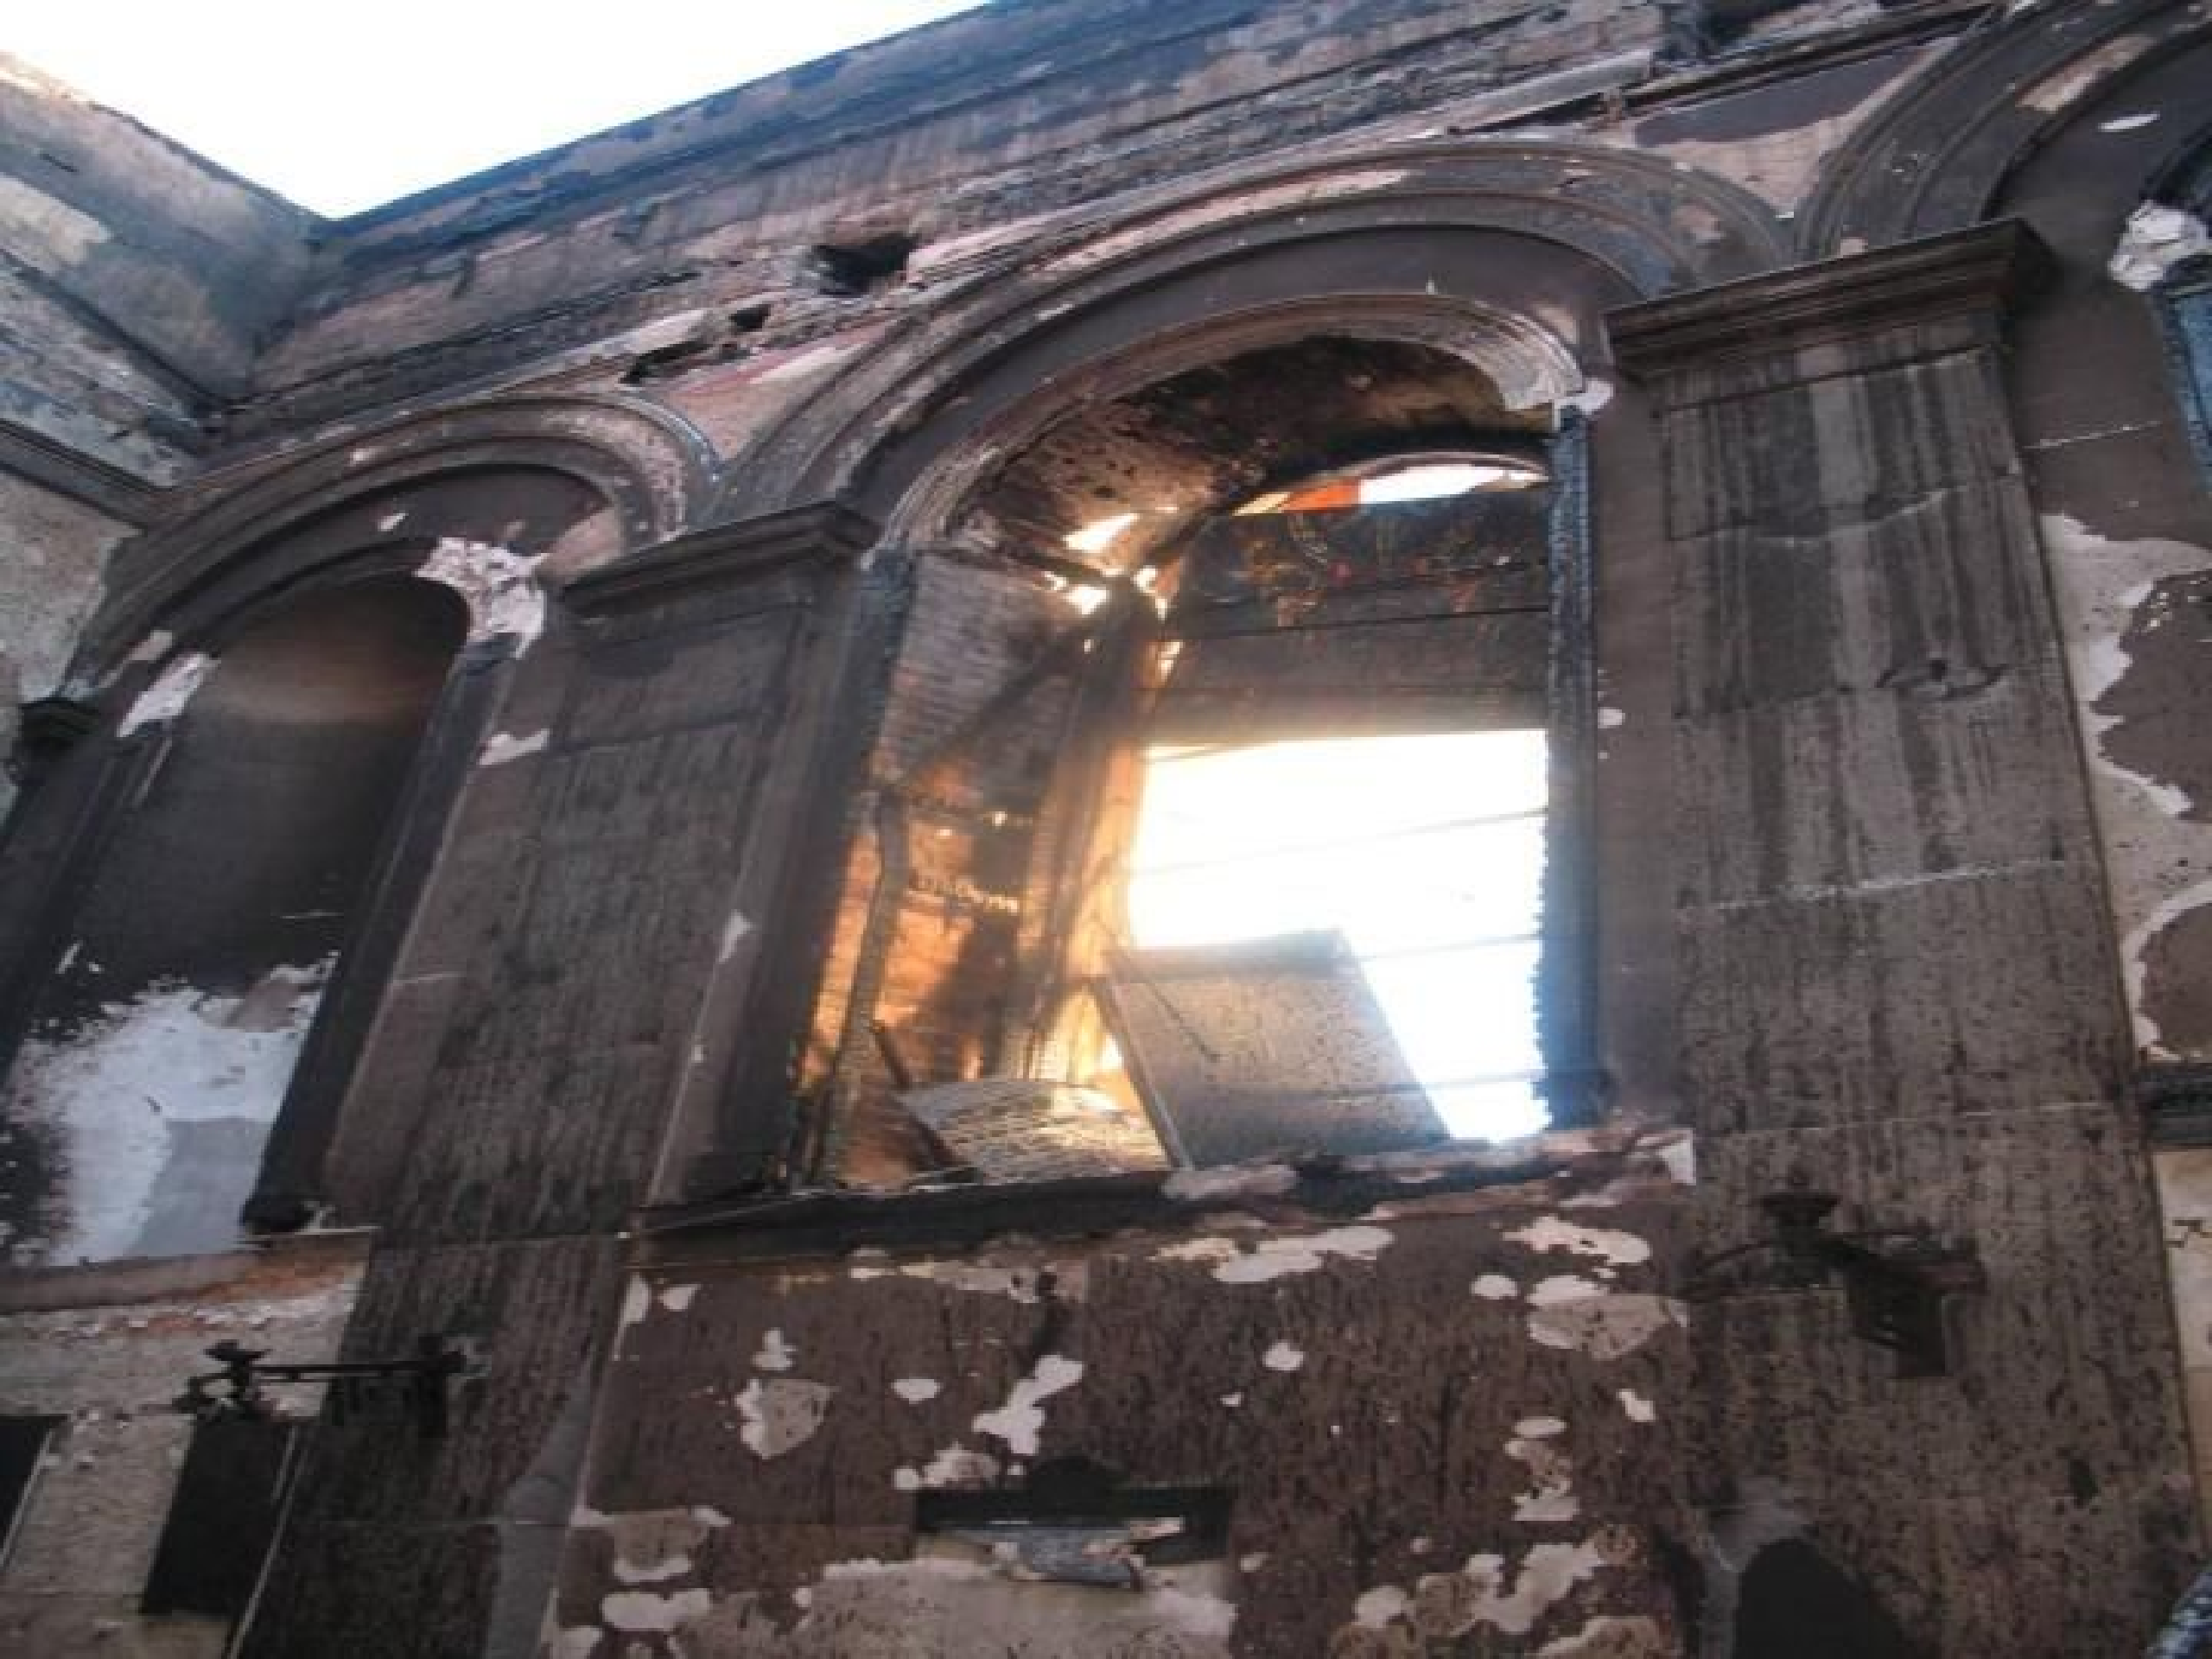
- Widespread damage has been suffered to all doors and windows serving both external elevations and internal partitions.
- Stained glass windows to include Harry Clarke windows within east and west transepts are extensively damaged though have been removed for assessment and restoration where feasible by appropriate specialists.
