St Mel's Cathedral Longford – Fire 25th December 2009

Summary of Nature & Extent of Damage

Presentation to the Diocese of Ardagh & Clonmacnois

Saturday 10th April 2010

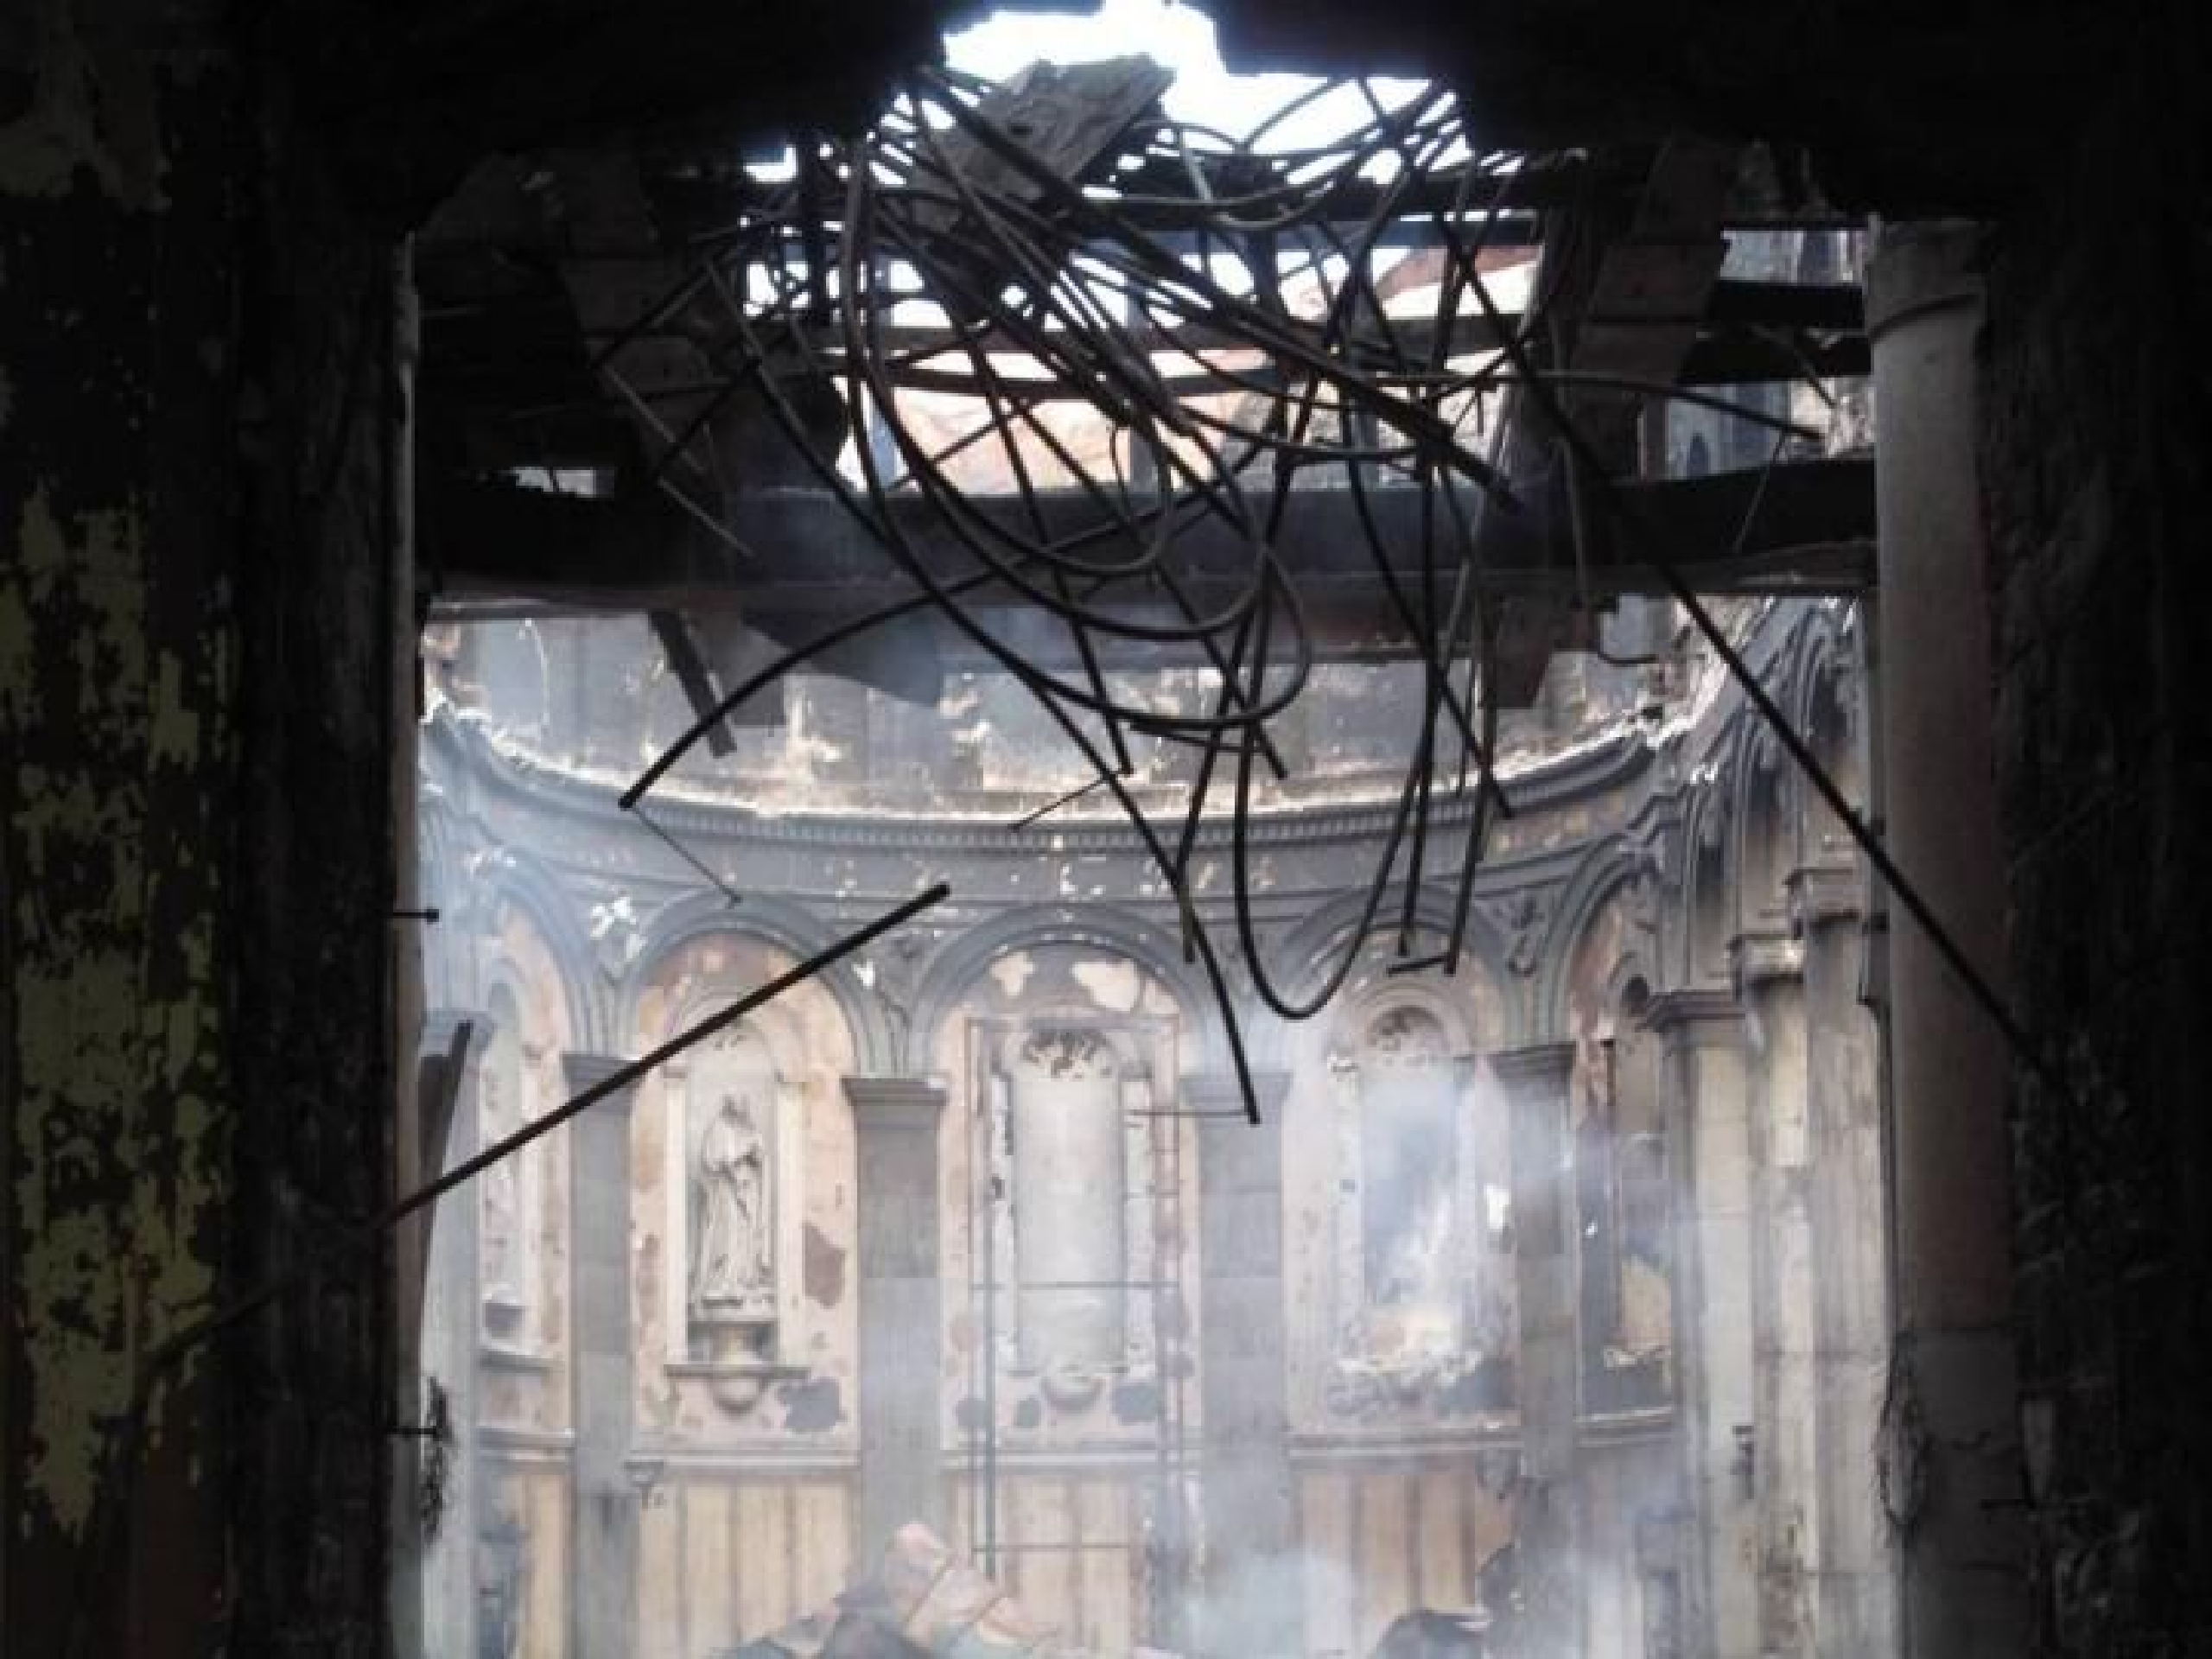
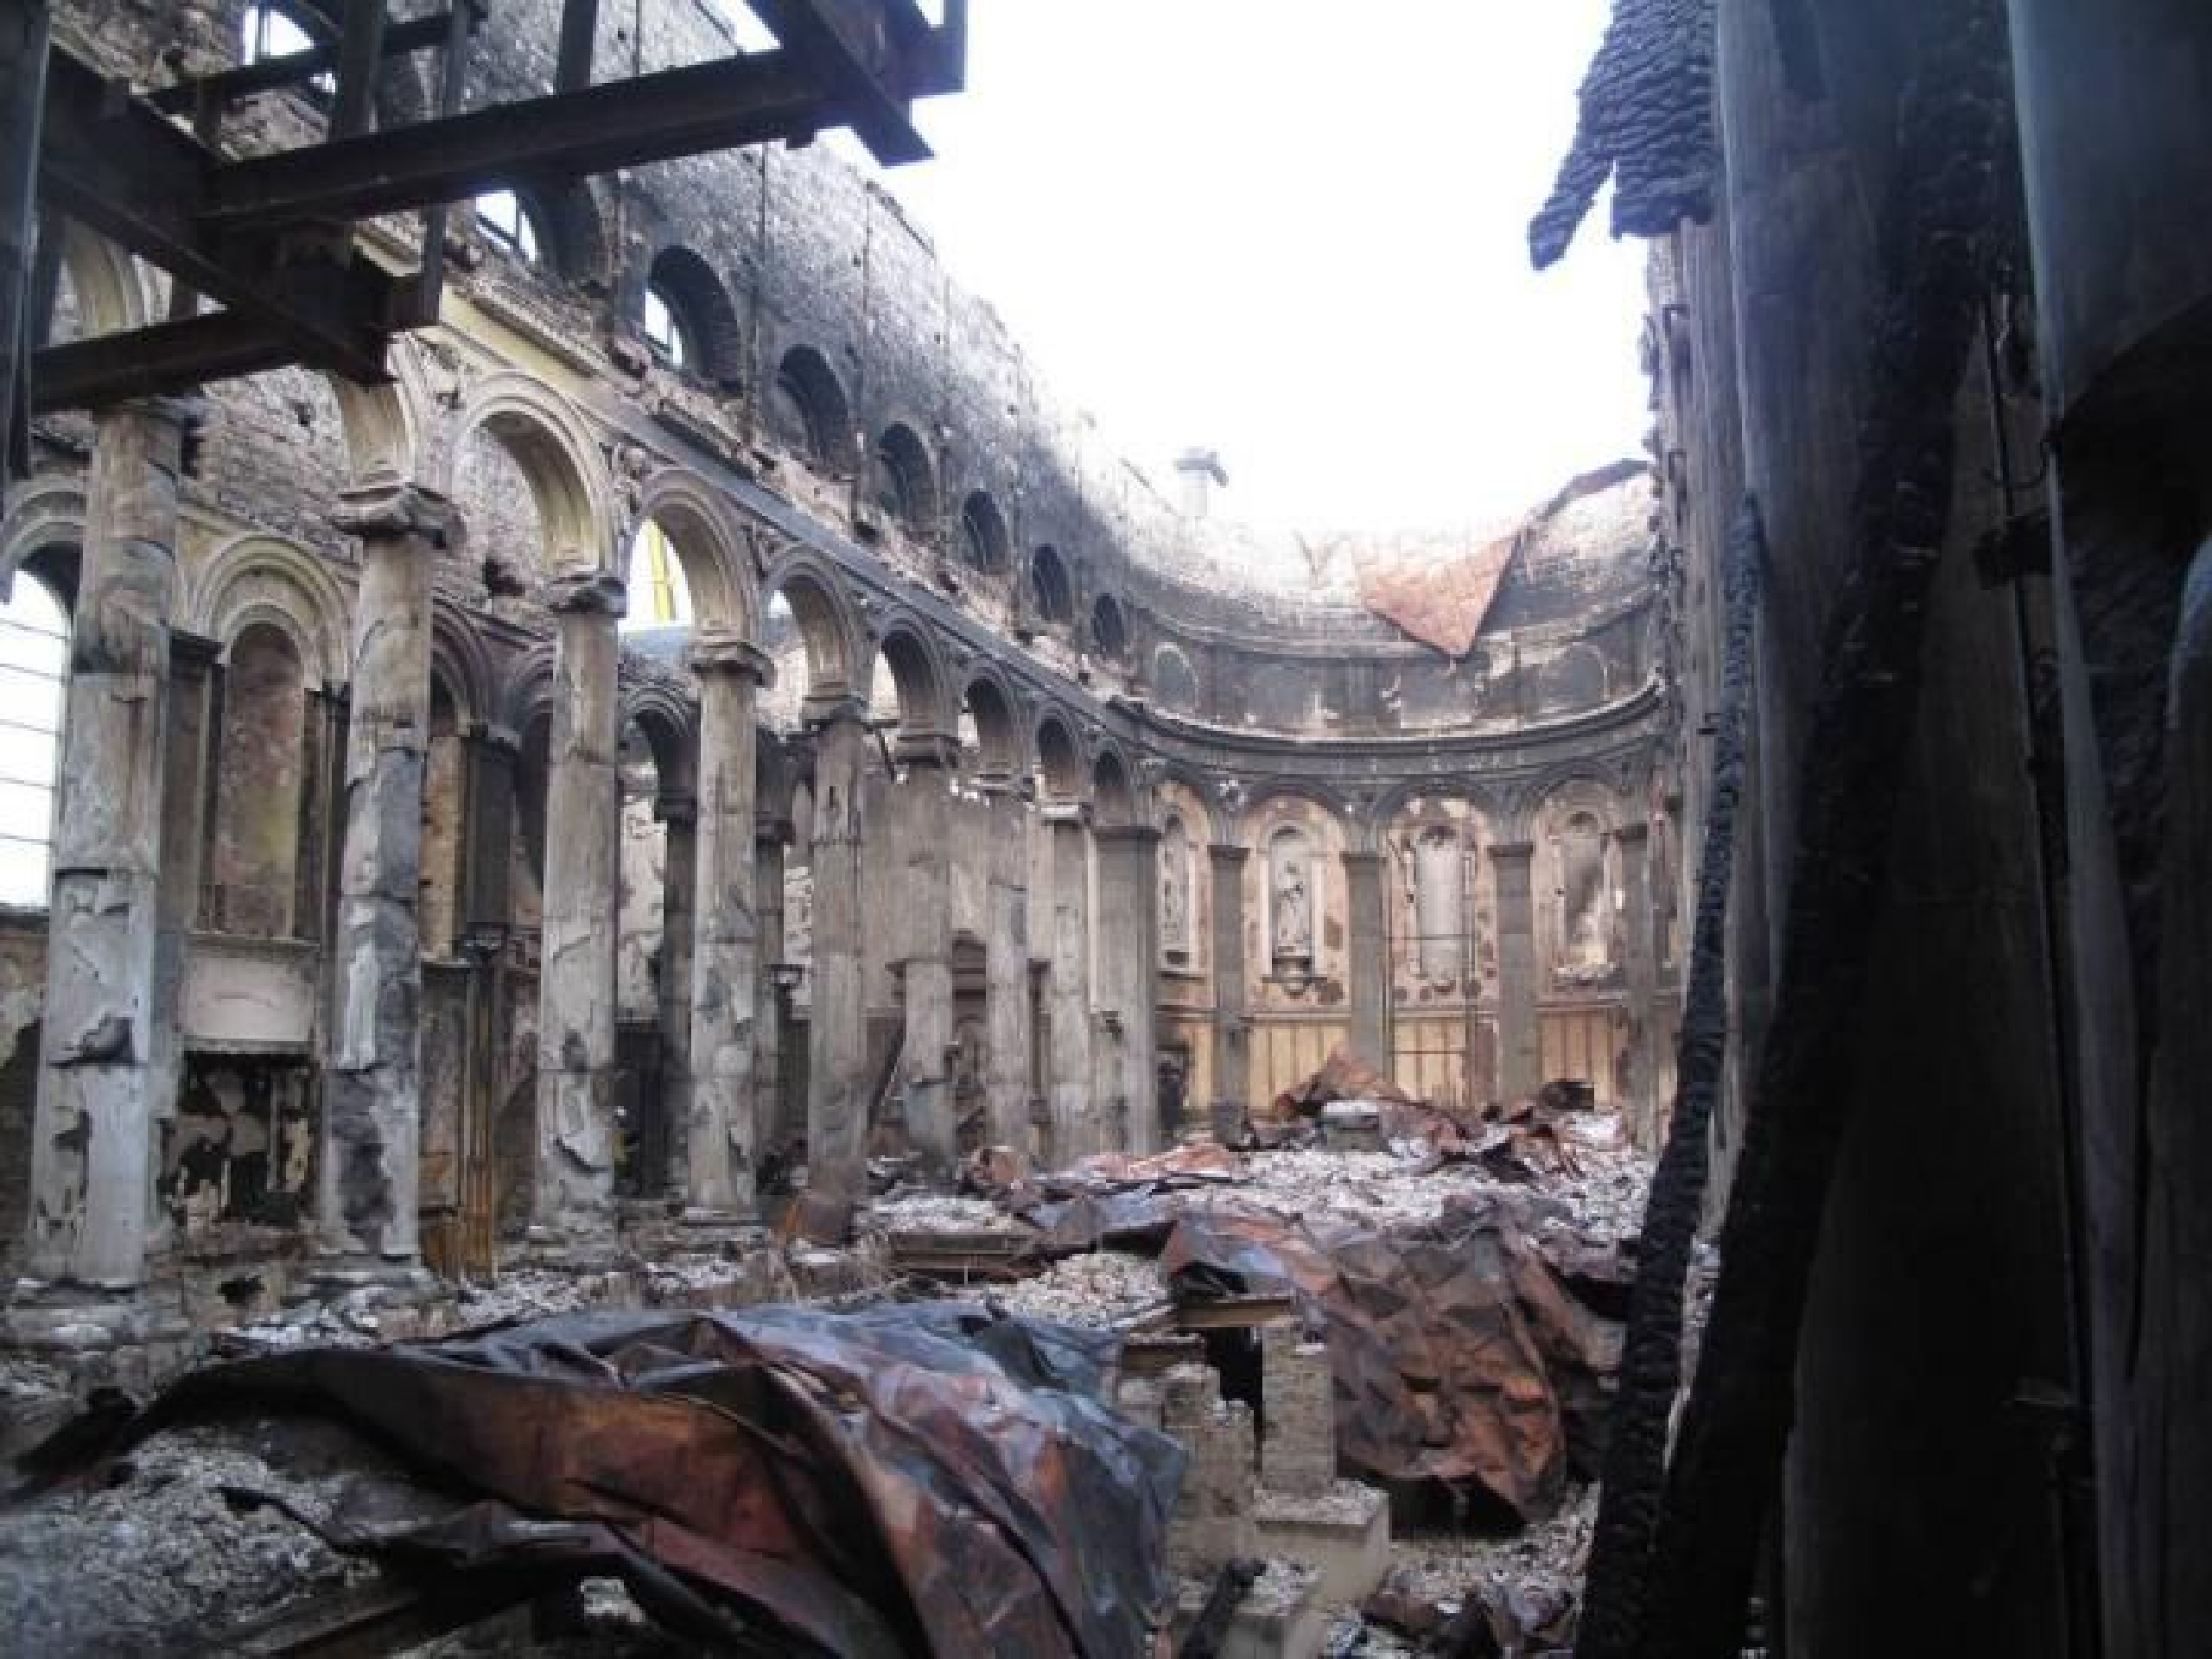
- Internal ceiling and wall plaster to include feature plasterwork and bulkheads, decorative finishes, panels and plaques have been effectively destroyed throughout.
- Minor elements within both transept chapels may be capable of restoration though the majority of finishes will unfortunately need to be renewed within their entirety.
- Redecoration will be necessary throughout all affected areas.

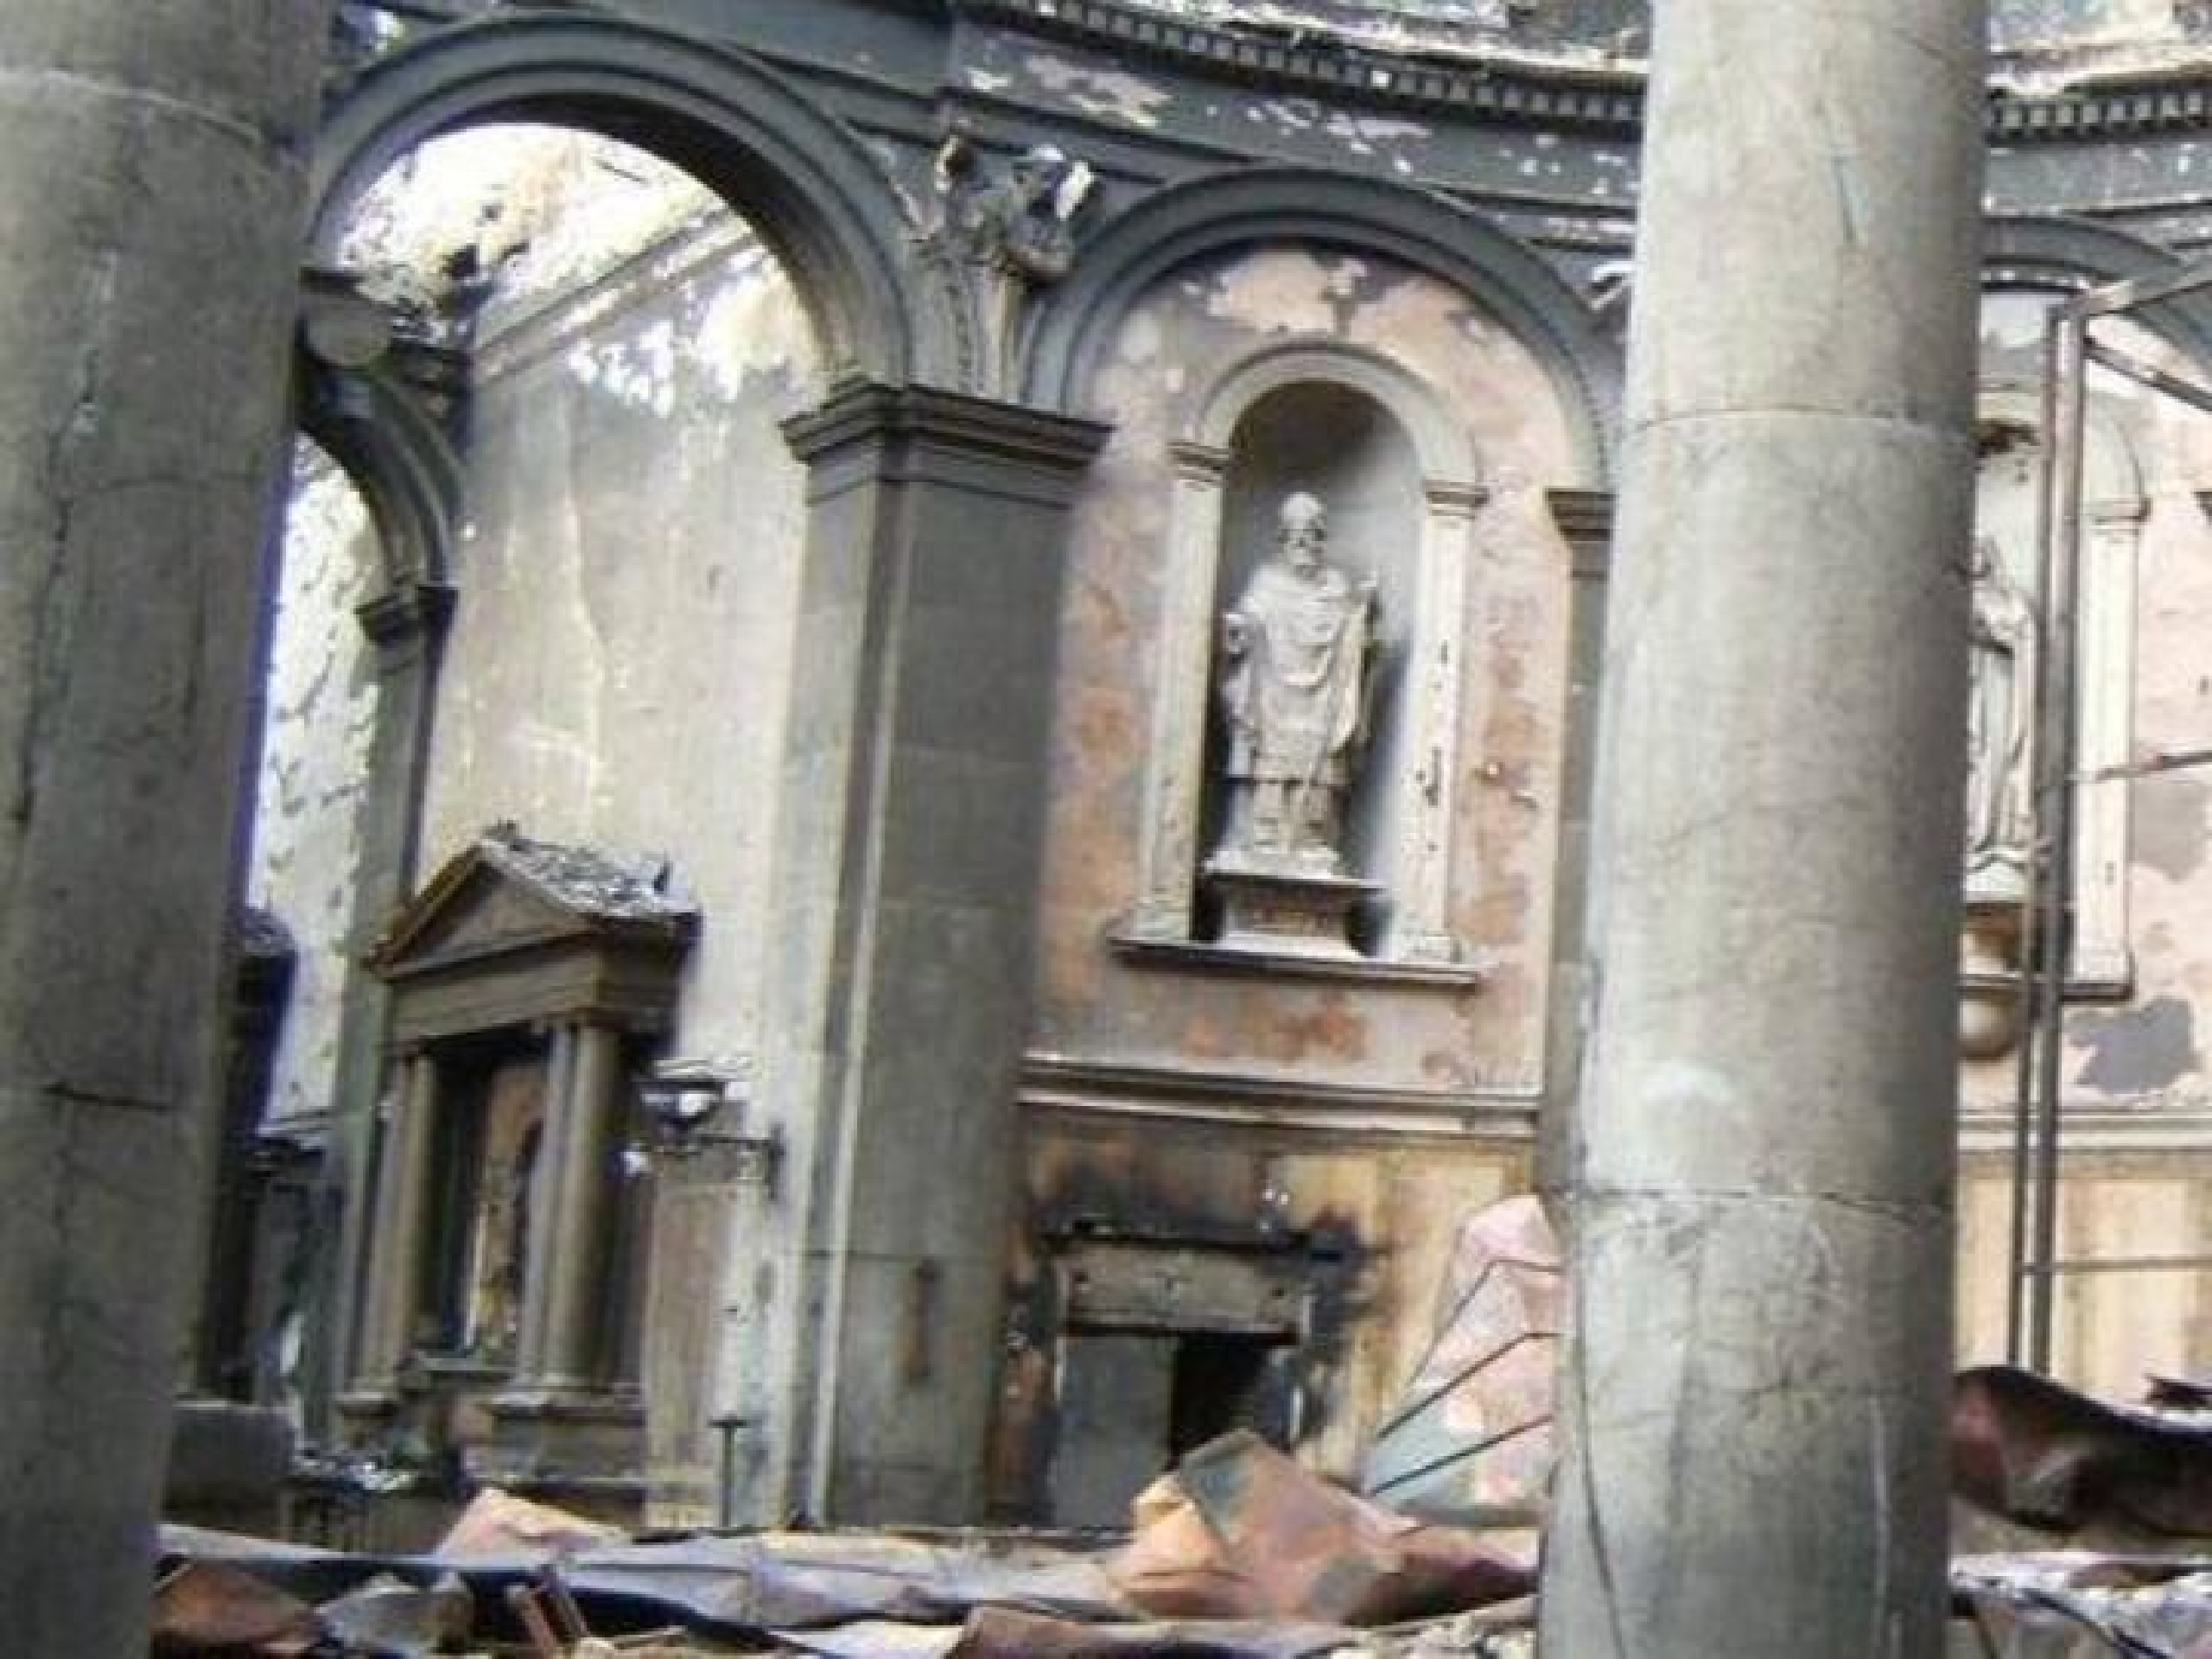
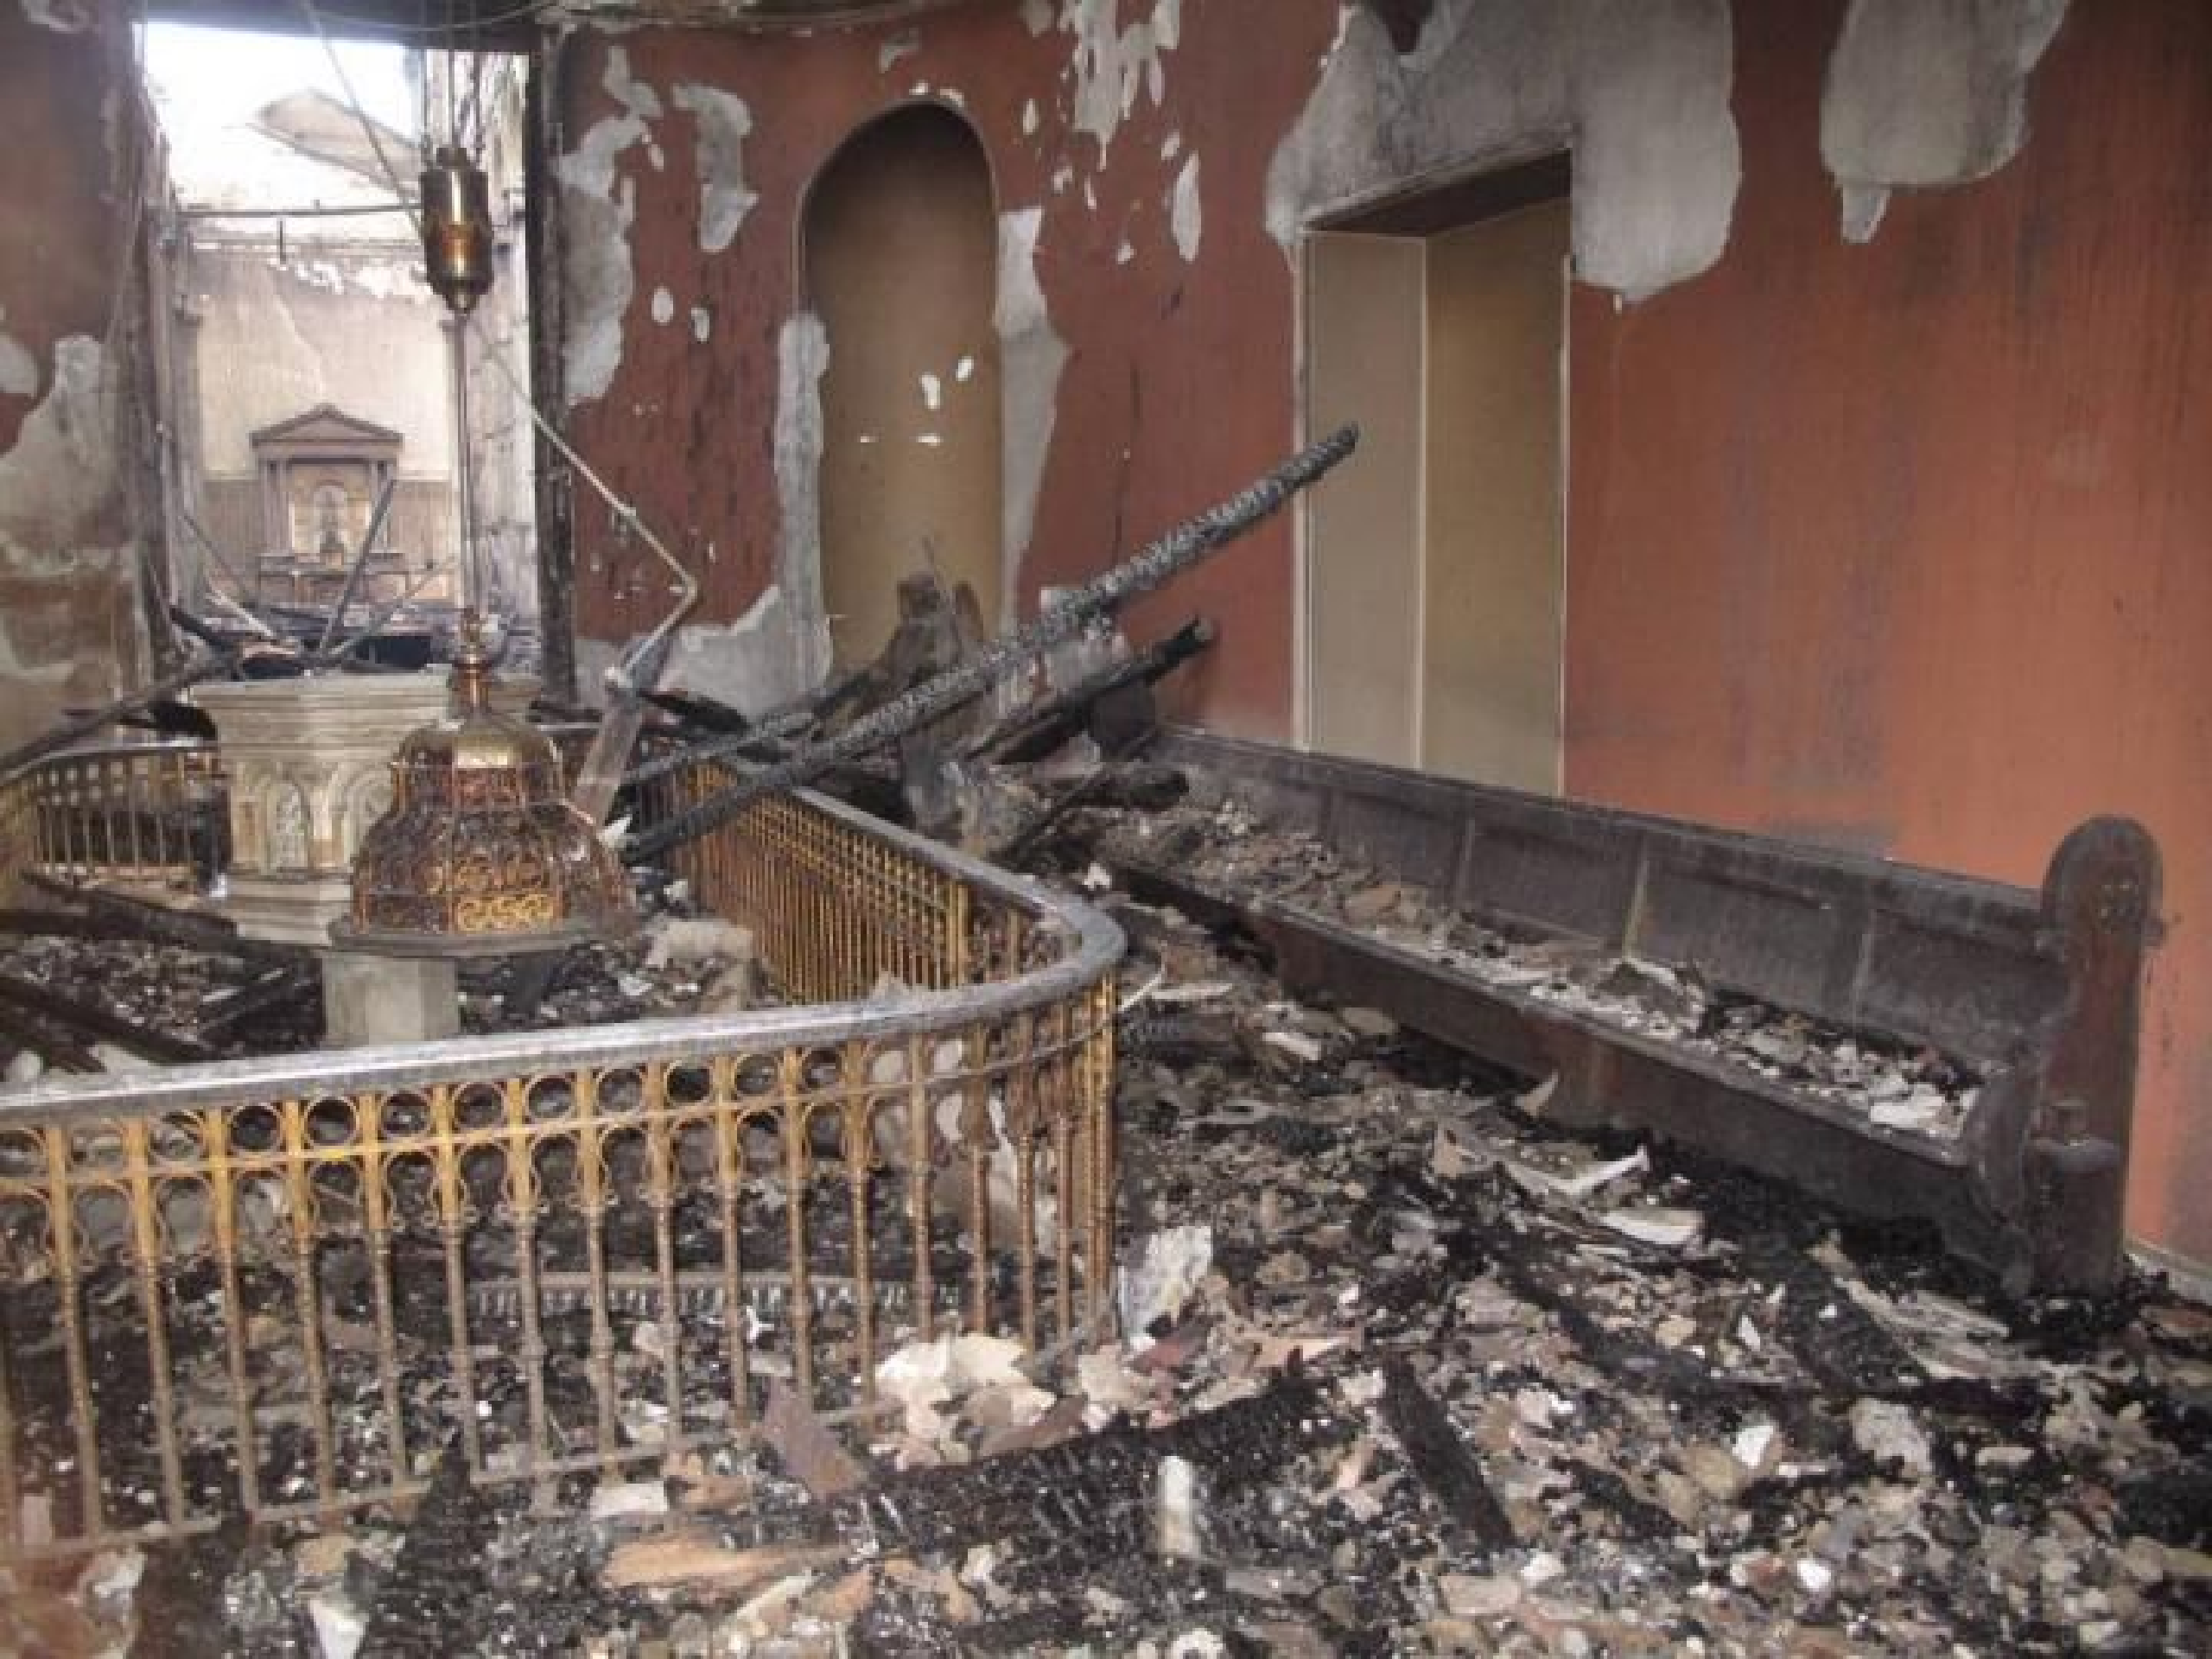
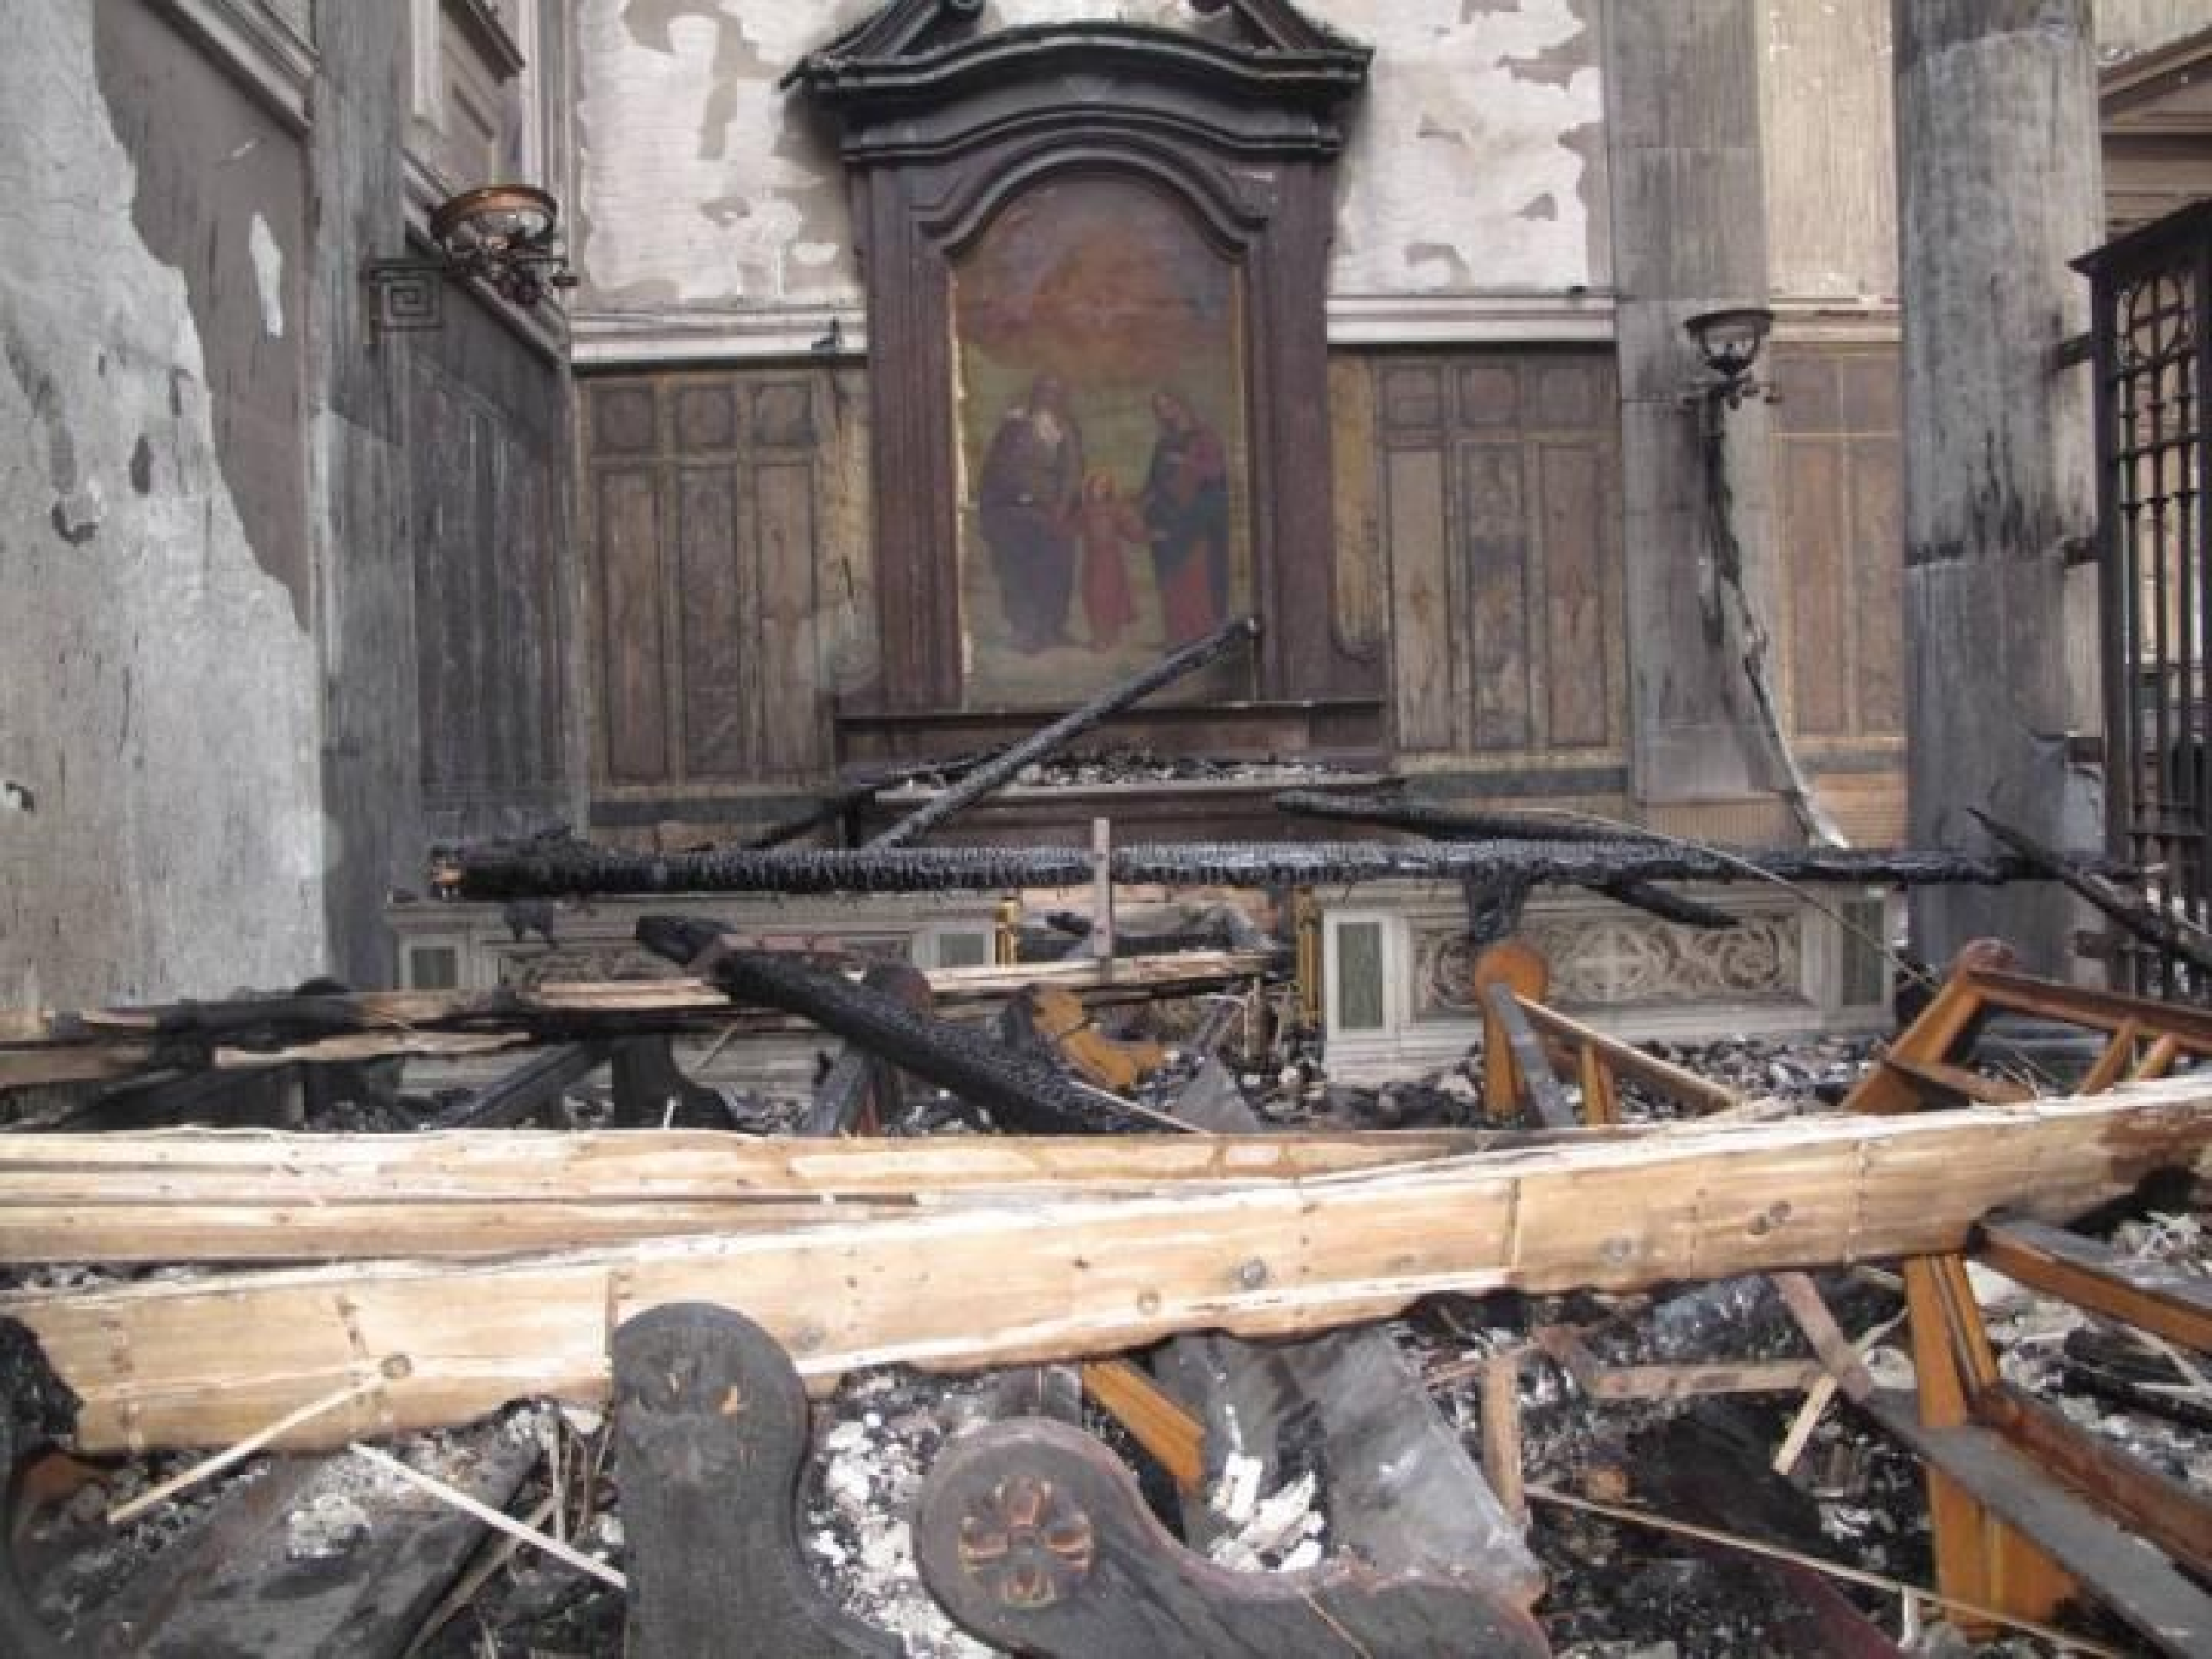
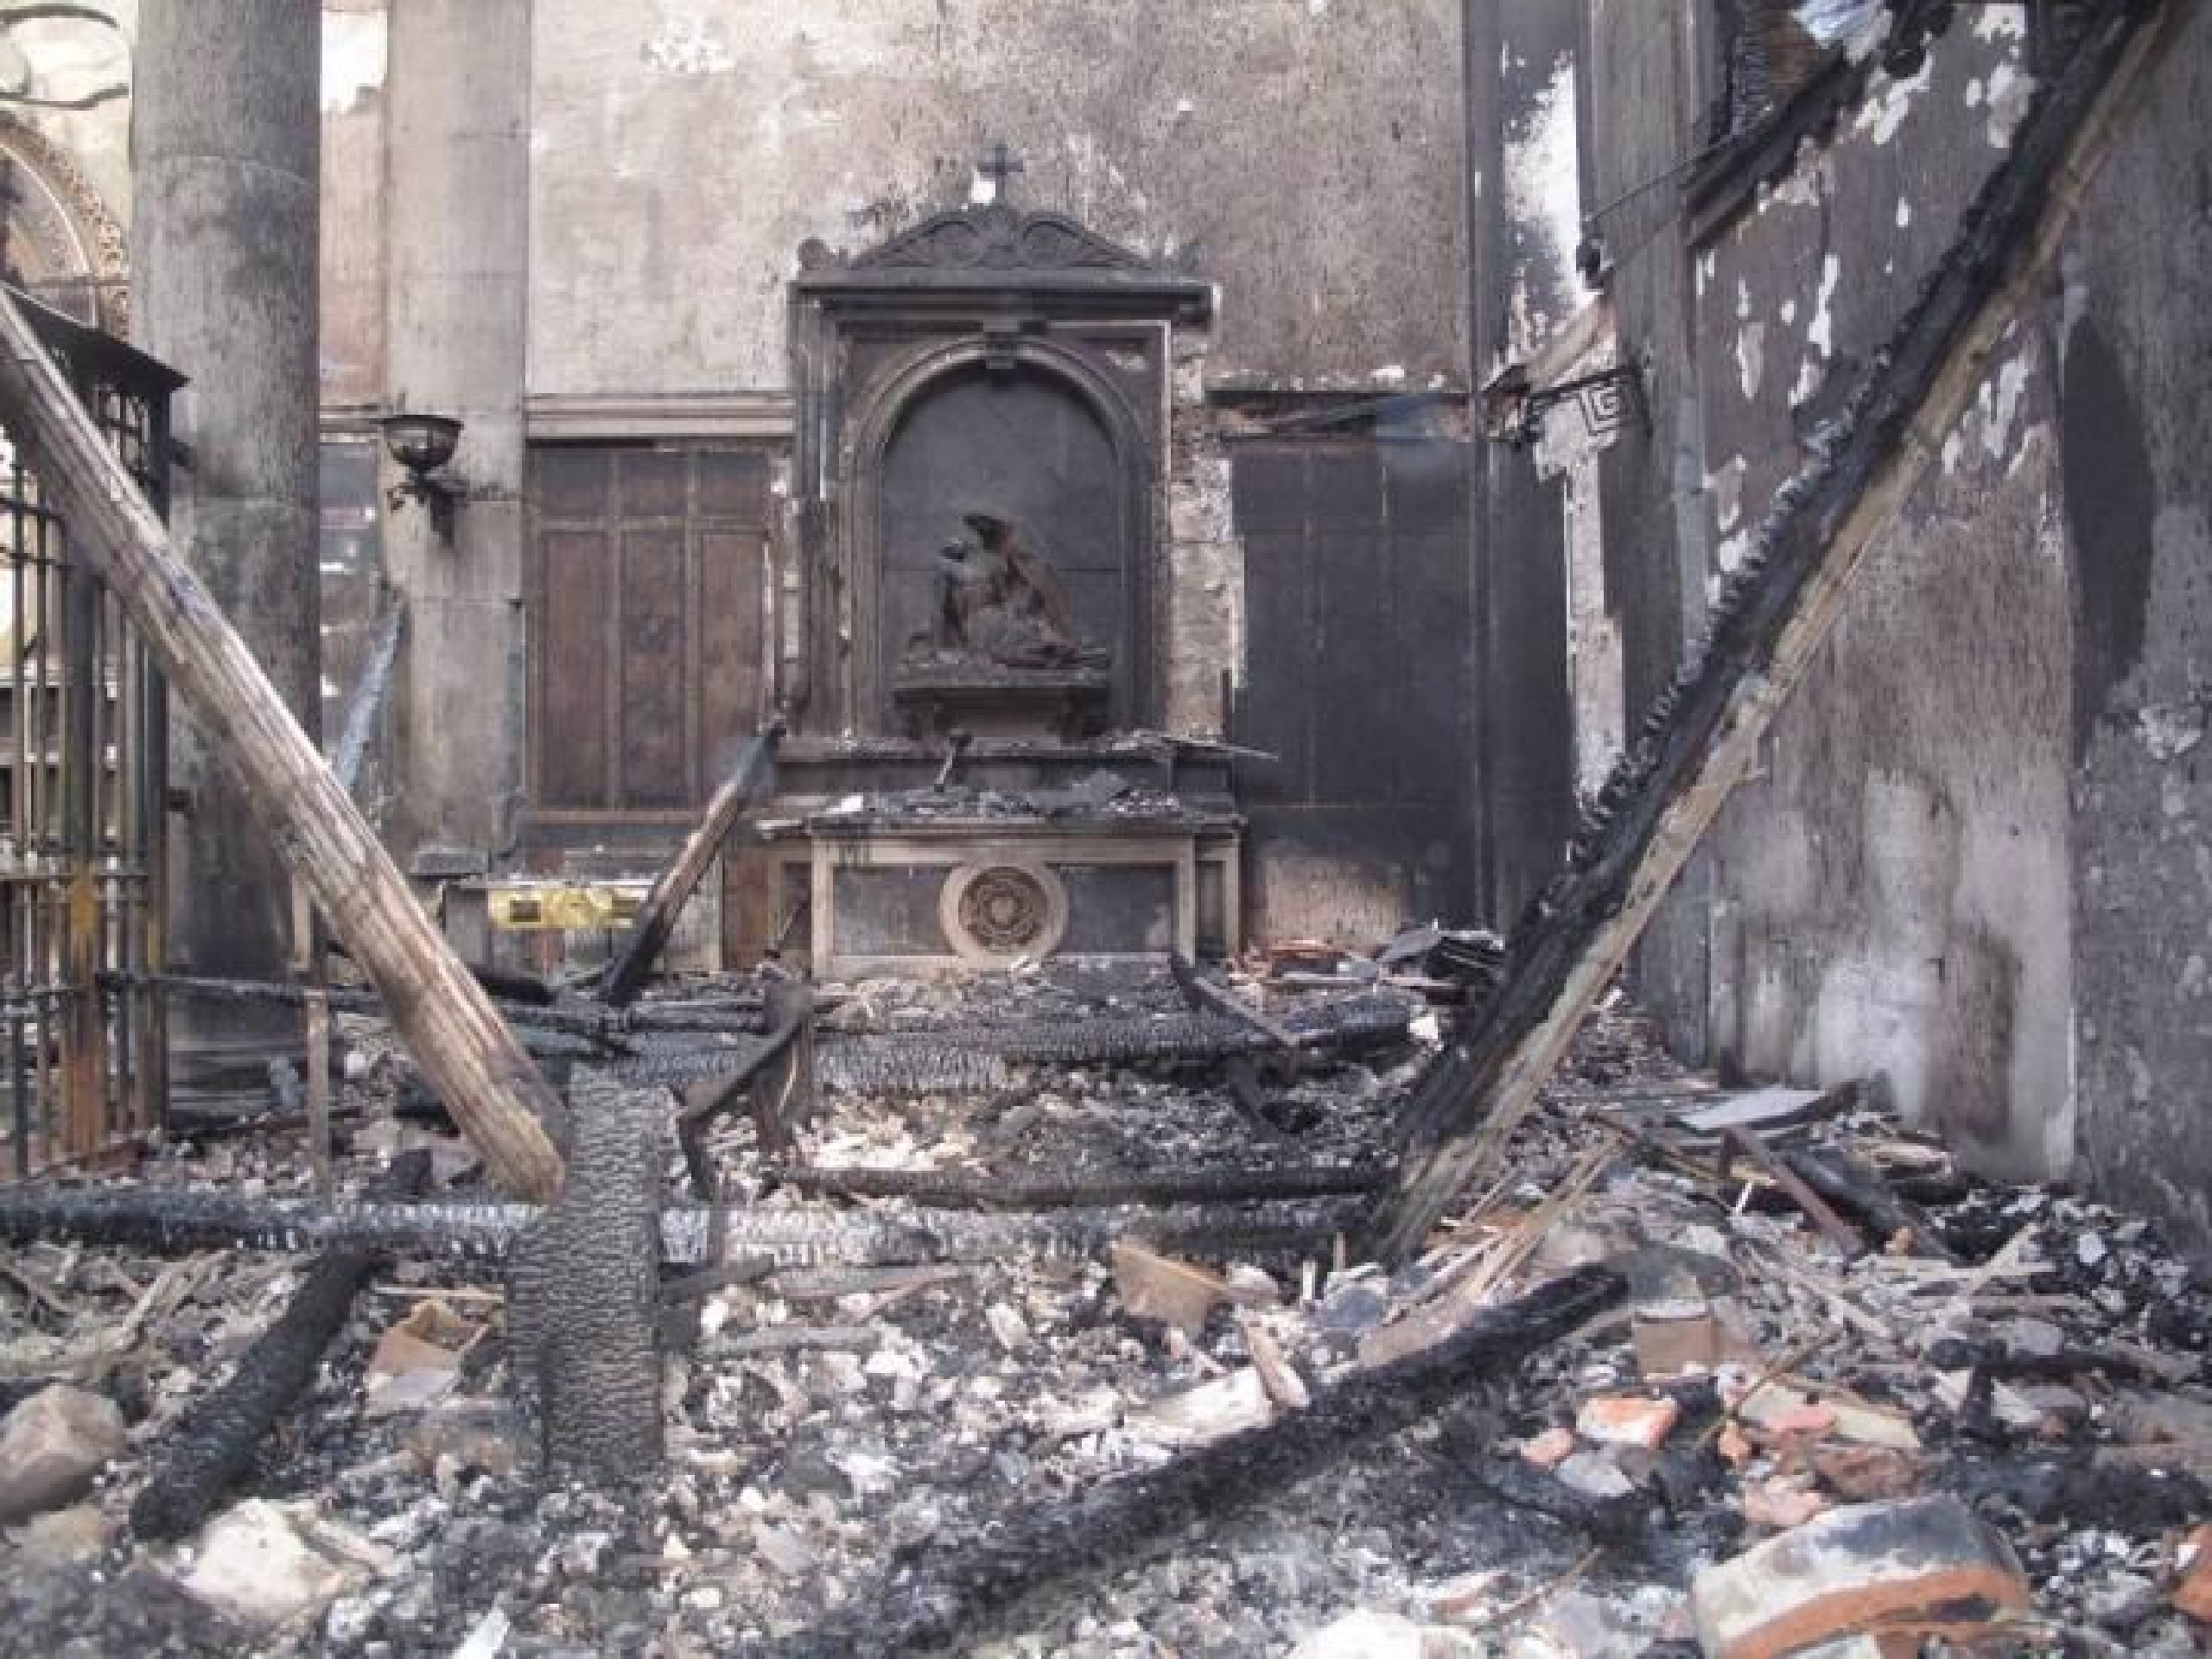
- Extensive damage has been caused to statues, altars and water fonts to varying degrees. One of the surviving statues was that of St Mel.
- Other items to include the organ gallery, pitch pine pews, confessionals, altars, stations of the cross, Ambo, Presidential Chair, rostrum and other contents have been destroyed.
- Extensive destruction was suffered to contents within the Cathedral museum. Many artefacts have however been recovered, details of which will be outlined further in this presentation.
