St Mel's Cathedral Longford – Fire 25th December 2009

Summary of Nature & Extent of Damage

Presentation to the Diocese of Ardagh & Clonmacnois

Saturday 10th April 2010

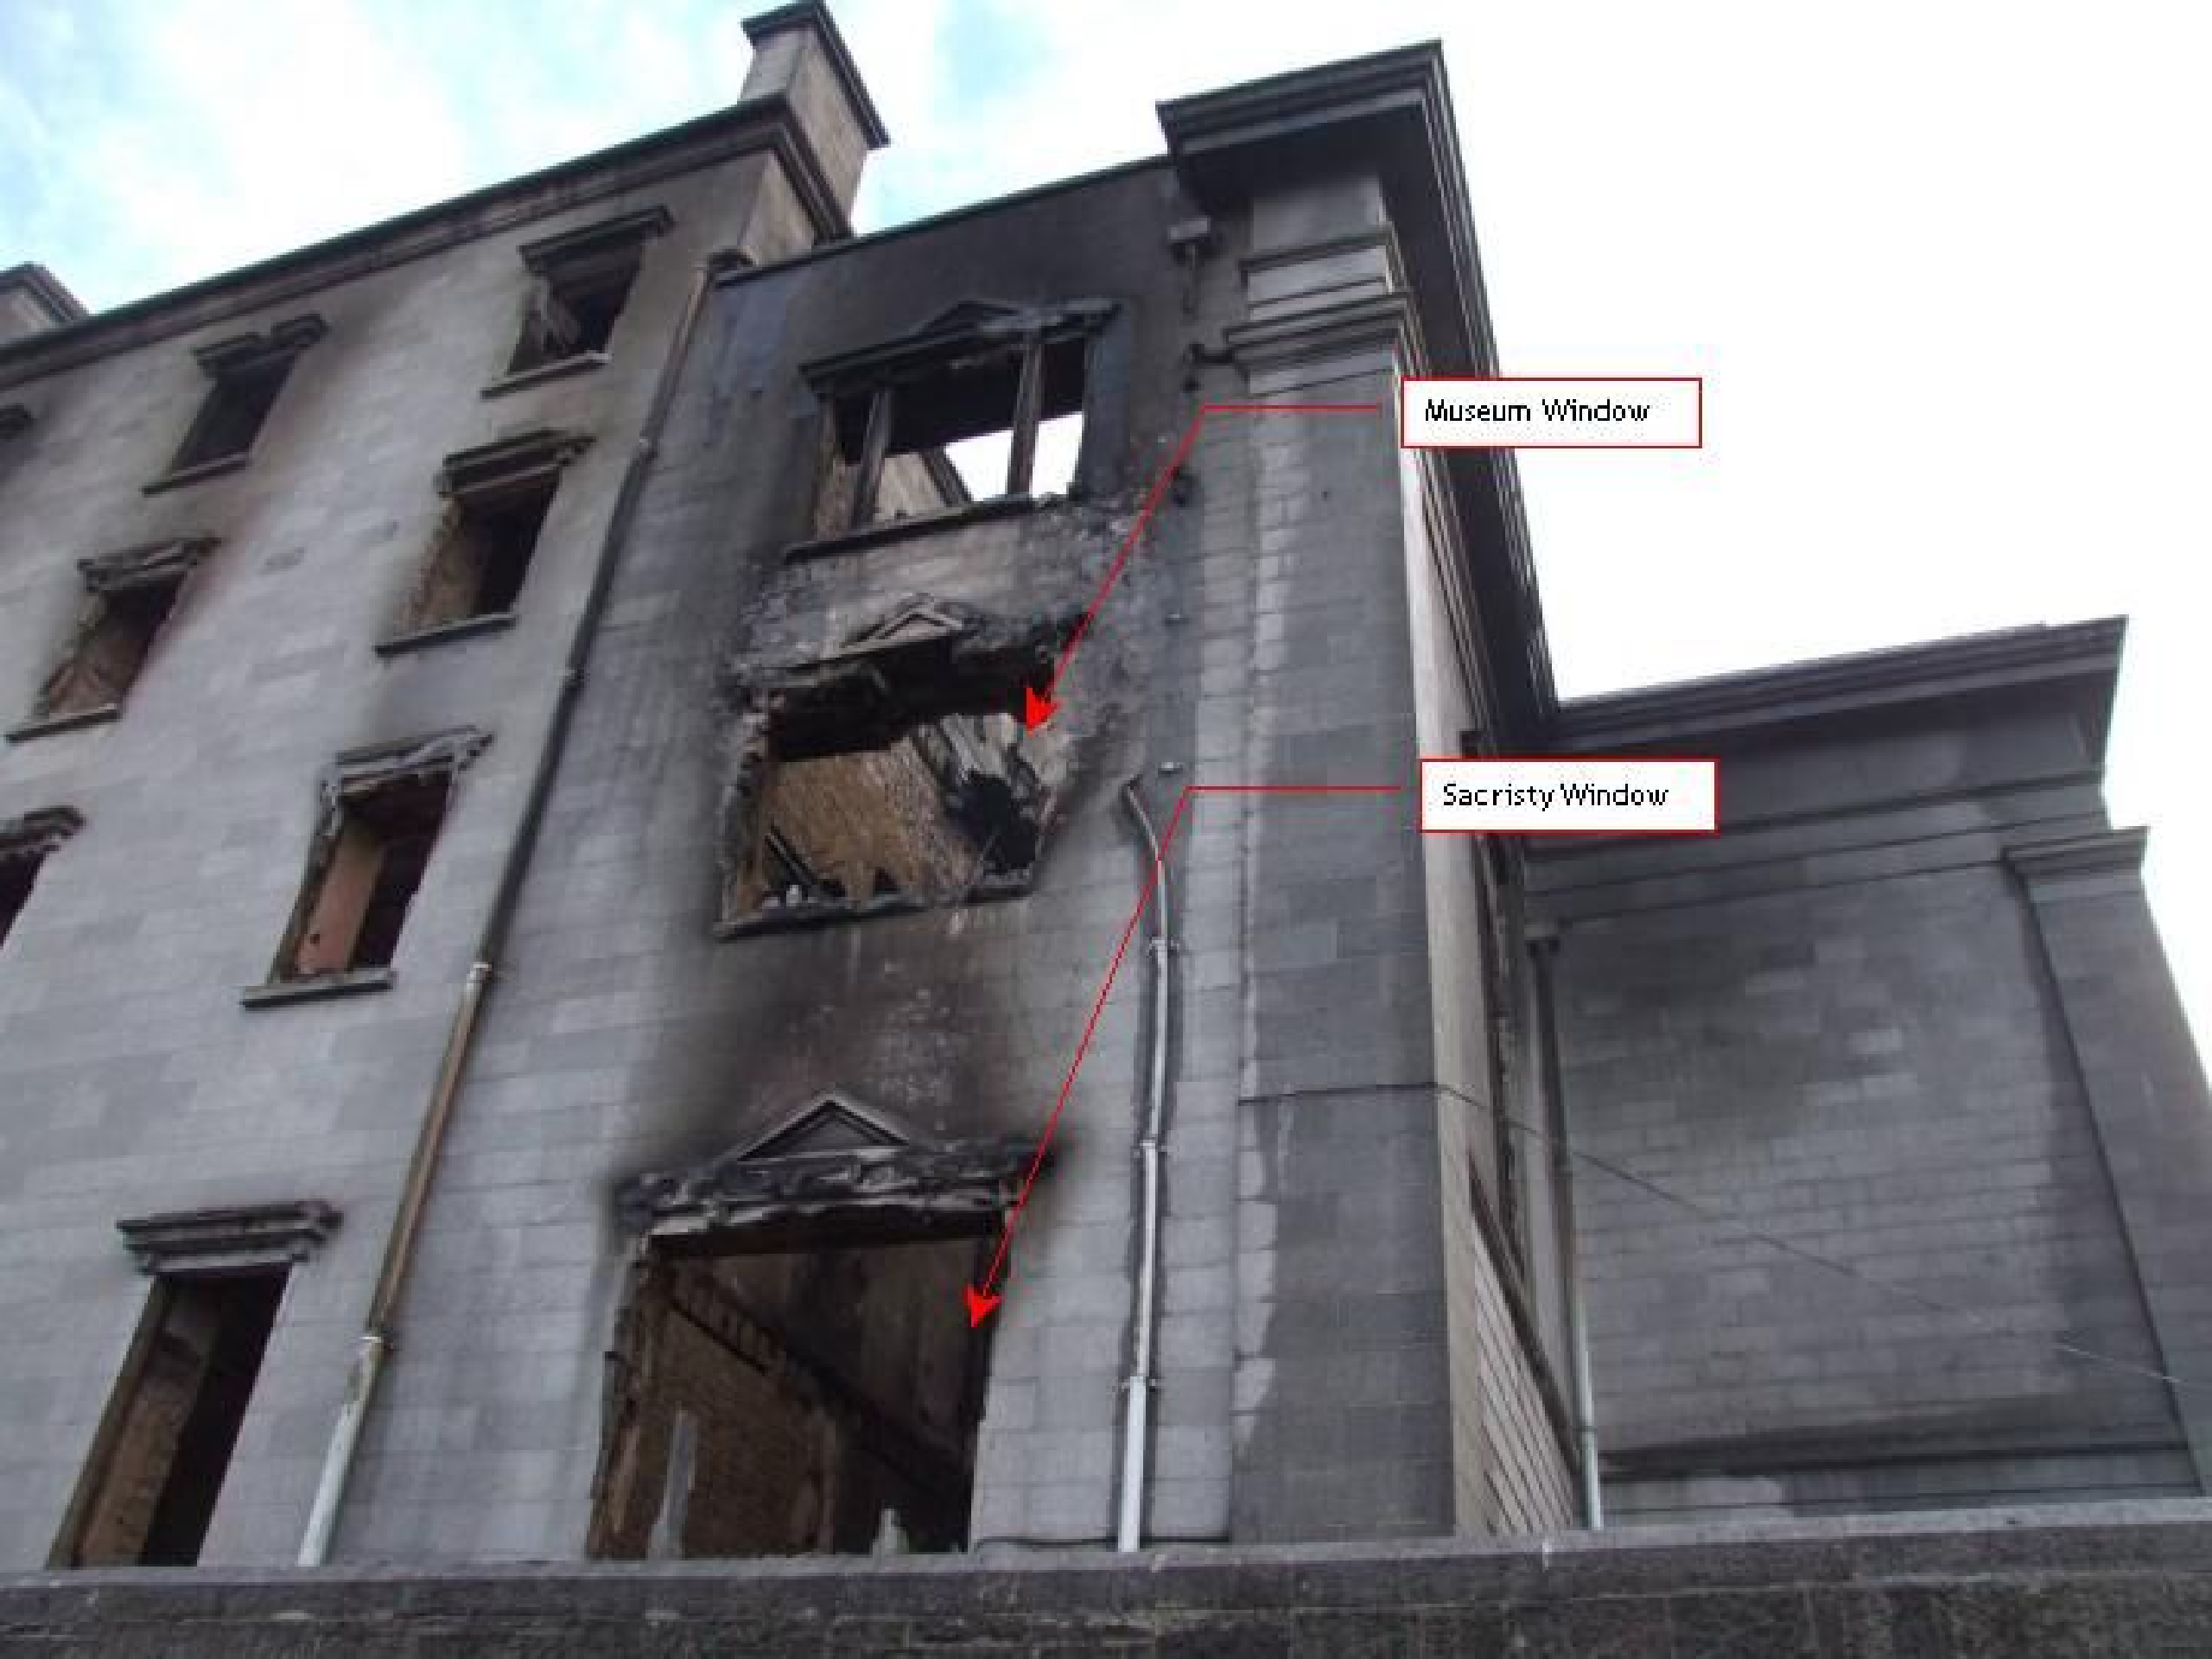
Museum Window

Sacristy Window
